Chapter 7

Classification of fault by Sweep Frequency Response Analysis

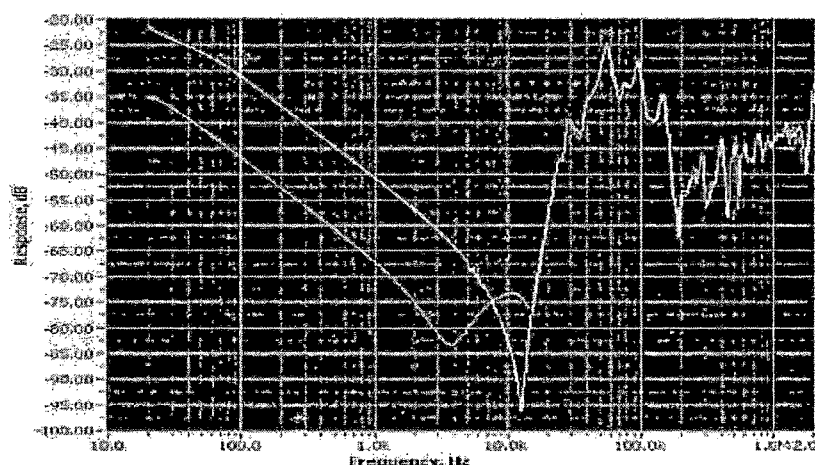
Figure 7.3: Open circuit plot for core fault (3-phase)

1. In core related fault like localized overheating of core due to circulating currents, there will be change in dB value or the change in shape of plot in frequency band of 10Hz to 1kHz based on the design of transformer as shown in Figure 7.3.
2. The short circuit plot of HV winding will be identical in two sister unit or between phase of one unit in the frequency band from 10Hz to 1kHz for core faults as shown in Figure 7.4.
3. The response of the center phase is slightly different between 200Hz and 500Hz area of frequency due to the different flux paths through the core compared to outer winding and it should not be misunderstood as core related issue. For core magnetization, it is possible to demagnetize the core and retest the transformer for SFRA. If

the low frequency variation does not go away - it is not a magnetization issue. Performing an Exciting current measurement before and after demagnetization would provide additional evidence for magnetization being the cause of variation.

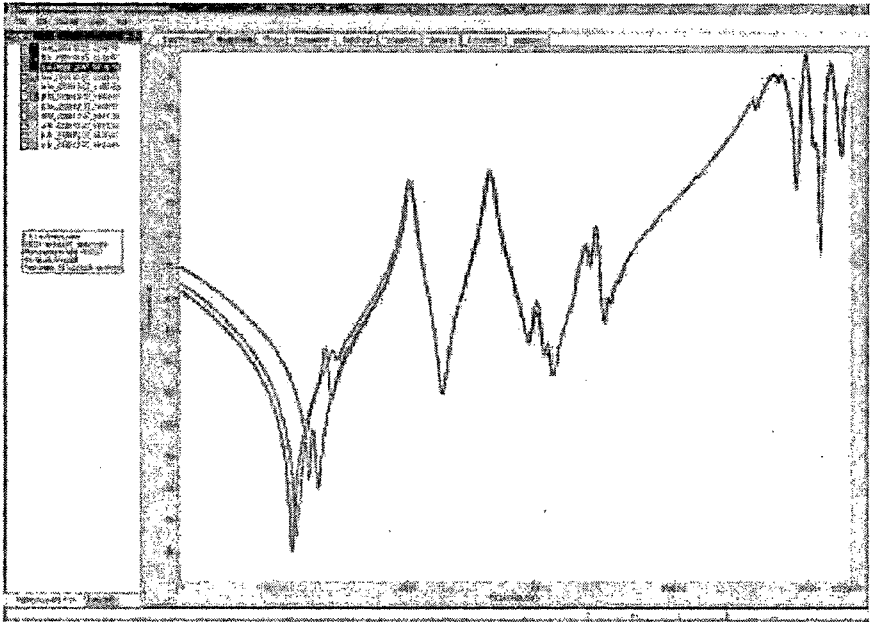
Figure 7.5: Open circuit plot for series winding (3-phase)

The SFRA test data (After installation at site) of new 100 MVA Auto Transformer, 220/132 kV is shown in Figure 7.5, Figure 7.6 and Figure 7.7. There was no base SFRA data available from factory test hence three phase comparison is performed in this case. It is evident that low frequency response of outer phases was not normal in frequency range of 10 Hz. to 1 kHz for open circuit SFRA plot shown in Figure 7.5 and Figure 7.6.

After detail investigation, it was found that connecting point of Core ground for earth connection was loose and visible from outside of the Tank. Transformer was commissioned

after making the earth point intact by repair and transformer is saved from unnecessary overheating of the core due to high eddy current circulation after energizing, if this problem was not rectified.

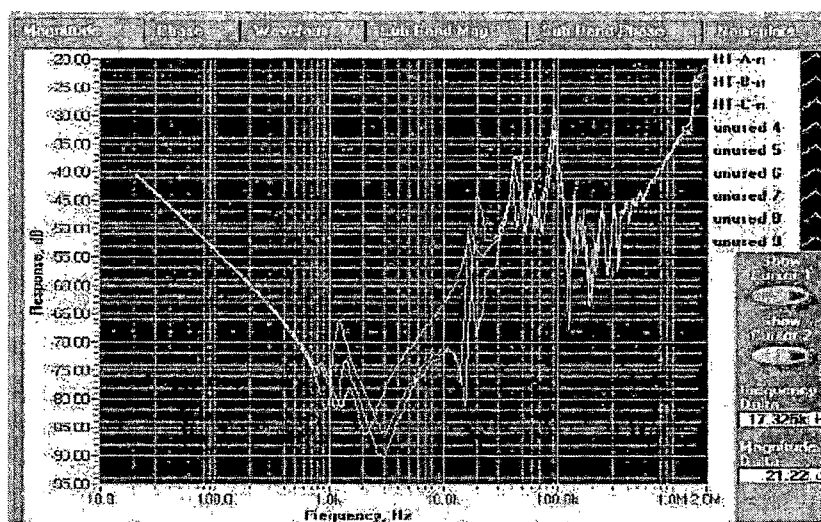
Figure 7.8: Open circuit plot after fault (3-phase)

250 MVA, 220 KV / 110 KV / 33 KV auto-transformer was indicating increasing trend of dissolved gasses, since its commissioning. The DGA analysis indicated core fault (hot spot). After un-tanking, no abnormality in the windings or core was noticed on physical inspection. SFRA test conducted in this condition only and showed marked deviation of response between the phases from 500 HZ to 10kHz frequency as shown in Figure 7.8. Here, the lower frequency is increased upto 10 kHz., since there was no oil and bushing on the transformer and overall capacitance of the winding is decreased. On removing the top yoke laminations obvious burn marks on lamination were observed. The top clamping board insulation pressed the laminations of the top yoke causing short circuited laminations at few places as shown in Figure 7.10. The core repair was carried out and all tests including SFRA test were done satisfactorily as indicated in Figure 7.9.

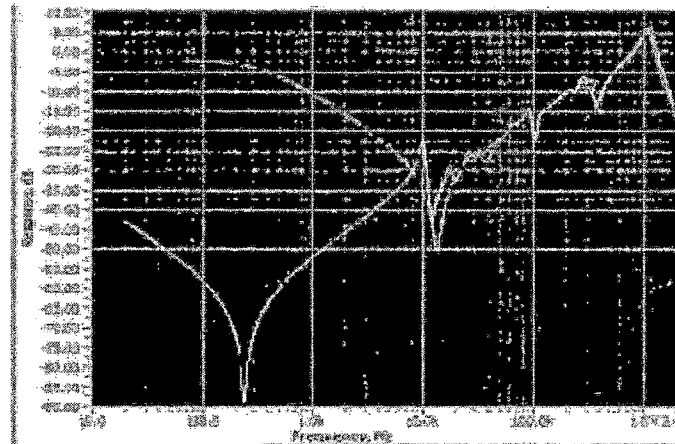
Figure 7.11: 3 phase Open circuit plot for shorted turn fault (blue color: H3-H0 phase)

1. In short circuit related fault, there will be change in dB value and change in shape of open circuit SFRA plot at frequency 10Hz to 1kHz , as shown in Figure 7.11.
2. The short circuit plot of HV winding will be not be identical in two sister unit or between phase of one unit in the frequency band from 10Hz to 1kHz for such faults as shown in Figure 7.12.
3. In case of the short circuit fault of turn to turn or disk to disk type like as indicated in Figure 7.13, the core circuit is bypassed and hence variation is observed in open circuit plot up to 10 kHz and first core resonance will be absent as it is evident in Figure 7.11.

From the three phase short circuit and open circuit plot, it was clear that there is short circuit turn to turn fault in the H3-H0 phase. In Figure 7.12 and Figure 7.11, the H3-H0 Phase winding deviates substantially from the other two phases in the lower

1. The trace starts at much closer to 0 db than its sister phase traces, indicating a characteristic decrease in impedance.
2. The first resonant point was eliminated and replaced by a flat trace in the lower frequencies indicating a large decrease in the winding inductance that would be expected with a shorted turn.
3. In addition, the initiation of the H3-H0 phase(high Voltage winding short circuit traces) obtained with the Low Voltage winding short-circuited shown a deviation in the starting db of about 10 db as indicated in Figure 7.12. This is indicating a change in winding resistance caused by faulty or deteriorated connections in one of the windings in that phase.

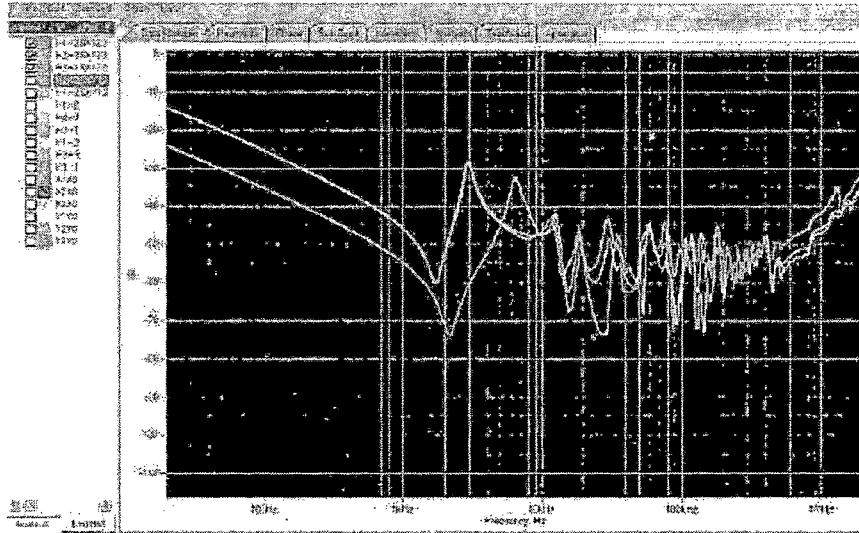
Figure 7.14: Short circuit plot for open circuit fault (3-phase)

1. In open circuit related fault, like developed high resistance or impedance in the winding circuit, there will be increase in dB value or the change in shape of plot at frequency 10 Hz. to 1 kHz.
2. The short circuit plot of HV winding will not be identical in two sister unit or between phase of one unit in the frequency band from 10 Hz. to 1 kHz for such faults as shown in Figure 7.14.

The Short Circuit SFRA test confirmed the high resistance of the H3H1 winding. The major variation is seen in the short circuit response of other two windings as their shape also got changed . It can be due to the increase of resistance which occurred during open delta case. As Winding resistance indicated that H3H1 had (15.5mohm) two times higher

resistance than other 2 phases (7.8mohm), it is obvious that H3H1 phase has open circuit fault .

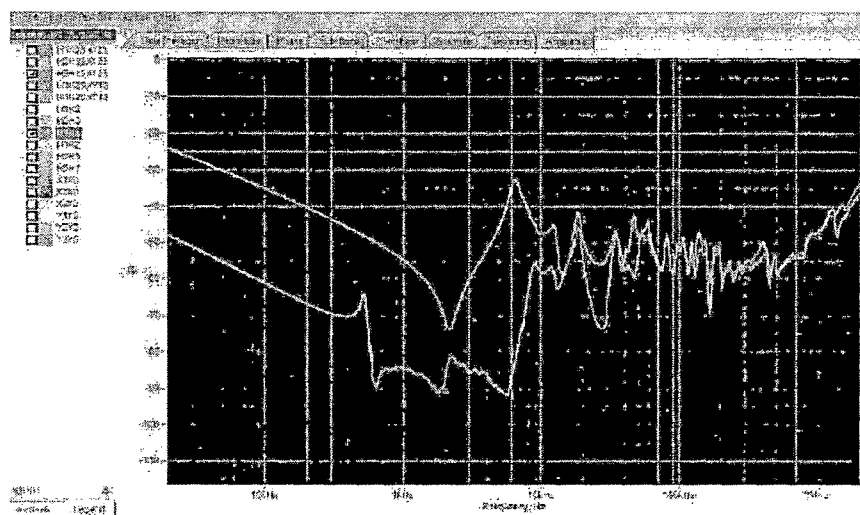
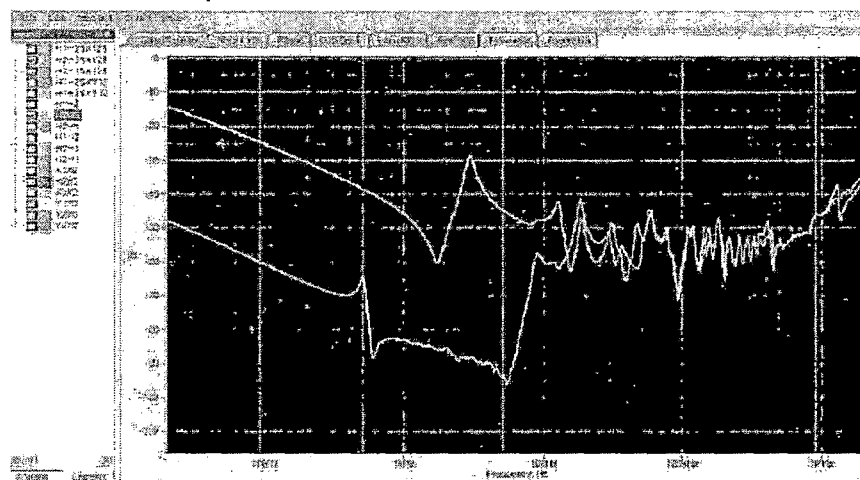
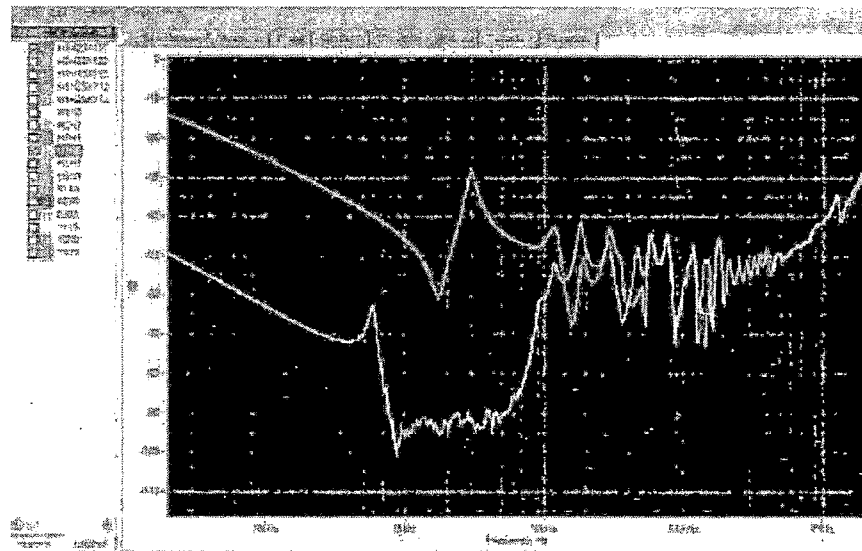
Consider that R is the Resistance of phase winding. Then, during the measurement through SFRA or Winding resistance in delta winding configuration, the equivalent resistance between phase is $2R/3$ for Delta winding . It increases to R for healthy winding and $2R$ for faulty winding in case of open Delta fault in the winding. So, it has effect on the Short circuit SFRA traces of HV winding for all three phase as evident from Figure 7.15, Figure 7.16 and Figure 7.17.

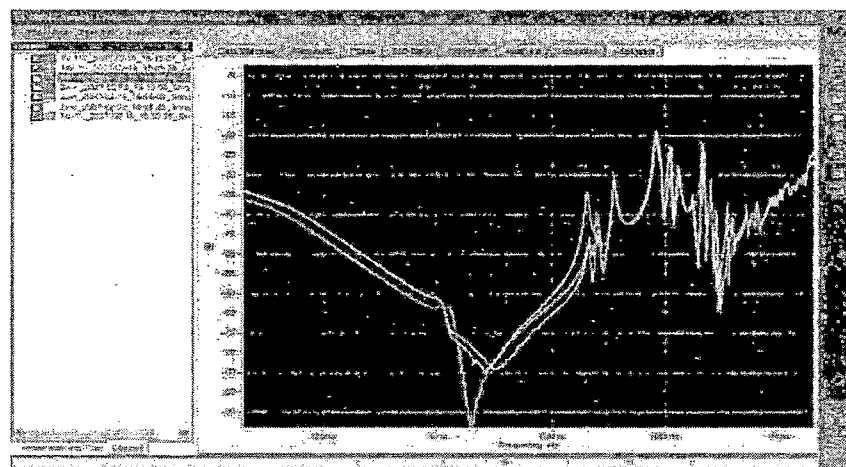
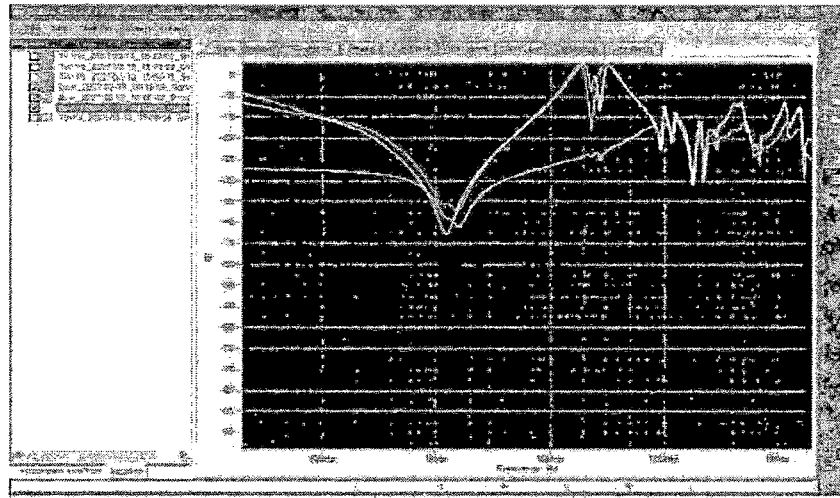
SFRA data of 100 MVA Power Transformer, 220 kV/ 24 kV , HV/LV (Delta/Star) was reviewed after a system fault. The Open Circuit SFRA test on LV winding as indicated in Figure 7.19 confirmed the high impedance fault in the V-Phase winding and it has affected the open circuit SFRA plot of HV winding also as indicated in Figure 7.18.

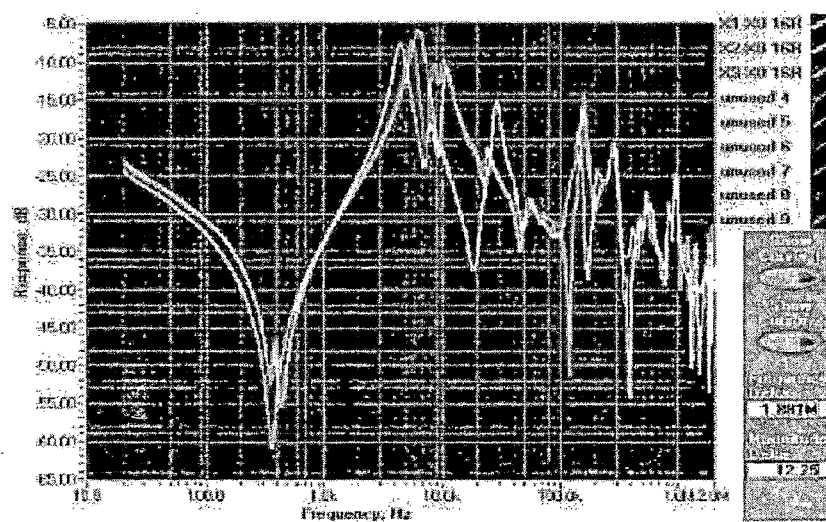
Figure 7.22: Three phase LV open circuit SFRA plot after fault

30 MVA, 138/69 kV Transformer was subjected to over current when a generator was switched in behind it, out of phase. It was carrying 36 MVA at the time of the incident. Figure 7.22 shows the LV winding traces and it was clear that the phase x1-x0 has shifted resonance in mid frequency area of 2 kHz. to 200 kHz. indicating winding movement or distortion on this phase as detected and shown in Figure 7.23.

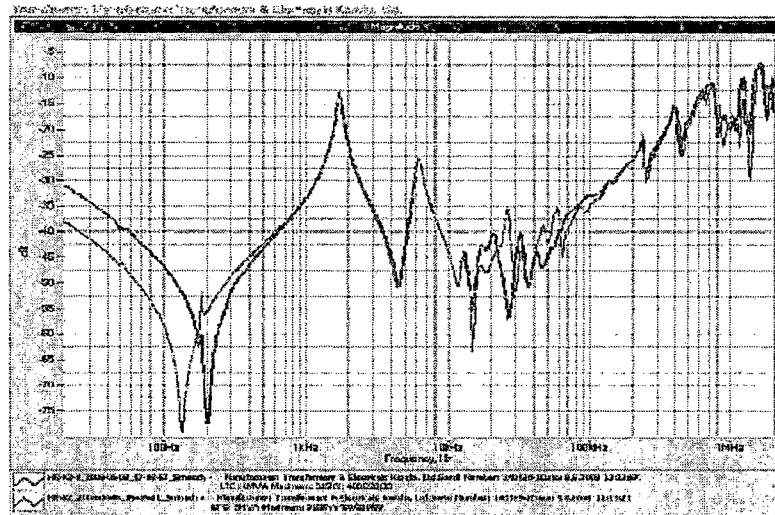
Figure 7.25: Open circuit SFRA plot of H2-X2 winding at Tap positions 1 for ICT 1 (Brown color) and ICT 2 (Blue color)

2. *For winding H2-X2-Tap 17 (Figure 7.25), the sister unit plots are not identical and showing major shift and anti-resonance in the response in the frequency region 10 kHz. to 200 kHz, which indicates that there is significant winding movement in Y-phase of the transformer. Also, clear shift in the resonance is observed in these plots which indicate the mechanical movement in the Y-Phase winding.*

Based on all these findings from the test data it is recommended to have internal inspection of the tap changer parts and winding of the transformer. Transformer should not be charged in this state and the root cause of the deformation should be identified.

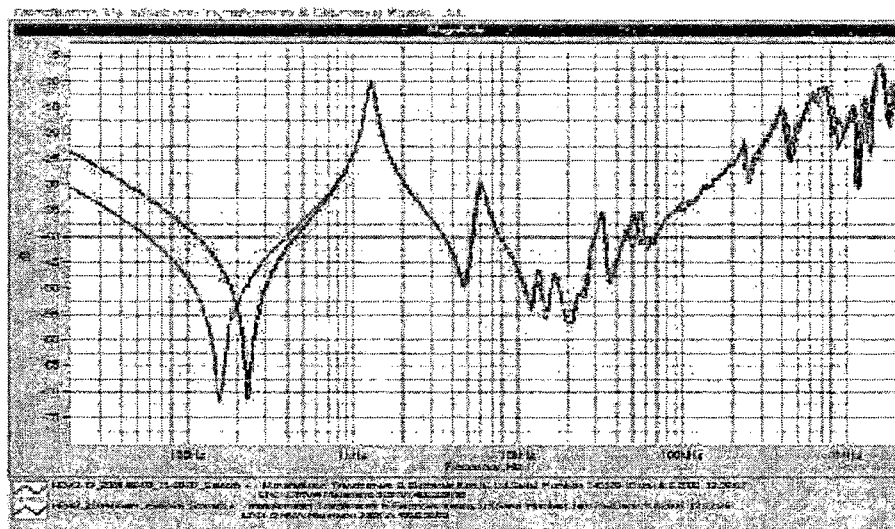
Figure 7.28: Open circuit SFRA plot of H2-X2 winding at Tap 17 for ICT 1 (Brown color)and ICT 2 (Blue color)

3. *Y-Phase deviation is not present in the H2-X2-Tap 17 (Figure 7.28), so it is clear that major deformation is in Y-Phase Tapping winding.*
4. For winding X2-N-Tap1 (Figure 7.31), X3-N-Tap1 (Figure 7.32), X1-N-Tap 17 (Figure 7.33), X2-N-Tap 17 (Figure 7.34), the sister unit plots are not identical

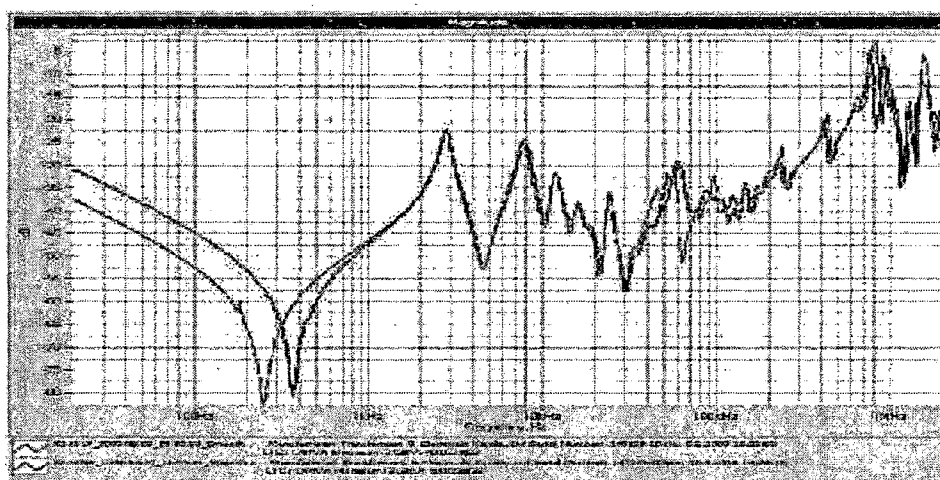
Figure 7.34: Open circuit SFRA plot of X2-N winding at Tap positions 17 for ICT 1 (Brown color) and ICT 2 (Blue color)

and showing major shift and anti-resonance in the response in the frequency region 20 kHz to 200 kHz, which indicates that there is significant winding movement in all phases of LV winding of the transformer.

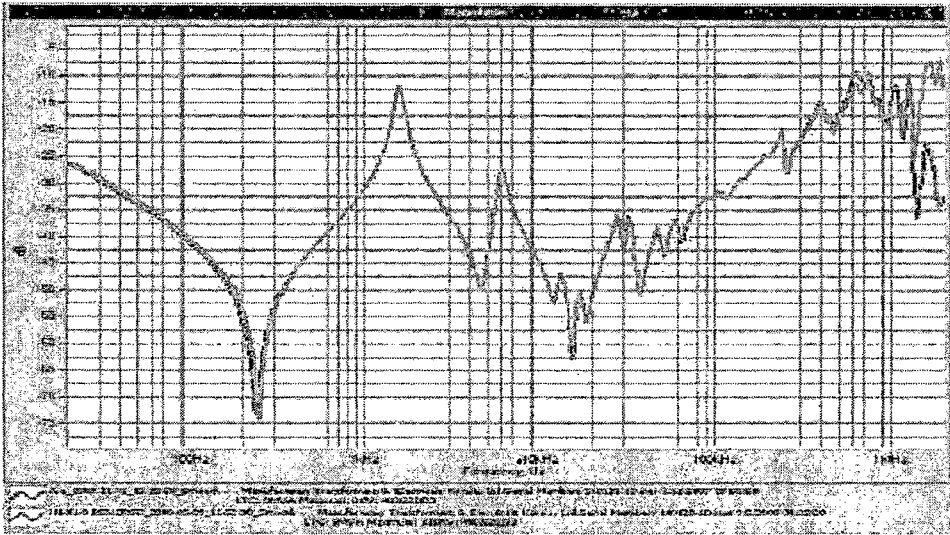
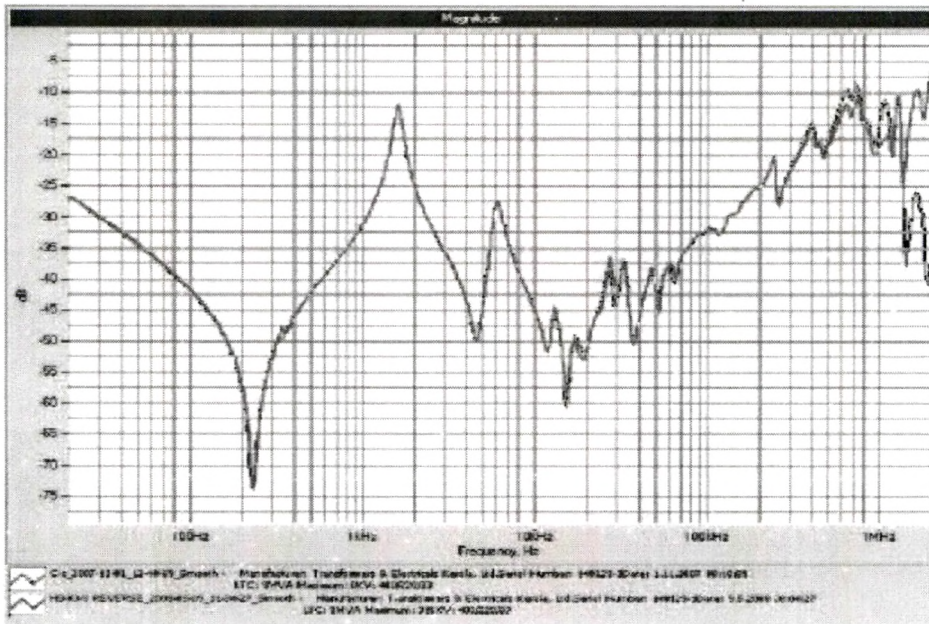
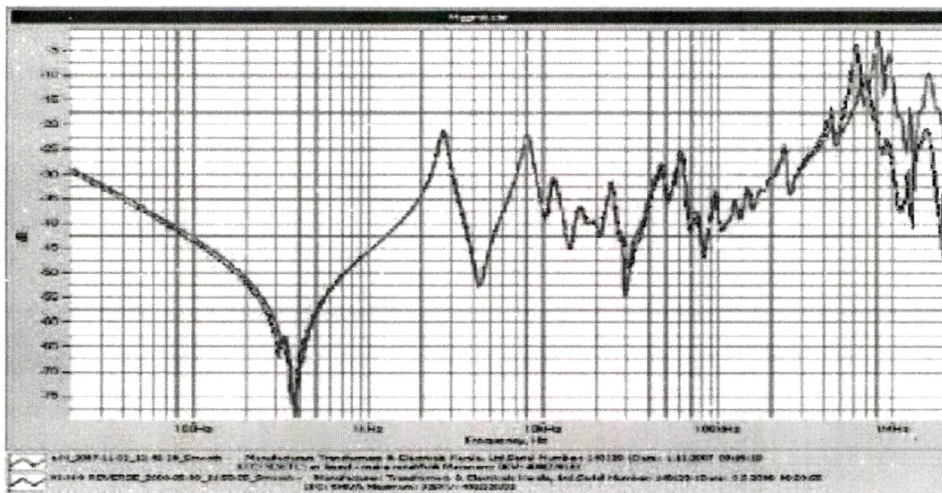
1. For winding H1-X1-Tap 9b (Figure 7.36), H3-X3-Tap 9b (Figure 7.38), X1-N Tap 9b (Figure 7.39), both plots are identical in region 10 kHz. to 200 kHz. which indicates that there is no significant winding movement in these part of the transformer. There is a significant shift in the region 1 MHz to 2 MHz. which may be due to change in the measurement direction of the bushing i.e. LV to HV winding or bad earth connection.
2. For winding H2-X2-Tap 9b (Figure 7.37), X2-N-Tap 9b (Figure 7.40), X3-N-

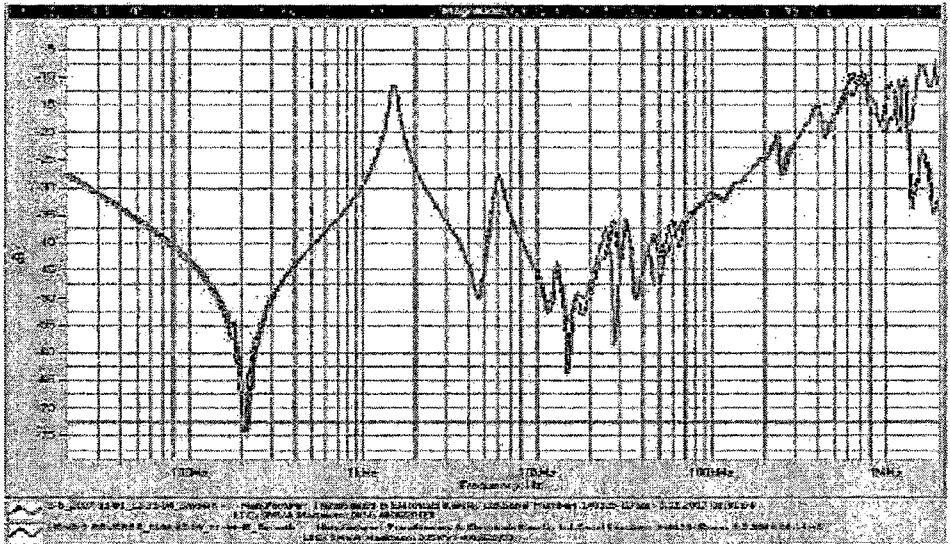
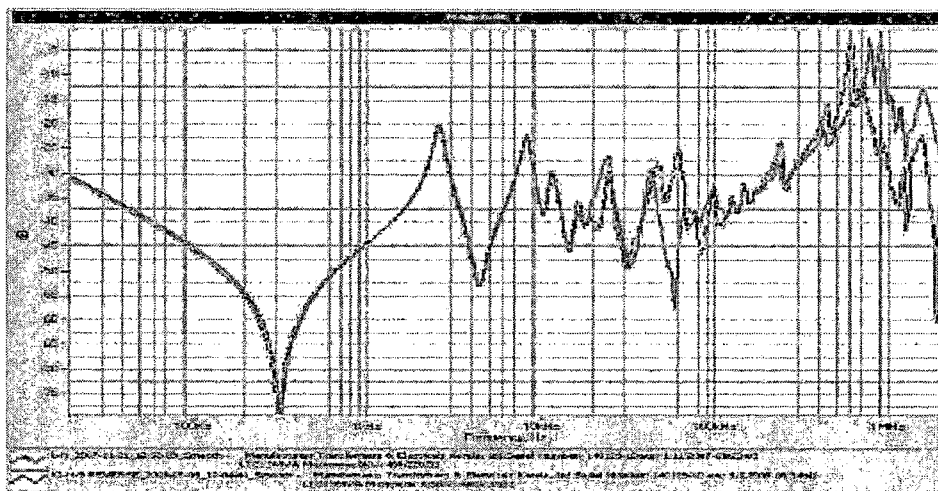
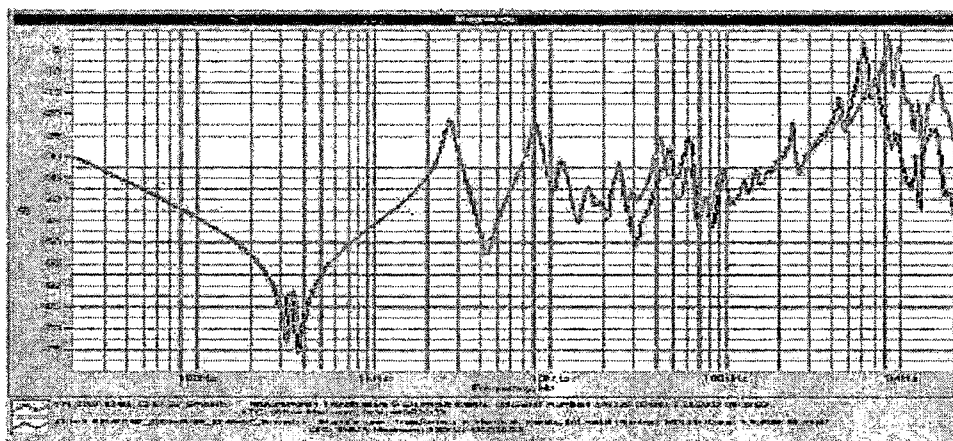
Tap 9b (Figure 7.41) plots are not identical and showing major shift and anti-resonance in the response in the frequency region 20 kHz. to 200 kHz., which indicates that there is significant winding movement in Y-phase and B-Phase of the transformer.

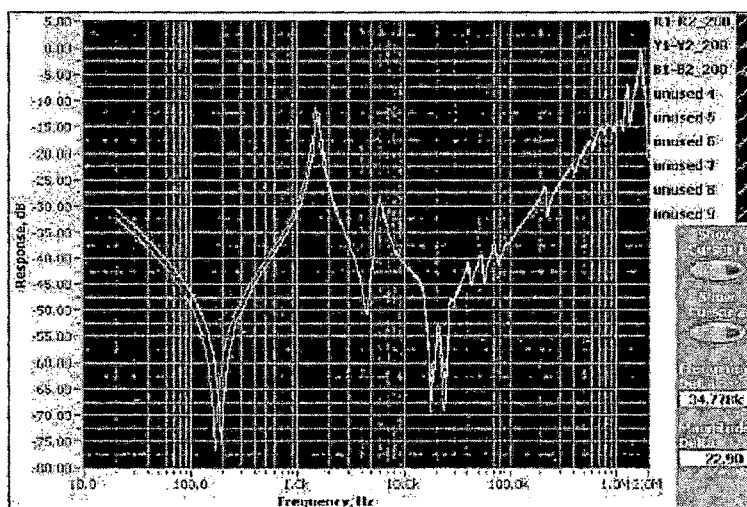
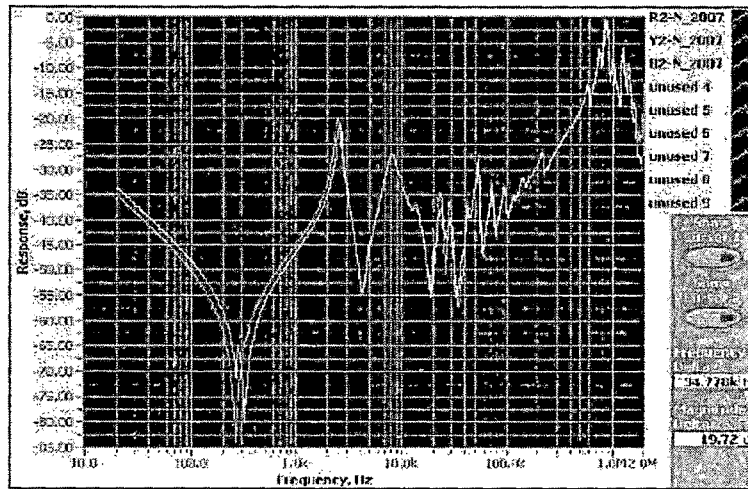
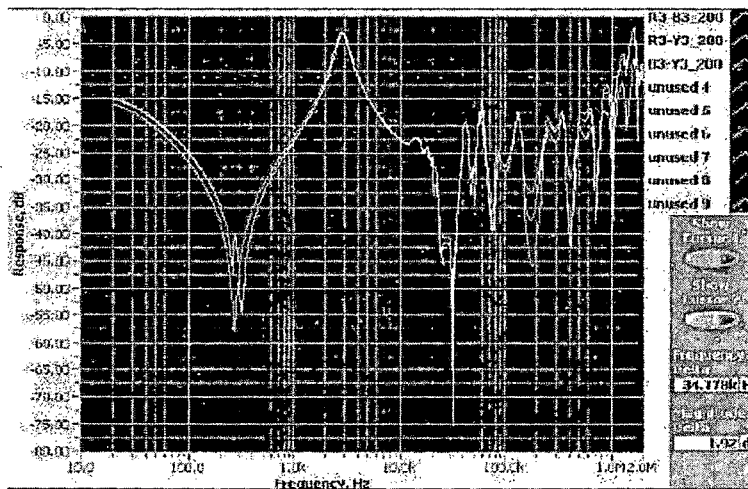
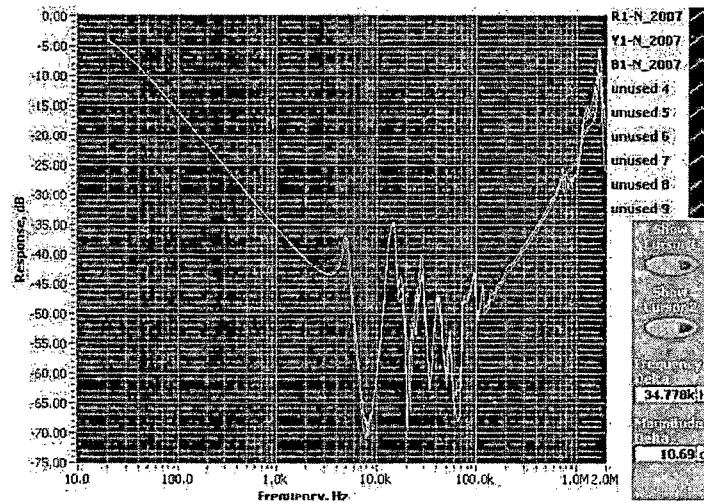
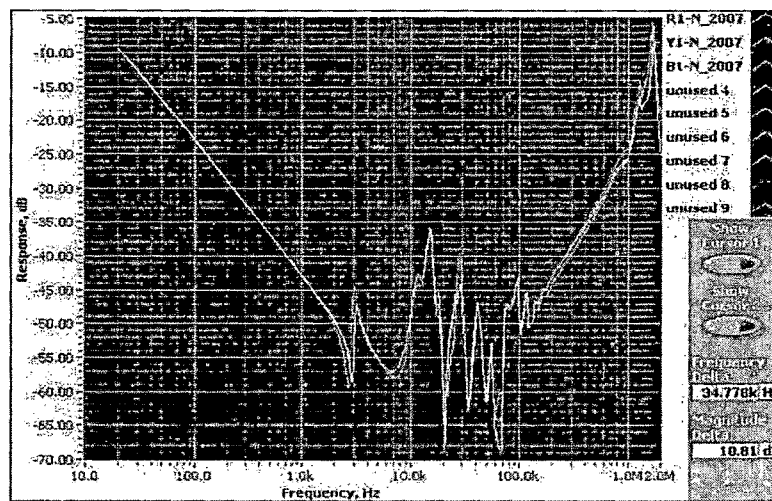
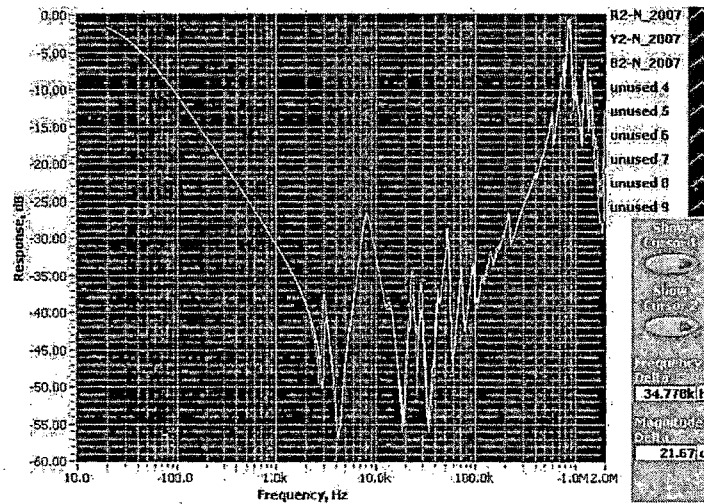
The three phase comparison of reference and fresh signatures separately are very good as indicated in Figures 7.52 to 7.57, while comparison of reference and fresh signatures of same winding do not match among themselves and this is common to all windings as

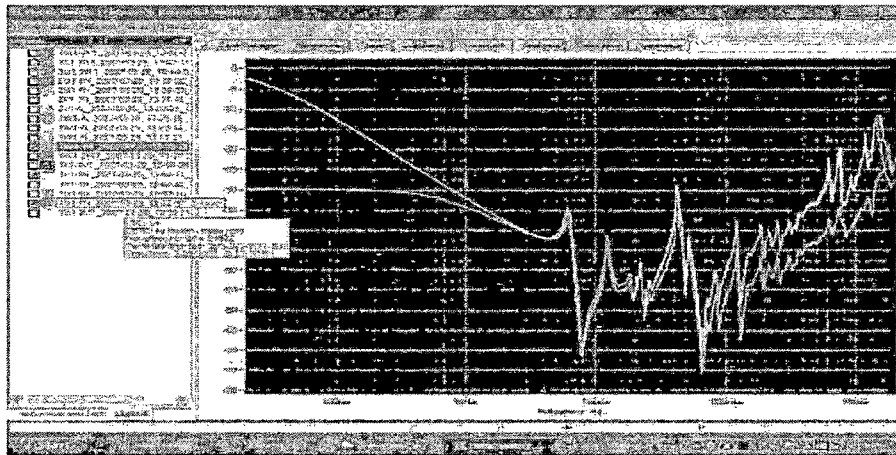
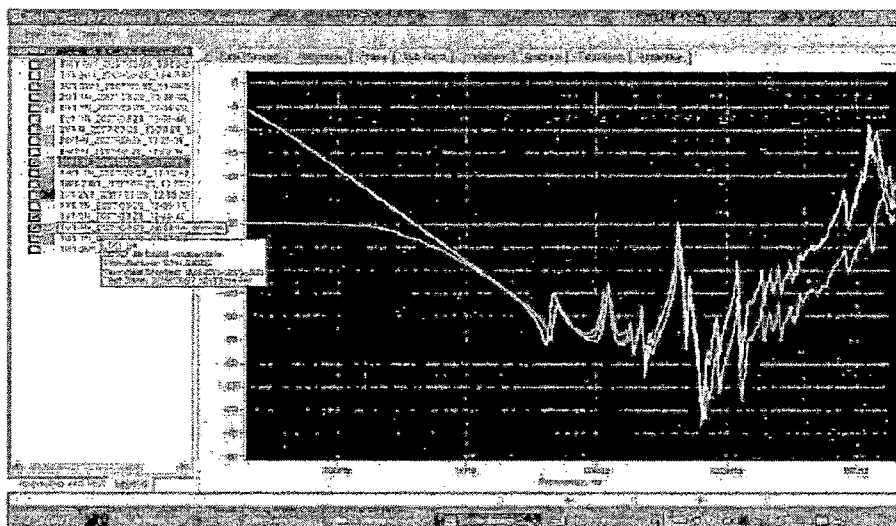
After a system fault, SFRA plot of three phase Auto Transformer with Tertiary winding of rating 315 MVA and rated voltage of 400/220/33 KV was analyzed as mentioned below. It was an overall deformation of U-phase common winding (1U-2U) of auto transformer which was evident from the SFRA plot shown in Figure 7.64. Also the same pattern of deviation is observed in SFRA short circuit plot indicating an high impedance fault with overall deformation of U-phase as mentioned in Figure 7.65 and 7.66.
