4. Engineering geological study of dam sites, Identification of Geotechnical problems and treatment

4.1 Engineering geological investigations at Narmada dam site

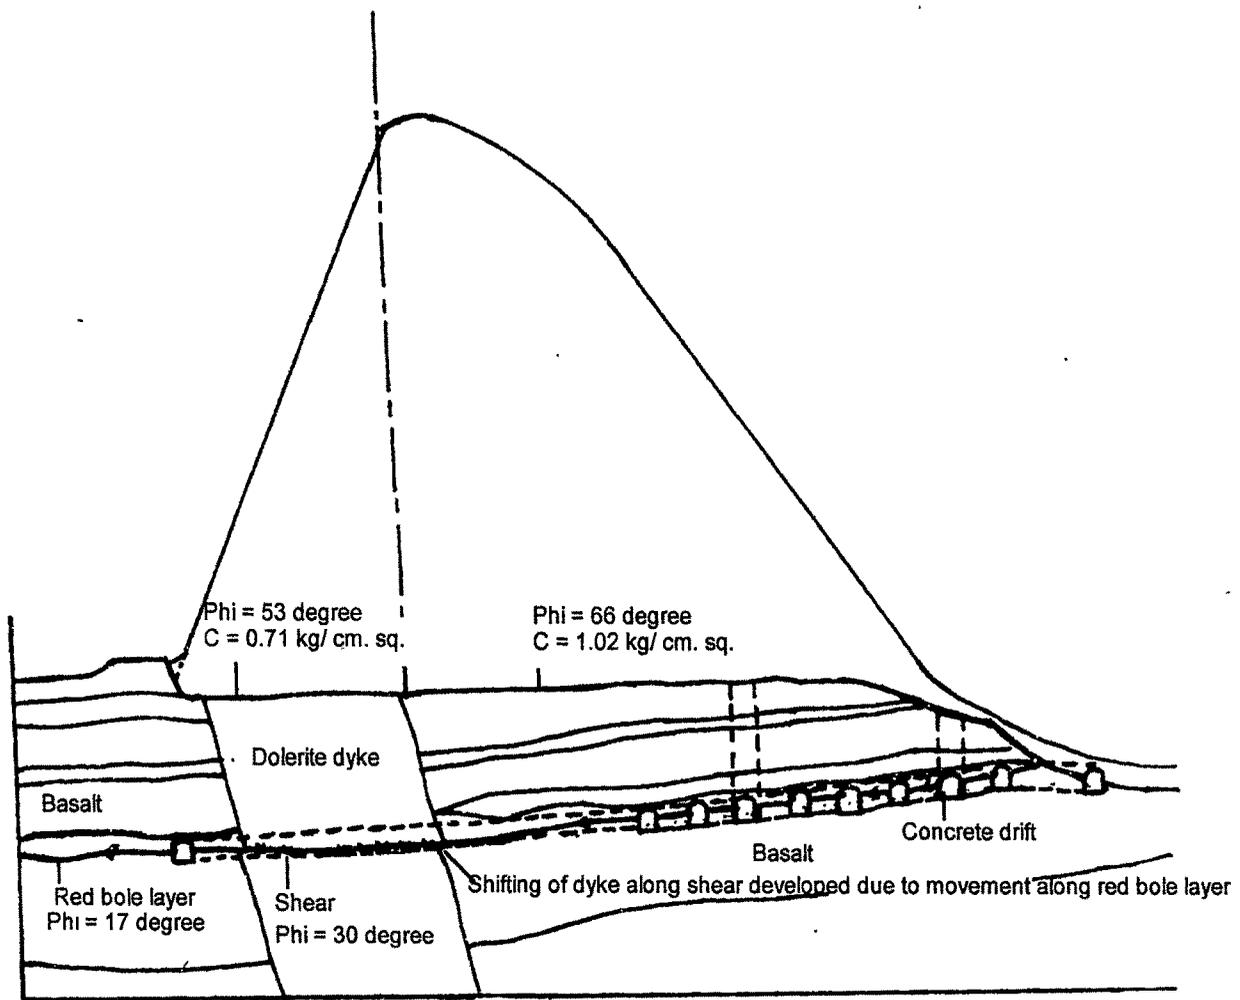
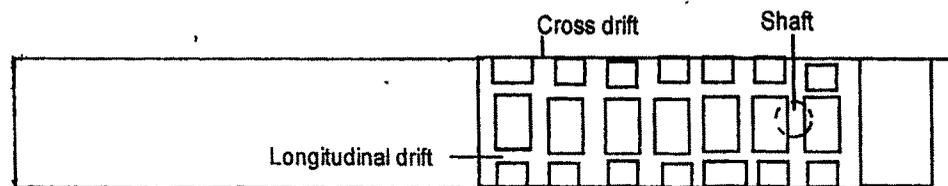
Fig. 17: Treatment of red bole layer in the foundation of Narmada dam left bank spillway block

a. Treatment for safety against sliding of red bole layer: Sliding stability problem was posed by red bole layer in the foundations of spillway blocks 28 to 42 on account of its low shear parameters ($\phi=17^\circ$). To increase shear friction factor and thus to prevent sliding of these blocks underground treatment was done for the red bole layer by excavating 3m wide drifts through approach shafts in grid pattern at right angle to each other leaving 4.5 x 8.5m rock pillar between them (Fig. 17). The drifts were excavated in such a way that red bole layer was intercepted at mid height of the drifts and back filled with concrete. Open concrete shear keys were also provided where rock cover was less than 5m (Plate 10). Total area of the treatment of red bole in each block is approximately seventy percent of the foundation area. Total rock excavation for the red bole treatment through shafts and drifts aggregating to 4858m running length was 47590 cum.

I. Geological cross-section of spillway block showing treatment of red bole layer

II. Foundation plan of treatment drift

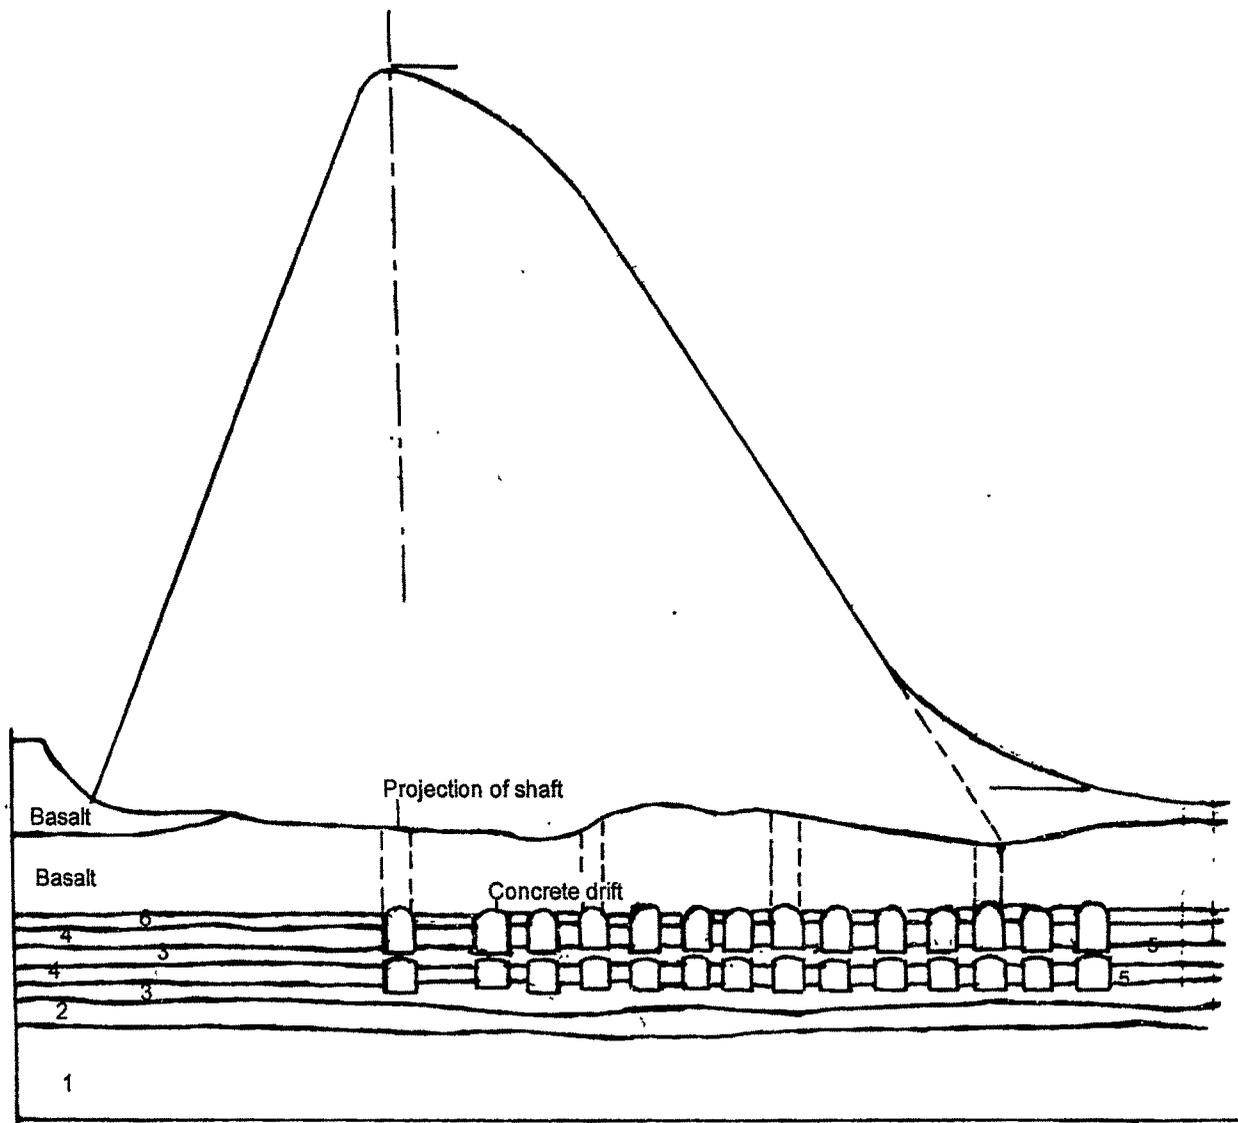
Fig. 18: Geological section of spillway block showing treatment of argillaceous sandstone layers at Narmada dam

b. Treatment for safety against sliding for sedimentary rocks: Sedimentary rocks are present at relatively shallow depth (about 10 to 18m below the general foundation levels) in the foundations of Right Bank spillway blocks-44 to 51 in juxtaposition with basalt flows. Riverbed fault has brought these sedimentary rocks at higher level. Contacts of argillaceous sandstone with quartzitic sandstone are sheared ($\phi =11^\circ$). Argillaceous sandstone layers are having phi (ϕ) value 17° . In view of low values of shear parameters of argillaceous sandstone layers as well as their contacts with quartzitic sandstone layers, underground concrete shear keys were provided to increase shear friction factor of the right bank spillway blocks-44 to 51. Average thickness of both the argillaceous sandstone layers is about 2.5m. These layers are separated by about 3m thick quartzitic sandstone. Upper argillaceous sandstone layer is overlain by 0.5 to 2m-tuff layer having sheared contact. Treatment to these weak layers was provided by excavating 3m wide and 3.6 to 6m (average height 4.5m; 2.5m+2m) high drifts through approach shafts in a grid pattern leaving rock pillar of size 8.5 x 8.5m (Plate 11 to 16 and Fig. 18).

Phi (degree)
6. Tuff	-
5. Contact of argillaceous sandstone and quartzitic sandstone	11
4. Argillaceous sandstone	17
3. Quartzitic sandstone	44
2. Pebbly sandstone	45
1. Limestone	-

Tuff layer was removed from the crown of the Upper argillaceous sandstone treatment drifts. Crown of the upper drifts was excavated in the sound basalt and of lower drifts in the quartzitic sandstone. The bottom of the drift was kept just below the argillaceous sandstone in the quartzitic sandstone for proper keying. The drifts replacing the lower and upper argillaceous sandstone are lying directly one over the other separated by upper quartzitic sandstone. Location of drift one above the other was planned to avoid concentration of stress on the weak layers and for easier drilling for contact grouting. In blocks 49 and 50, thickness of quartzitic sandstone in between argillaceous sandstone layers is less than a meter; hence, some of the lower and upper drifts were combined from safety consideration. The maximum height of the combined drifts is 12.5m.

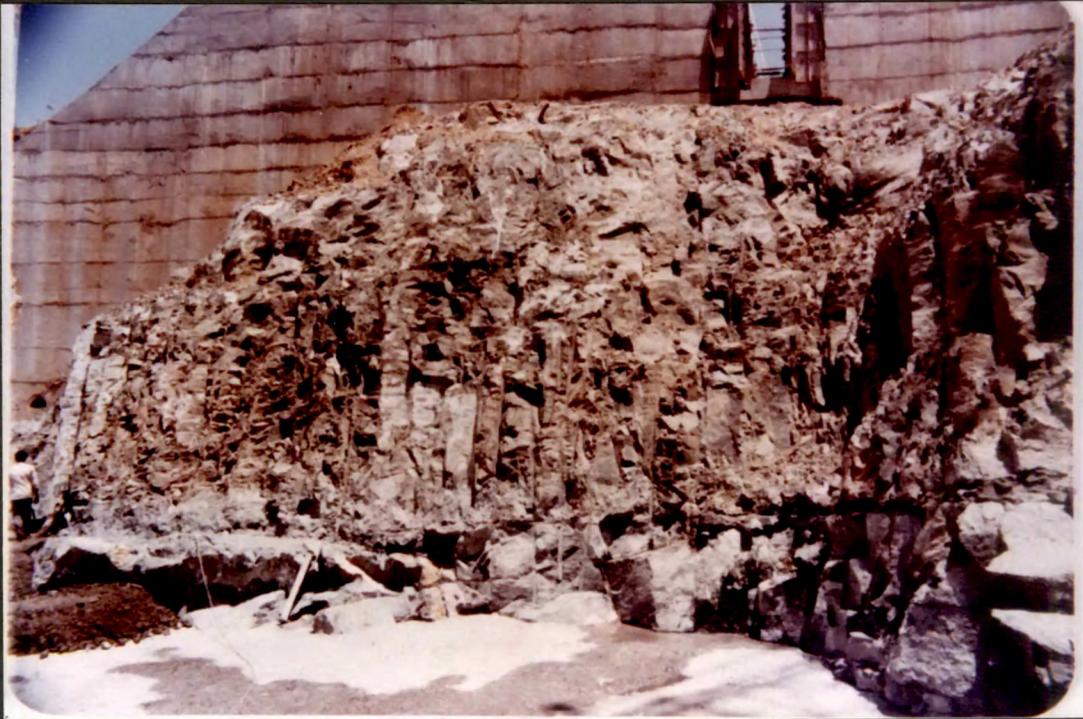
Plate 10: Disposition and treatment of red bole layer at the toe of spillway Block, Sardar Sarovar (Narmada) Project

(a) Disposition of red bole layer in the foundation of spillway block

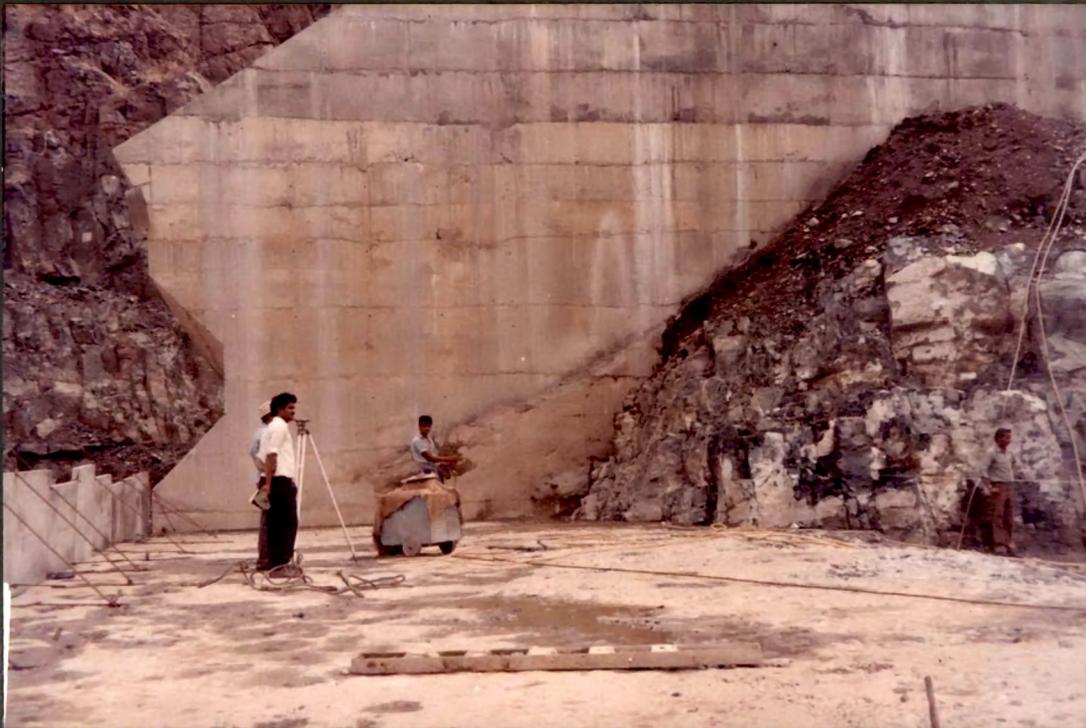
(b) Open concrete shear key in the foundation of spillway block

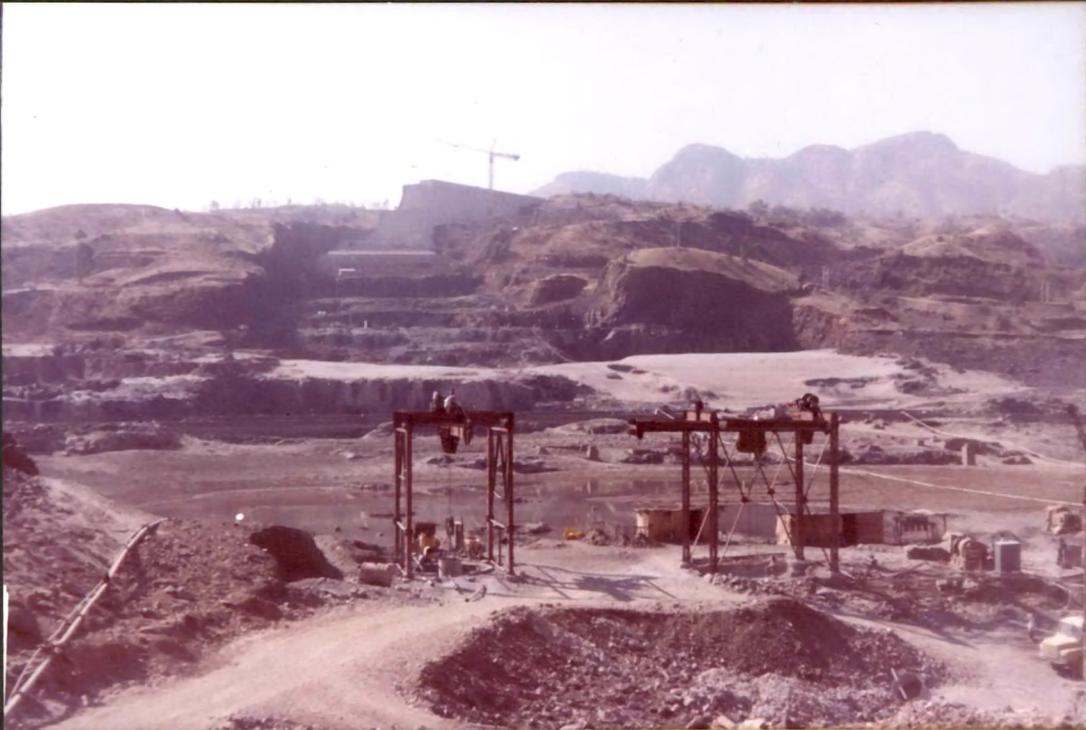
Plate 11: Treatment of the argillaceous sandstone layers in the Right Bank foundation of spillway blocks through shafts, Sardar Sarovar (Narmada) Project

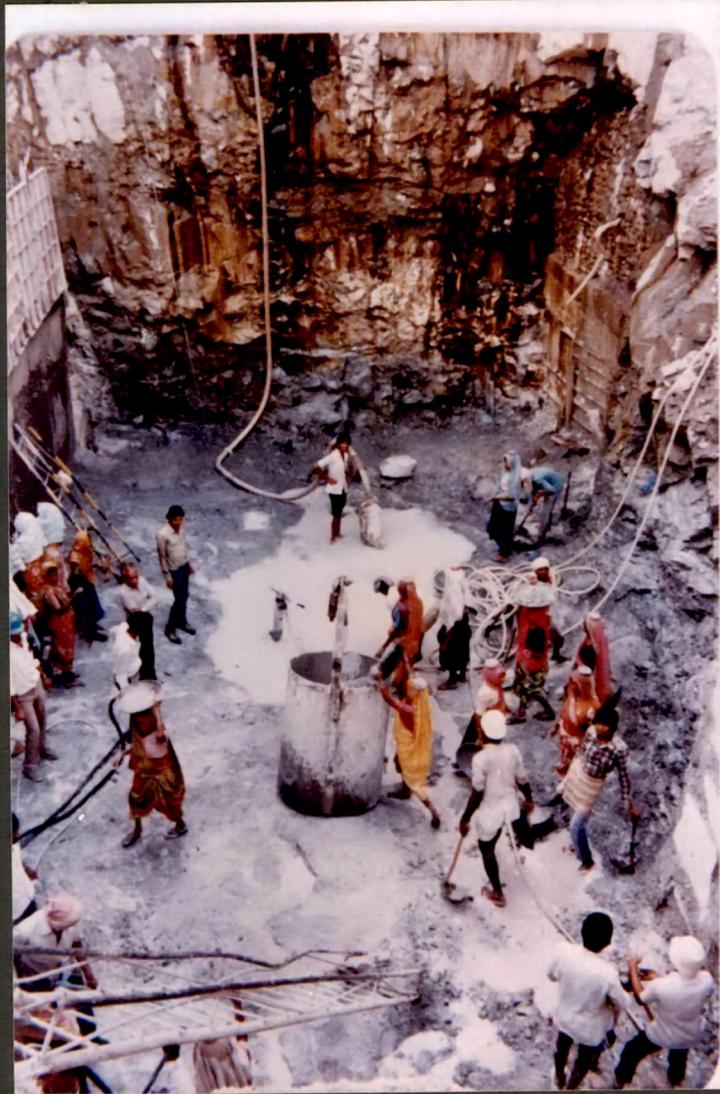
Plate 12: Treatment of upper argillaceous sandstone through drift and shaft in the foundation of spillway block, Sardar Sarovar (Narmada)Project

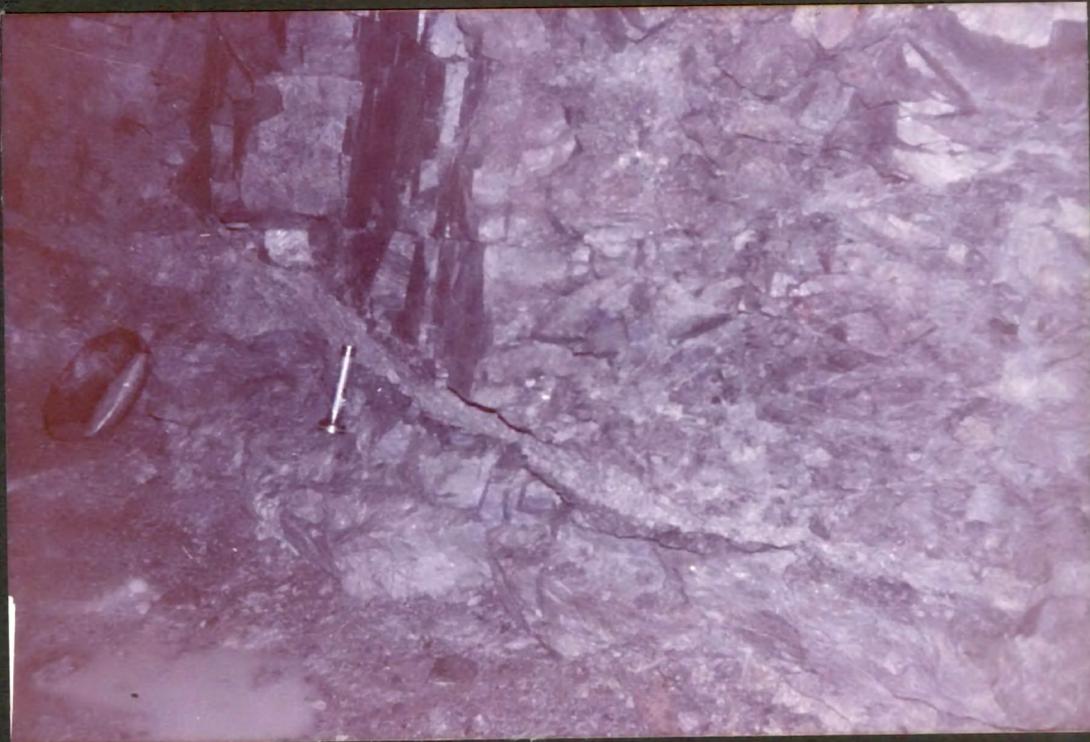
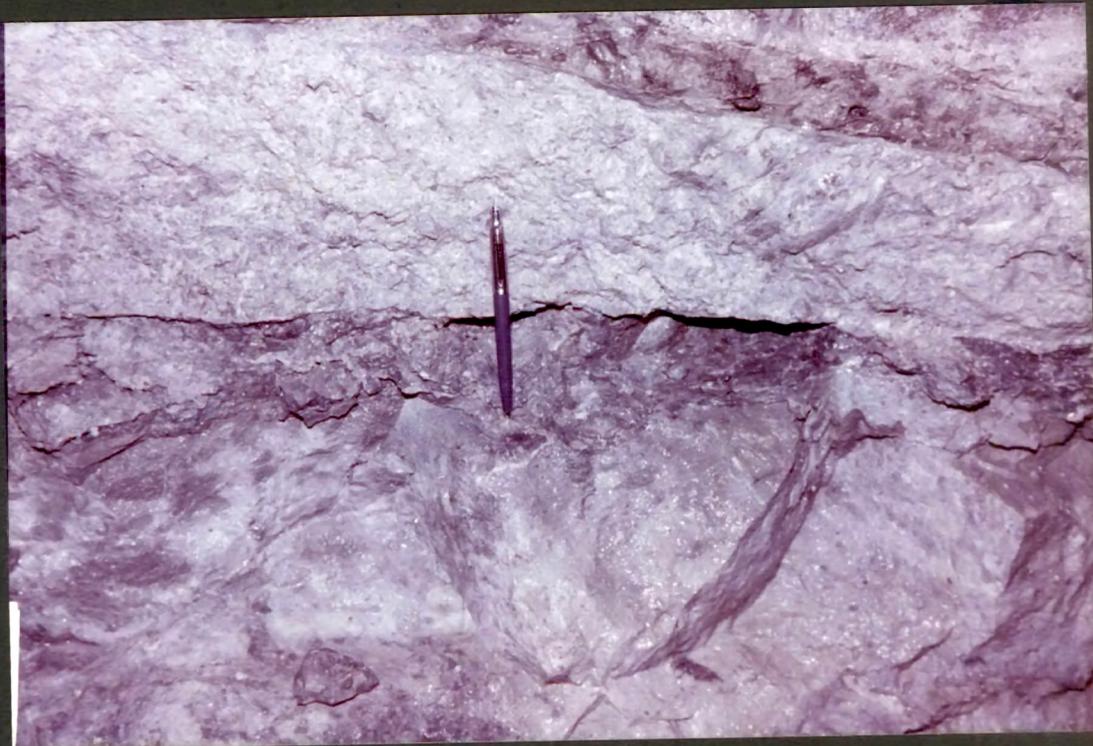
Plate 13: Sub- horizontal shear exposed in the treatment drift traversing the argillaceous sandstone, Sardar Sarovar (Narmada) Project

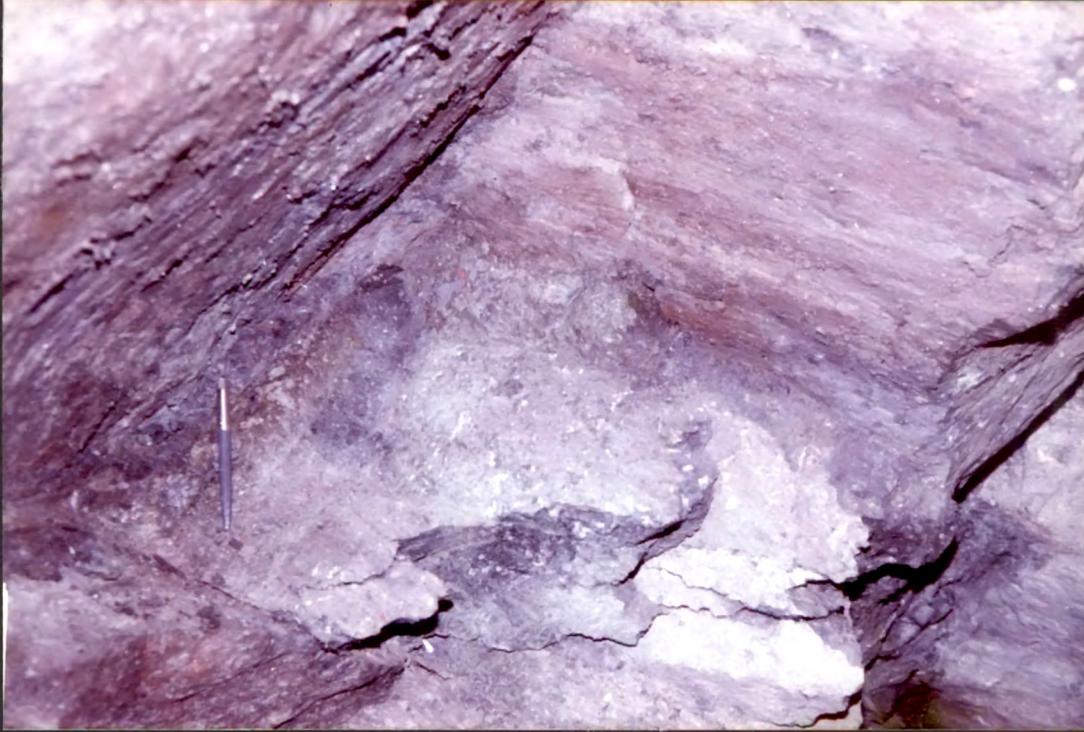
Plate 14: Treatment drift for the upper argillaceous sandstone layer,
Sardar Sarovar (Narmada) Project (a & b)

(a) Sheared tuff layer exposed in the crown of the drift

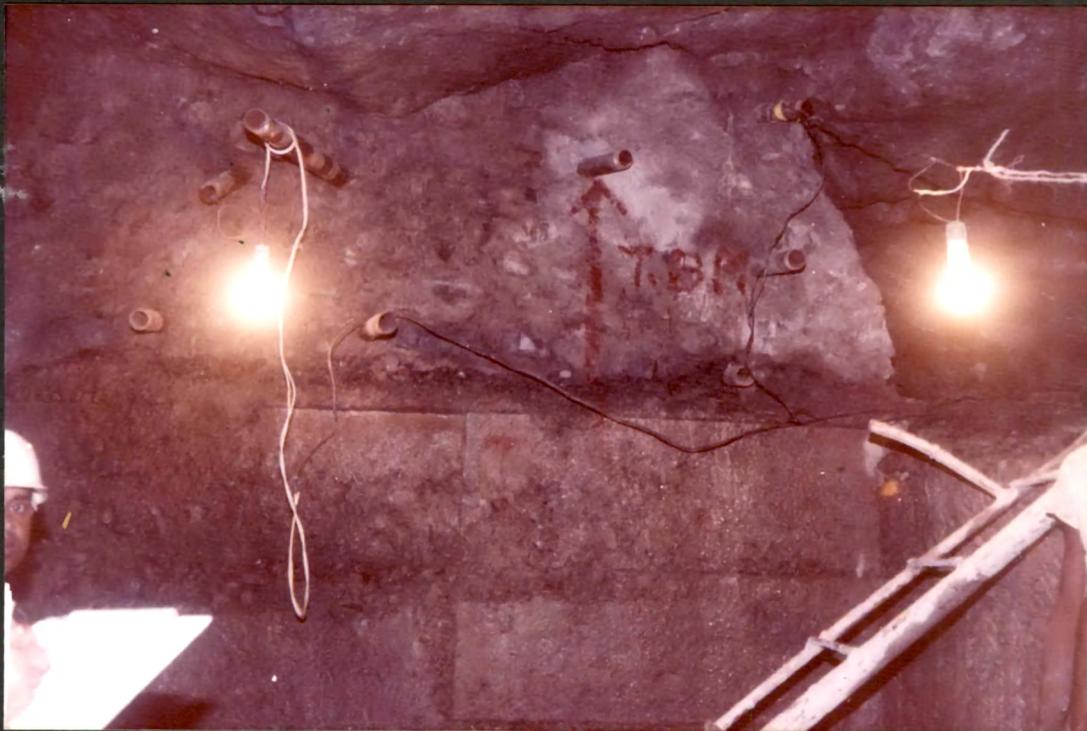
(b) Colcrete in the upper (crown) part of the drift

Shape of the roof of drift is semicircular. Experience of the Karjan dam and experimental drifts at Narmada dam showed that there was large shrinkage gap in case of pump concrete in the crown. Therefore, colcrete was done in the crown (i.e. 1/3 height) of the drift for better concrete and rock contact (Plate 14). Consolidation-cum-contact grouting through holes spaced at 2m centre to centre (c/c) was done in grid pattern in the foundation of treated blocks to ensure good contact of the concrete, colcrete and rock. Grout will also fill voids, if any, remaining due to concrete shrinkage and/or inadequate filling of irregularities in the rock surface, besides sealing of open joints (Prakash 1990).

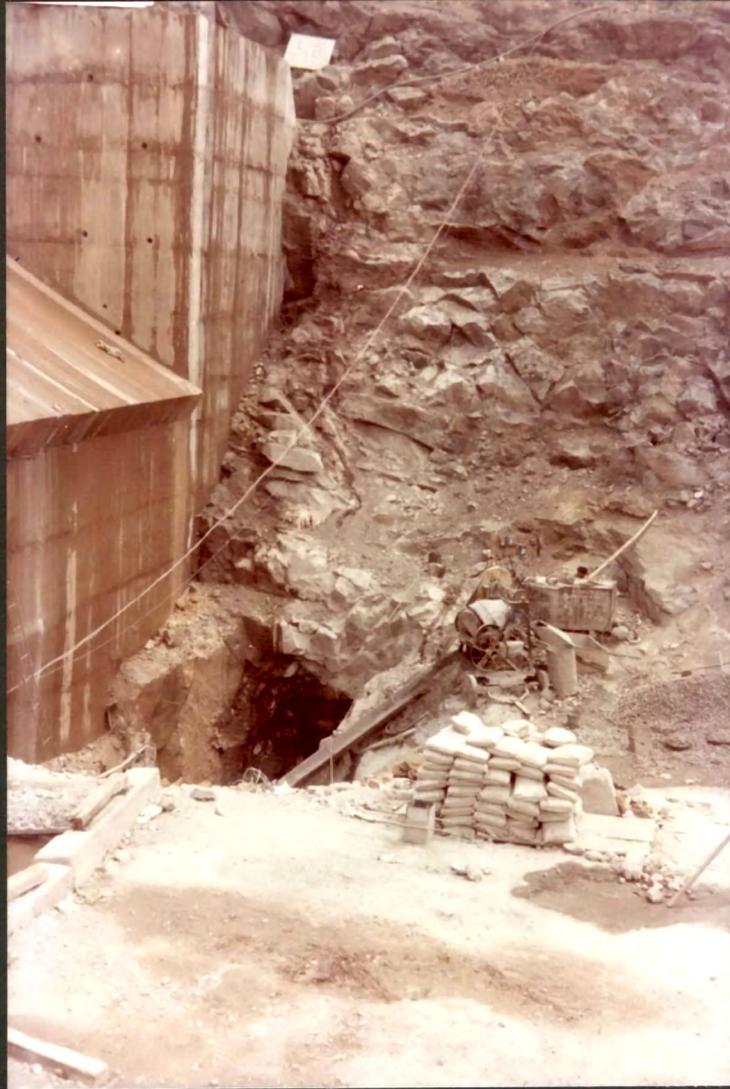
Plate 15: Excavation of approach drift for the treatment of weathered rock seam in the foundation of block L-5, Karjan dam

b. Treatment of Left non-overflow (LNOF) blocks: Weathered seams encountered in the foundation of LNOF blocks at different elevations were analysed. Removal of the weathered seams was done in the foundation of block L-4 where rock cover was shallow (3 to 4m) and concrete shear keys were provided in block L-5 for deeper seam (Plate 15).

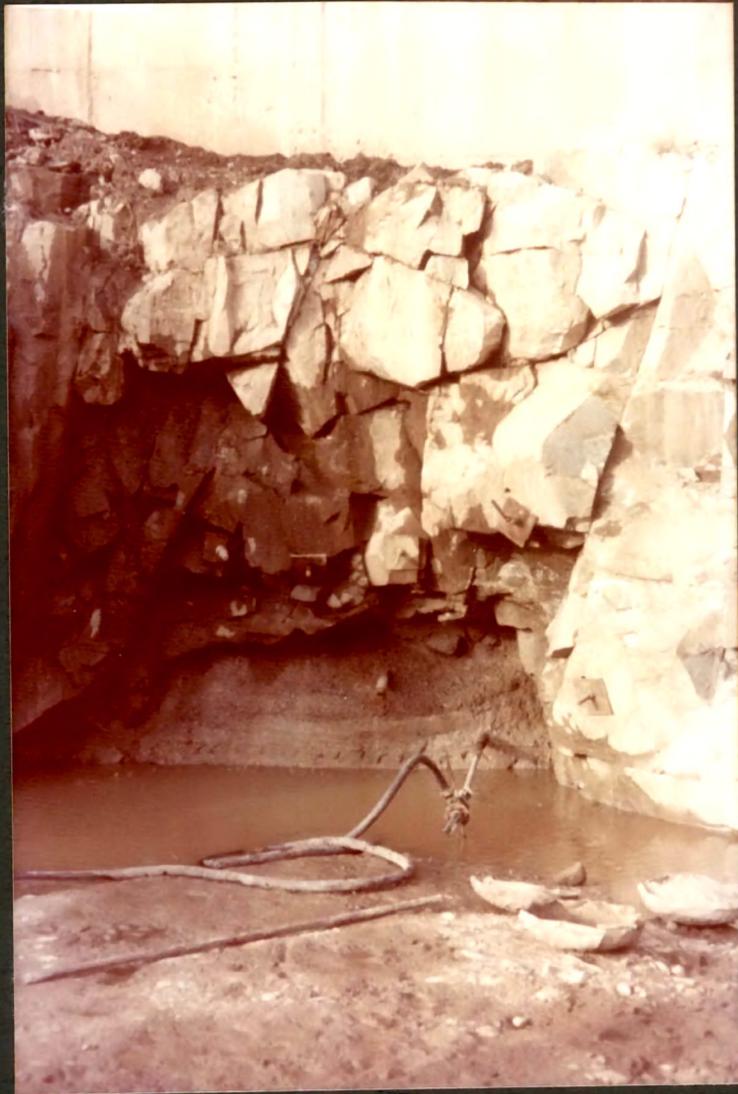
Plate 16: Pump concrete in the crown of treatment drift in the foundation of spillway block, Karjan dam

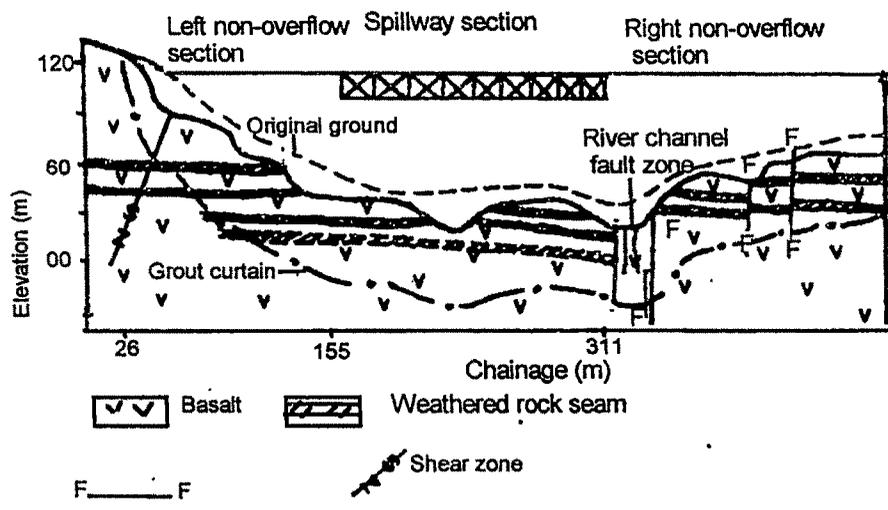
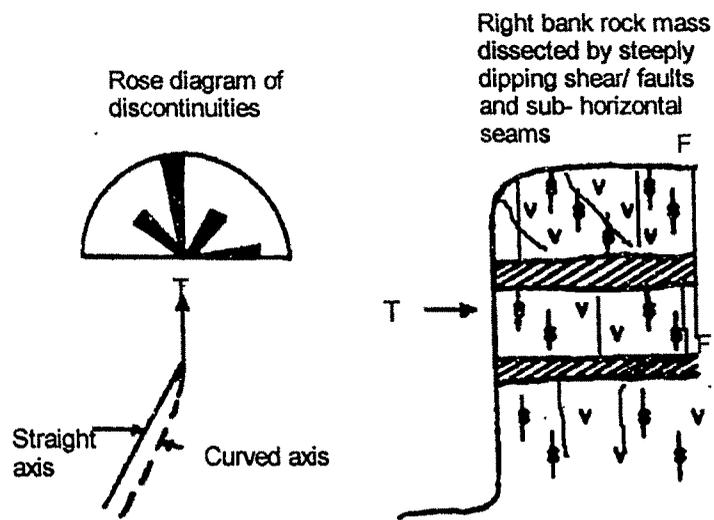
Fig. 19: Geological sections of Karjan dam showing foundation condition

(i) Curvature in the alignment of dam: It was thought to lay the blocks in the riverbed in the manner of an arch with a flat mild upstream curvature in order to induce the blocks to act as a monolith for mobilising greater combined resistance against sliding. Idea of curvature in the alignment of dam was dropped due to two reasons firstly, all the blocks had seams below them secondly, abutment rocks were not found geologically suitable for arch action (Fig. 19).

I. Longitudinal geological section of dam

T- Direction of resultant thrust in case of curved dam axis

II. Critical geological abutment conditions

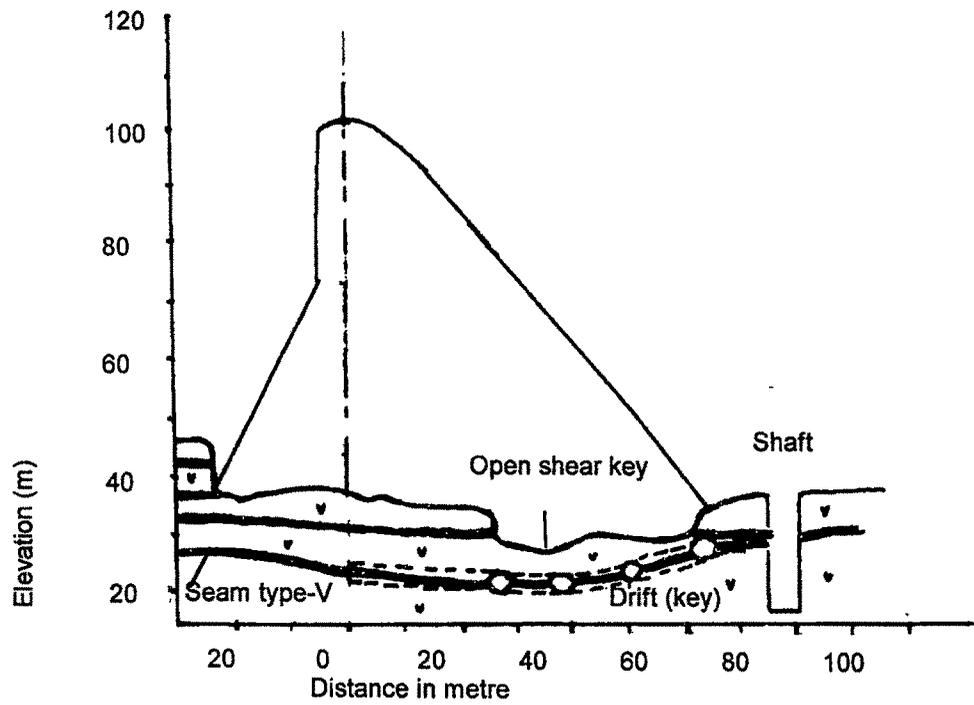
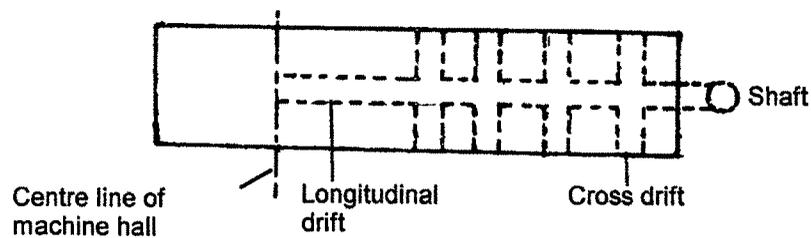
Fig. 20: Treatment of Weathered rock seams in the foundation of Karjan dam spillway block

c. Treatment of spillway blocks: Spillway blocks-1 to 7 are resting over various weathered seams located at varying depths in the foundations. Sliding analysis showed that three to four drifts/plugs of 6 to 8m widths were required for the spillway blocks-1 to 5, for ensuring minimum required values of factors 'F1' and

'F2'. Accordingly, concrete drifts were provided in the foundation of spillway blocks-1 to 5 and open concrete shear keys in the foundation of spillway blocks-6 and 7 (Fig. 20). Pump concrete was done in top 1/3 rd. portion of the drift (Plate 16). Shear keys were provided in the foundation of spillway blocks-6 and 7, without any joint in between to take the advantage of the available cross shear though it has not been considered in the stability analysis.

I. Geological cross-section of spillway block

II. Foundation plan of treatment drifts

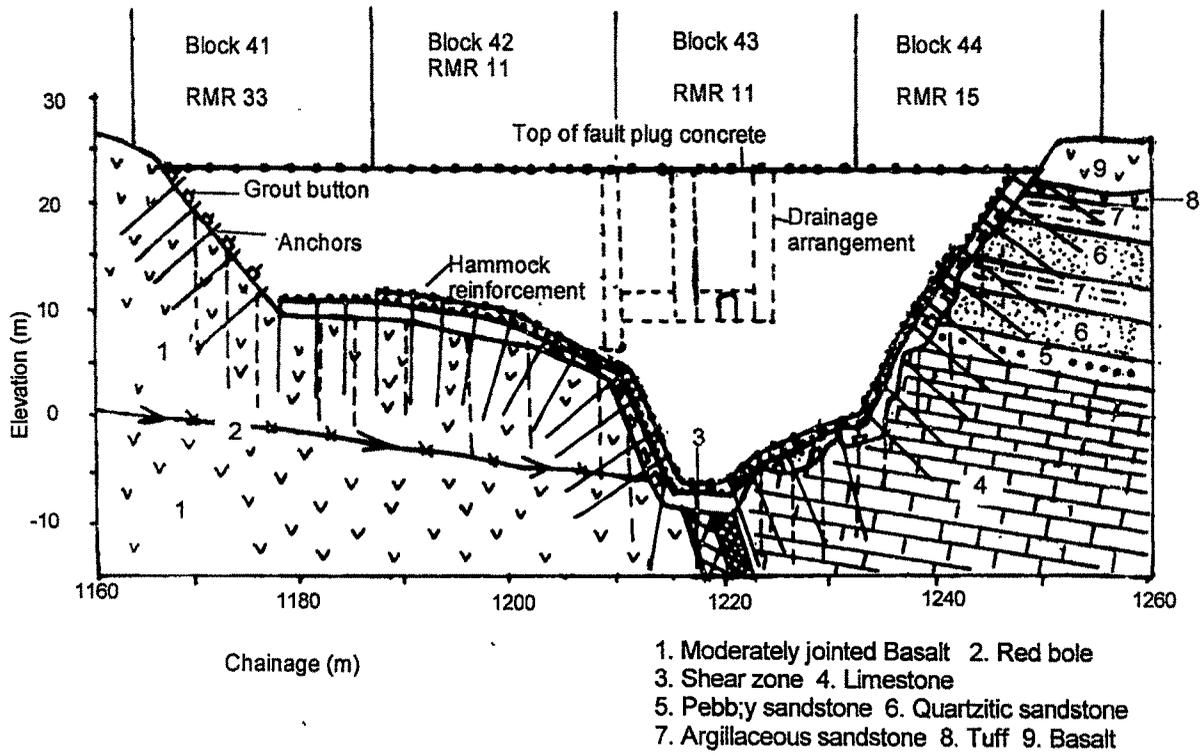
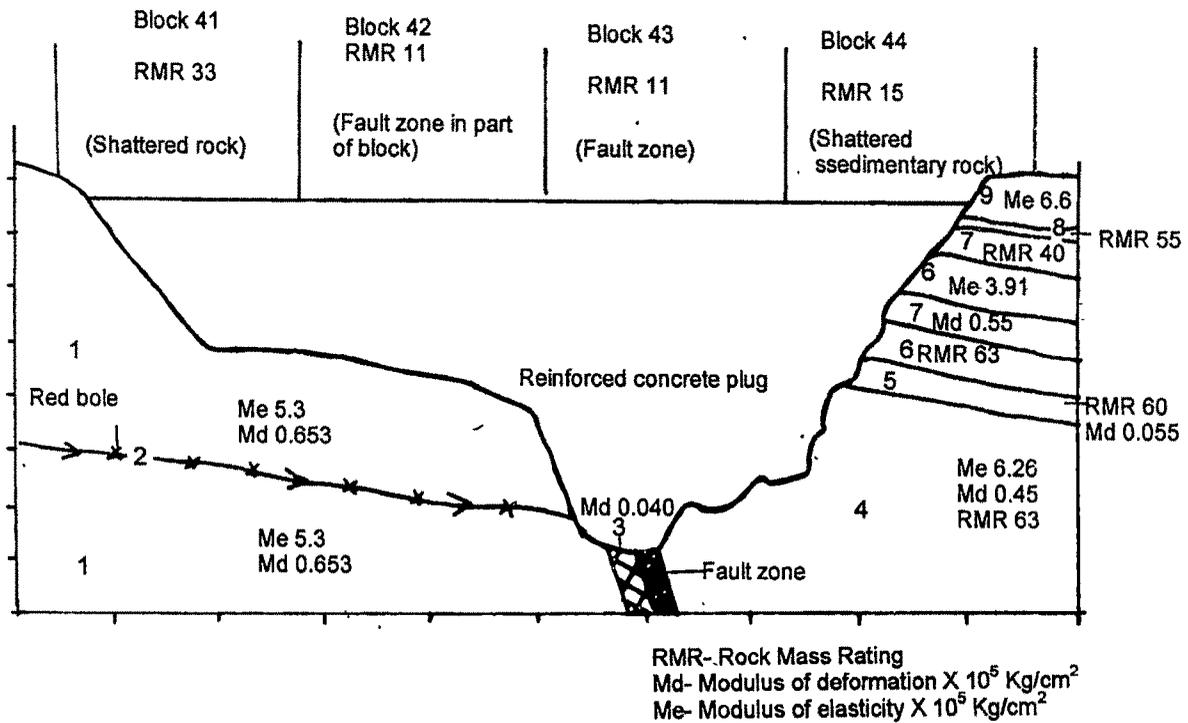
Fig. 21: Rock mass characteristics and treatment of Narmada river channel fault at the dam base

b. Geotechnical assessment of the fault zone: Rock mass rating of almost unhealed (HL4-HL5) fault zone material is very poor (RMR 11). In situ test results indicated low values of modulus of deformation for the fault zone ($0.04 \times 10^5 \text{kg/cm}^2$) and relatively high values for the basalt ($0.653 \times 10^5 \text{kg/cm}^2$) and sandstone ($0.38 \times 10^5 \text{kg/cm}^2$). Ratio of modulus of elasticity and modulus of deformation of the basalt adjacent to fault zone vary from 1.87 to 2.4 and of sedimentary rocks from 2 to 4 indicative of weathered and jointed nature of the rock mass (Fig. 10). In view of the low modulus of deformation of fault zone and high modulus ratio of the abutment rocks of varying physico-engineering properties (Fig. 9 to 11), problem of differential settlement in the foundations of riverbed blocks 41 to 44 was apprehended.

I. Treatment of fault zone

II. Rock mass rating and modulus properties of fault zone and adjacent rocks

(v) Treatment for settlement/ differential settlement: Based on two dimensional photo elastic studies depth of fault treatment plug was initially designed to be 1.5 times width of the fault zone but the actual treatment was carried out to a depth varying from 2.15 to 2.83m times the width depending on the site conditions and geotechnical judgment. Fault zone material was removed by excavating a trench down to El. (-) 16.5m in the upstream and to El. (-) 8 m in the downstream of the dam. Thus depth of the concrete (reinforced) plug provided was 34.5m (El.+18 to -16.5m) in the upstream and 26m(El.+18 to -8.0m) in the downstream (Mehta & Prakash 1990). In view of very poor quality of fault zone material (RMR 11) and poor quality of abutment rocks (RMR 11 to 33) this 34.5m deep concrete plug was reinforced. Construction of reinforced concrete plug was done monolithically below five spillway blocks 40 (block 40 forms one of the shoulder of the plug) to 44 upto El.18m and above it construction joints were provided for raising respective spillway blocks separately (Fig. 21).

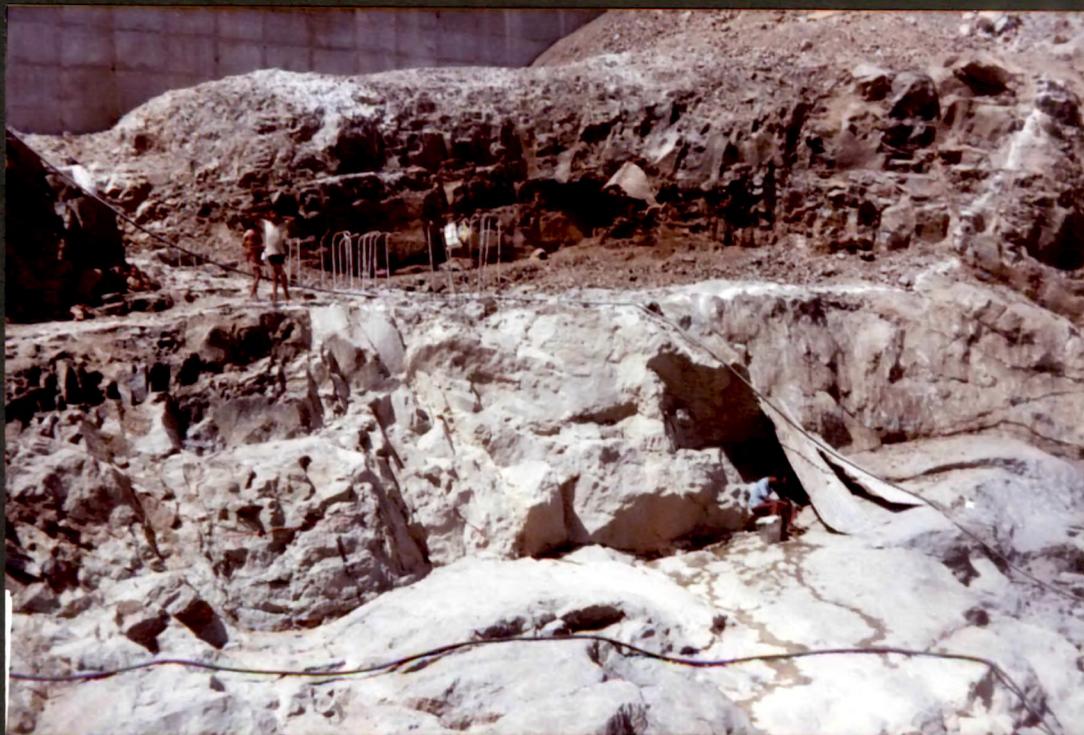
Plate 17: Foundation treatment of block-16 & 17, Sardar Sarovar (Narmada) Project

a. Main dam blocks: In-situ tests conducted on the foundation of block-16 on highly jointed weathered basalt (DS4, W3, RQD4, RMR-40) gave average value of deformation modulus of weathered rock as 0.04×10^5 kg/cm² and modulus of elasticity as 0.075×10^5 kg/cm². The ratio of two-modulii (1.87) also suggests weathered and jointed nature of the rock mass. Major part of the block-16 was lying over weathered rock zone having 5 to 6m highly jointed rock cover (Plate 17

(a) Removal of weathered rock mass in part foundation of the block-16

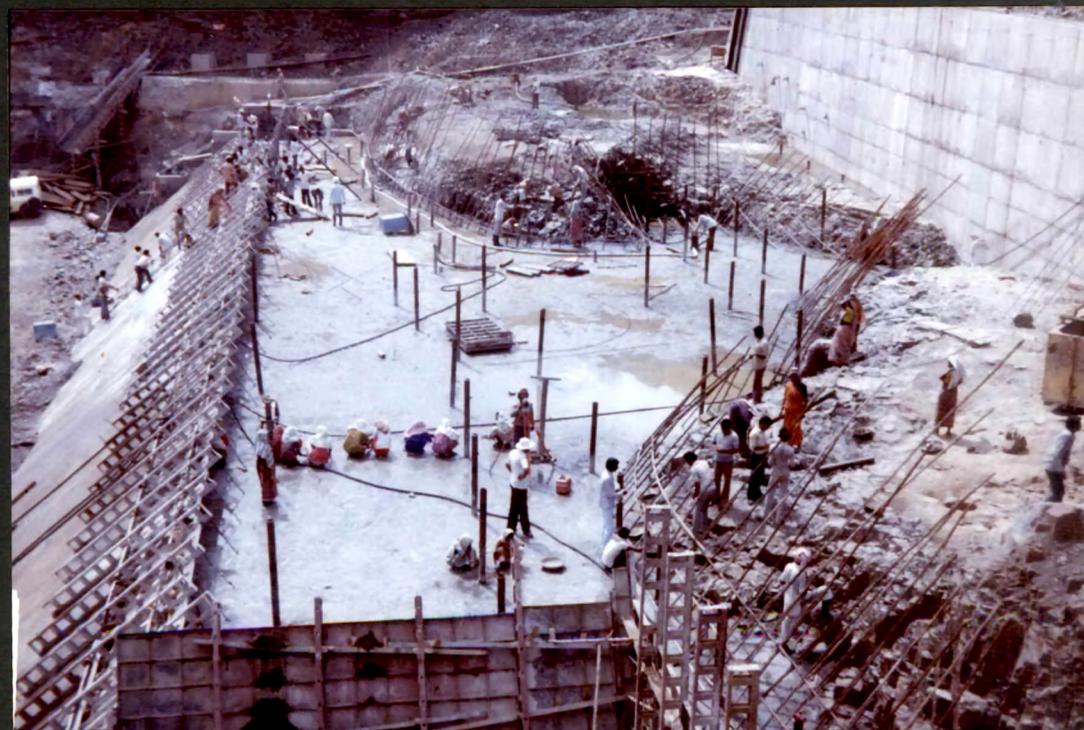
(b) Hammock reinforced concrete in the foundation of block-16 and sloping concrete in the foundation of block-17

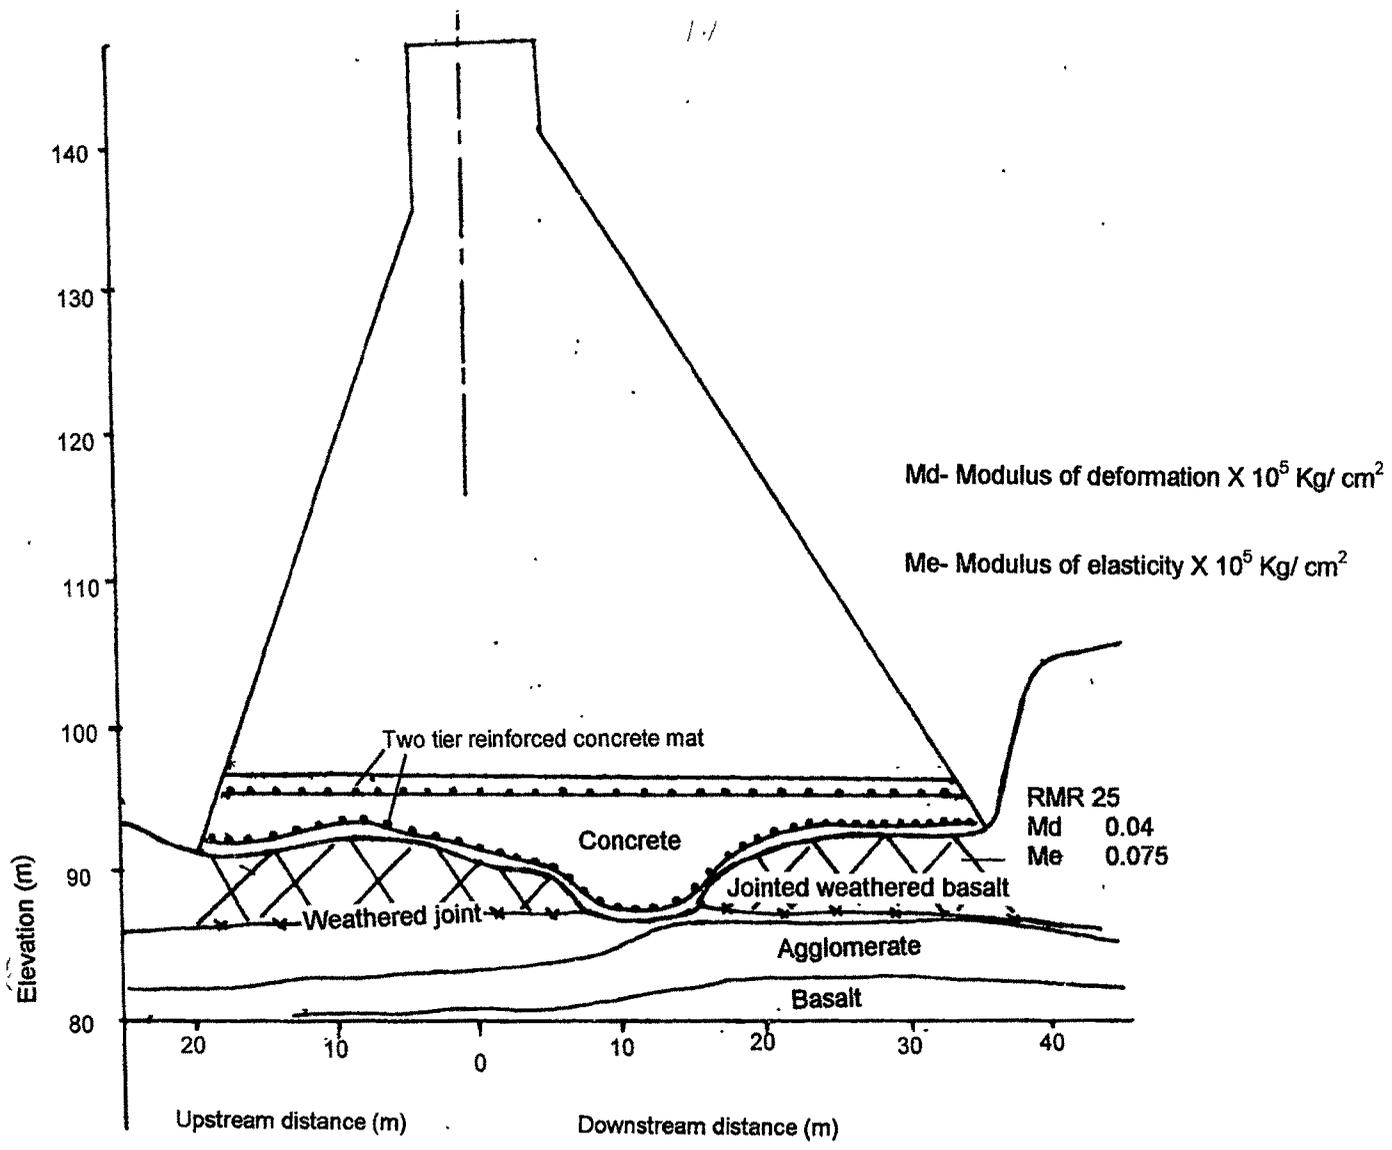
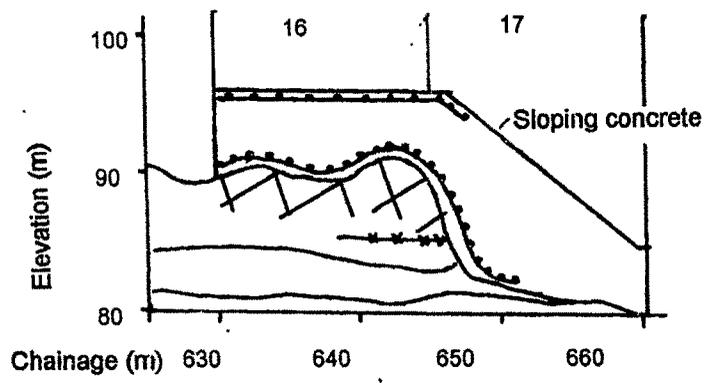
Fig. 22: Foundation treatment of weathered rock in the foundation of block-16 & 17

I. Cross-section of block-16

II. Longitudinal section of block- 16 & 17

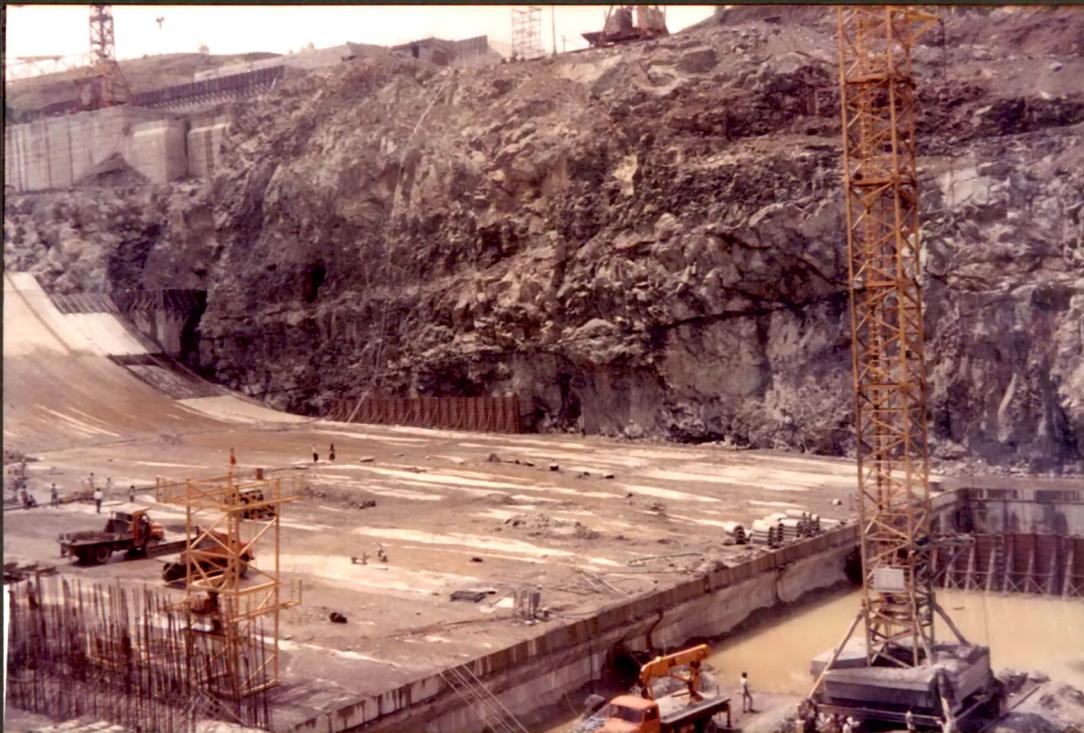
Plate 18: Disposition of red bole layer in the foundation of divide wall between Lower Chute and Stilling Basin, Sardar Sarovar (Narmada) Project

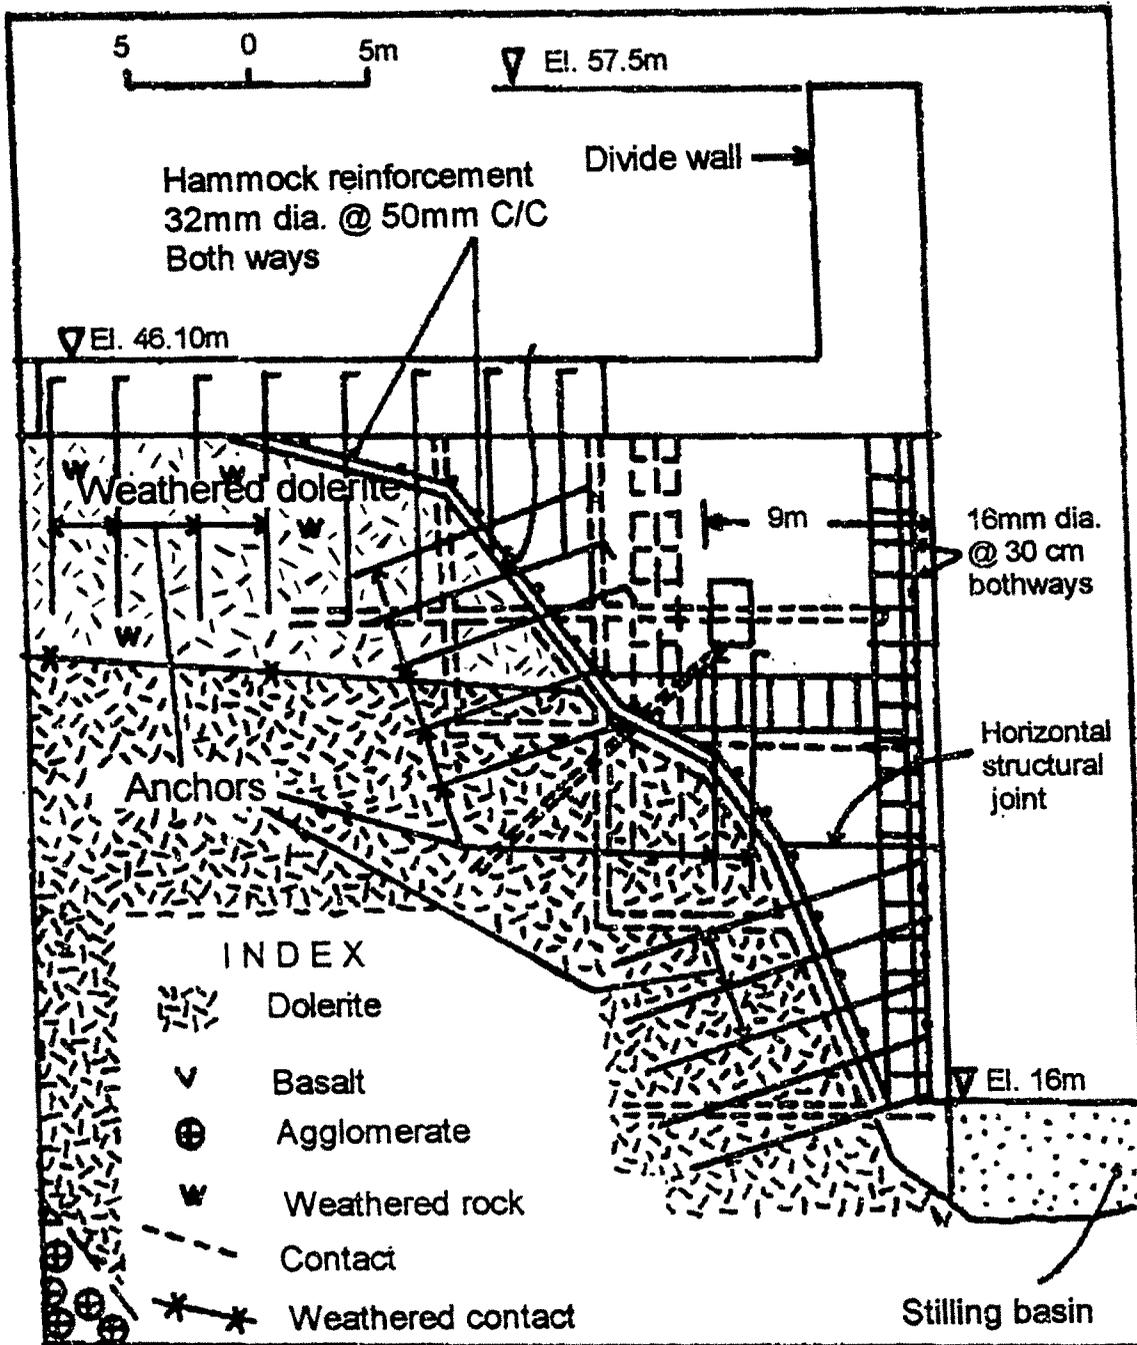
Fig. 23: Typical section of Narmada dam left divide wall block-28 showing foundation treatment of scoured rock
