4. Engineering geological study of dam sites, Identification of Geotechnical problems and treatment

4.1 Engineering geological investigations at Narmada dam site

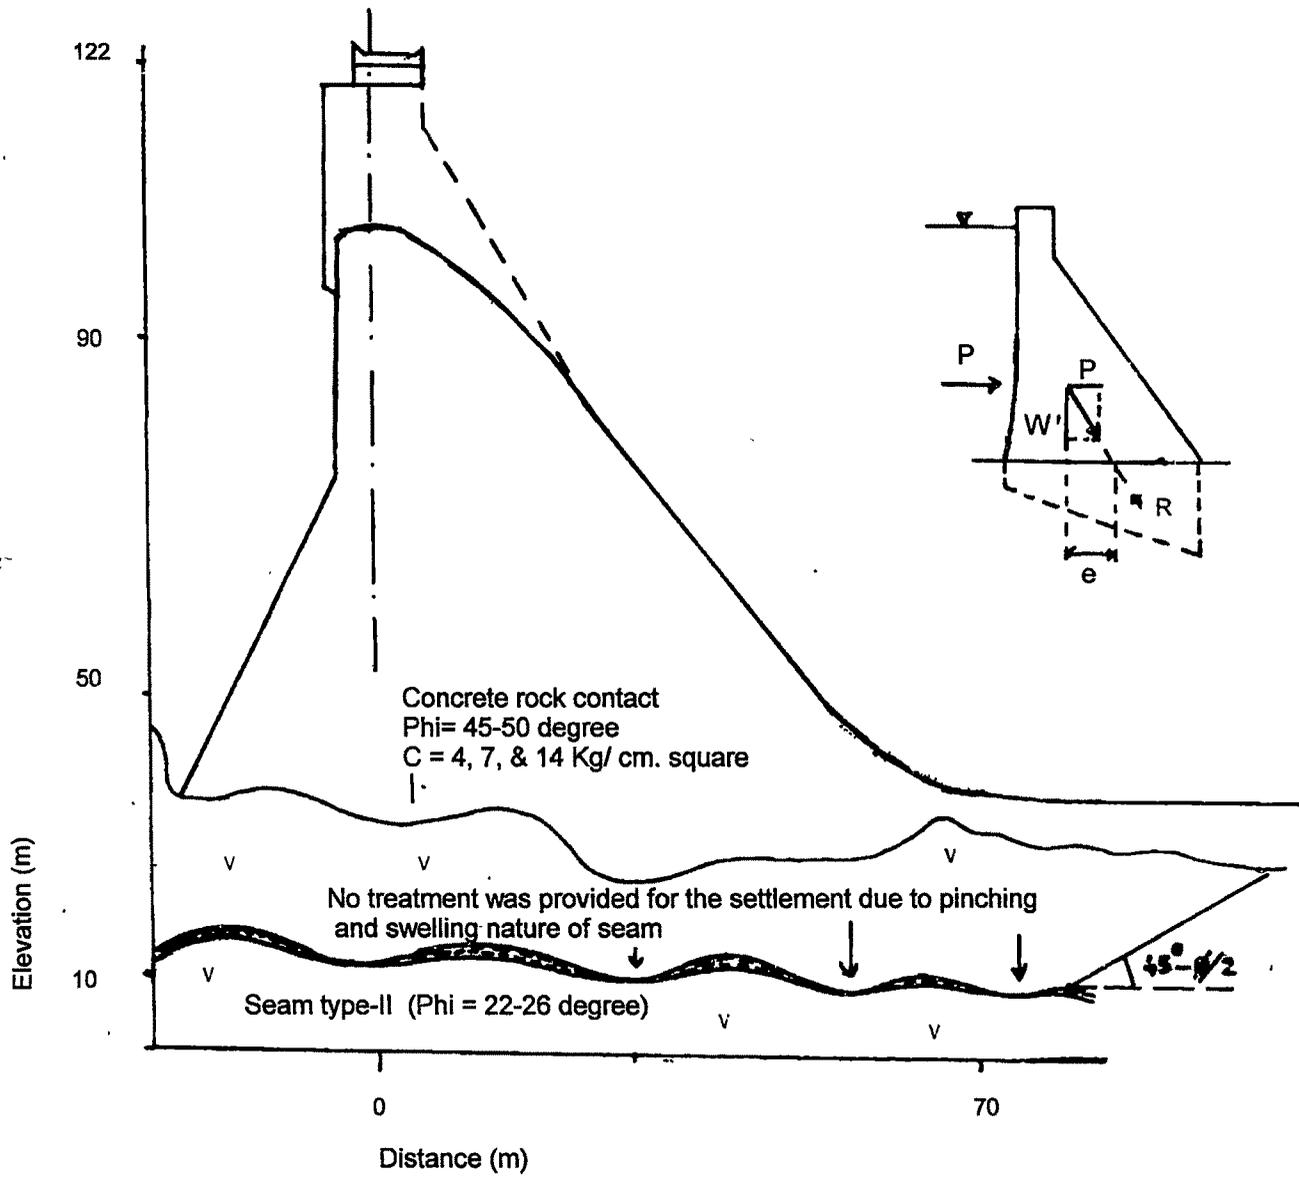
as they lie one over other at 3 to 5m intervals in the spillway blocks and at 4 to 10m intervals in the NOF blocks. These seams in general are of pinching and swelling type and of wavy disposition. Therefore, no treatment was provided to these seams from the settlement consideration as load of dam blocks would be transferred to underlying rocks at the points of rock to rock contacts of seam (Fig. 24). Moreover, these seams would be under confined condition due to construction of concrete shear keys. Treatment was also not provided even for 2m thick seam in the foundation of LNOF block-L3 on the consideration that dam was to be constructed slowly (i.e. slow loading of the foundation) and whatever settlement would have to take place would be completed during construction of the dam itself (Fig. 25). This seam is having shallow (3 to 4m) jointed (BS2-BS3) rock cover (Prakash and Mehta 1990).

Fig. 24: Geological section of Karjan dam spillway block showing disposition of pinching and swelling type weathered rock seam

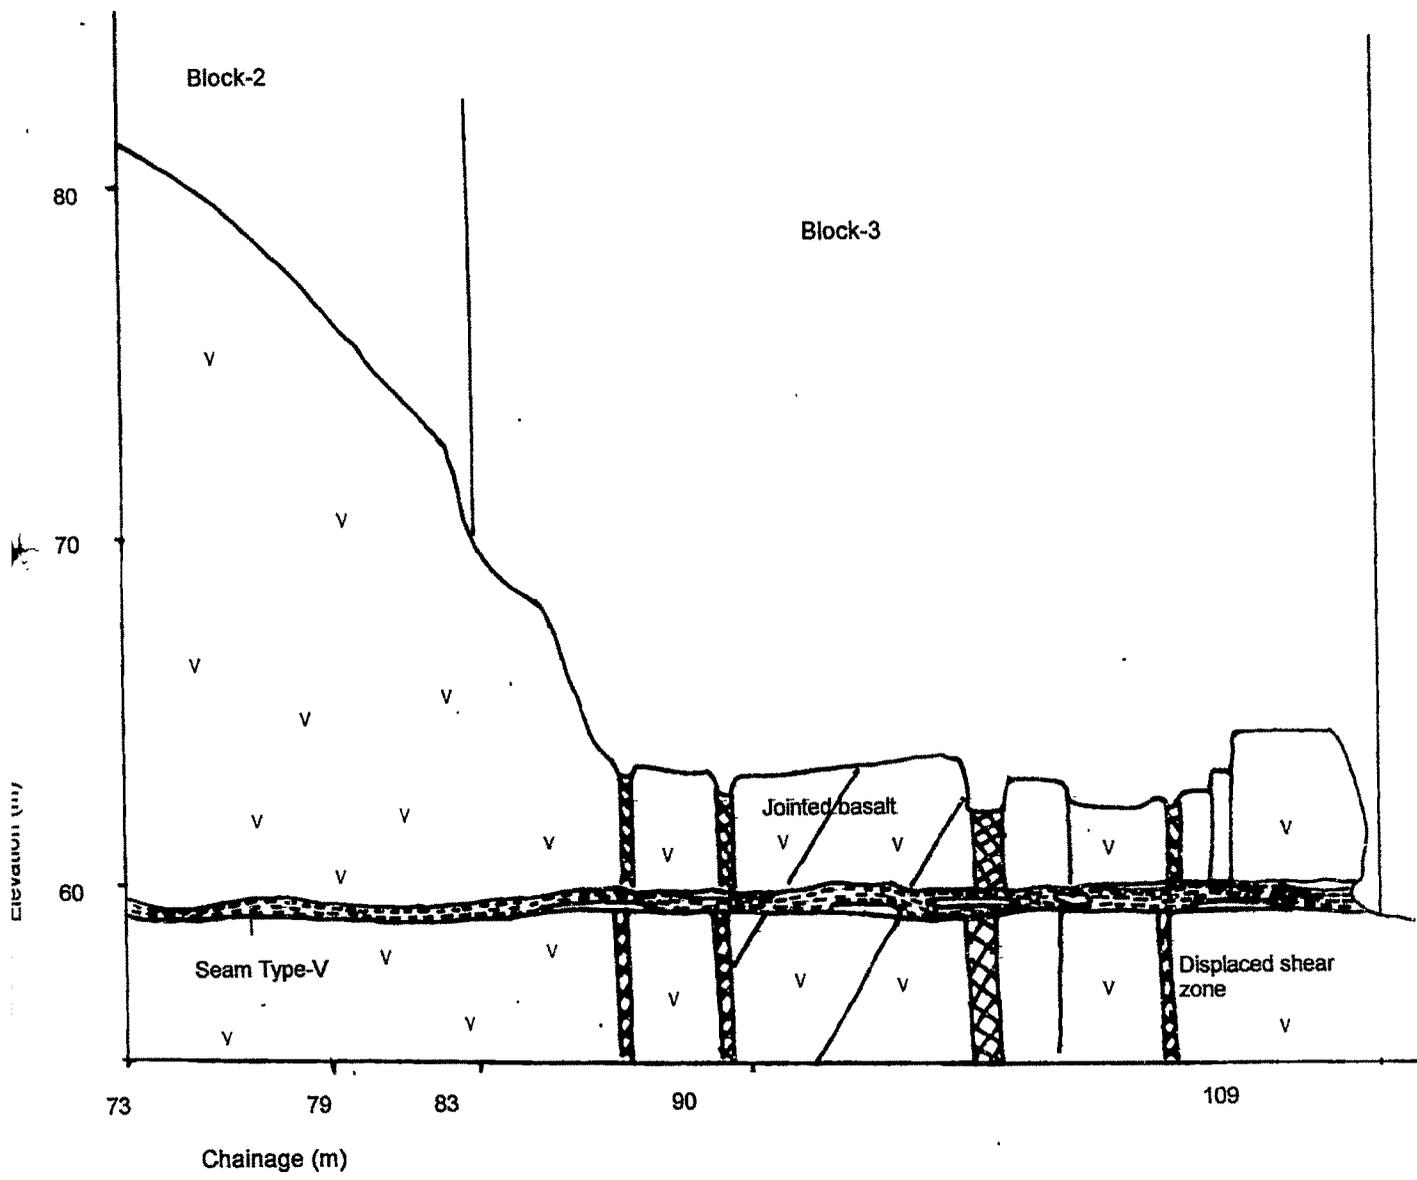
Fig. 25: Longitudinal geological section of Left Non Over Flow block showing disposition of weathered rock seam

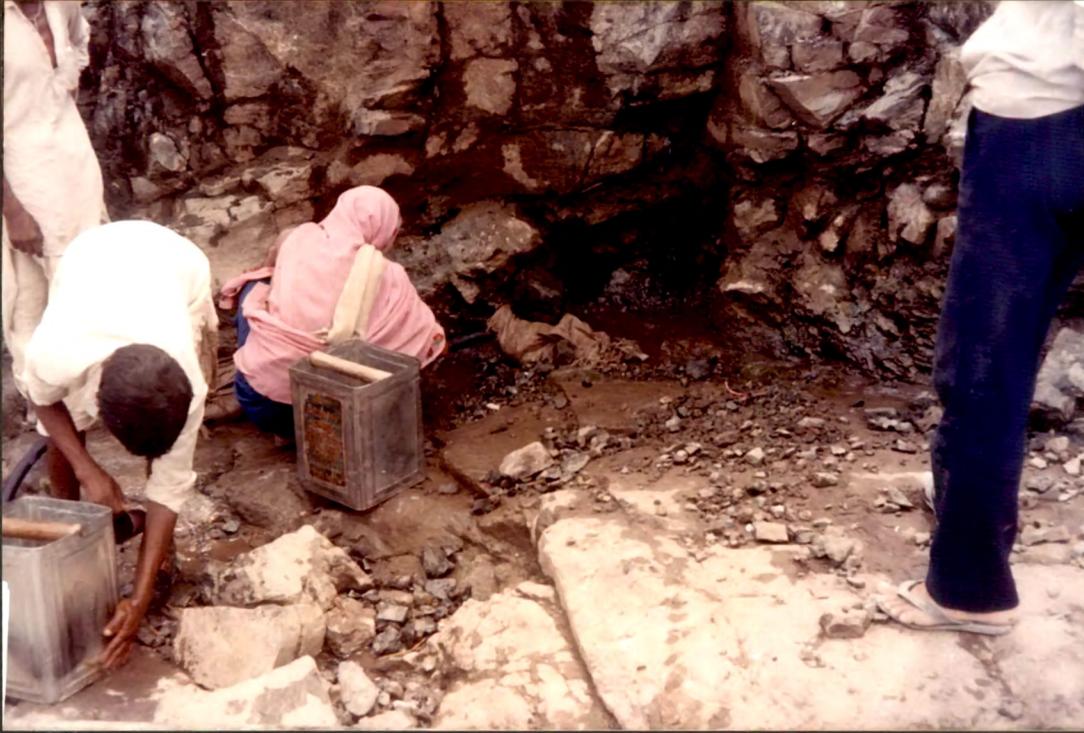
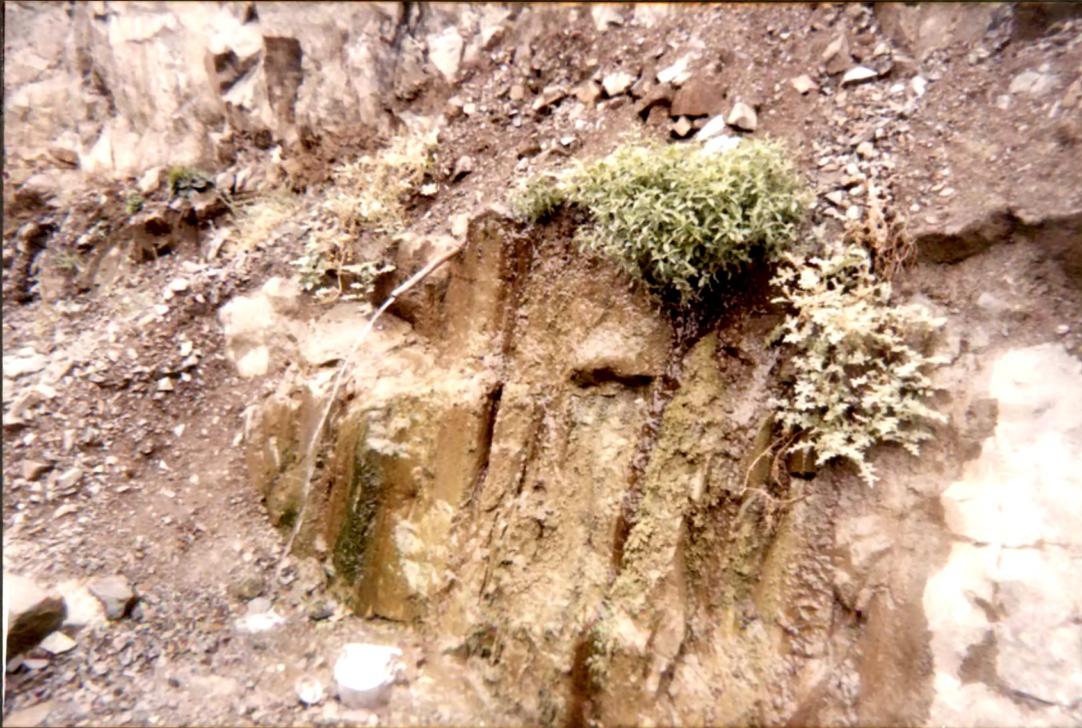
Plate 19: Seepage along flow contact, Sardar Sarovar (Narmada) Project

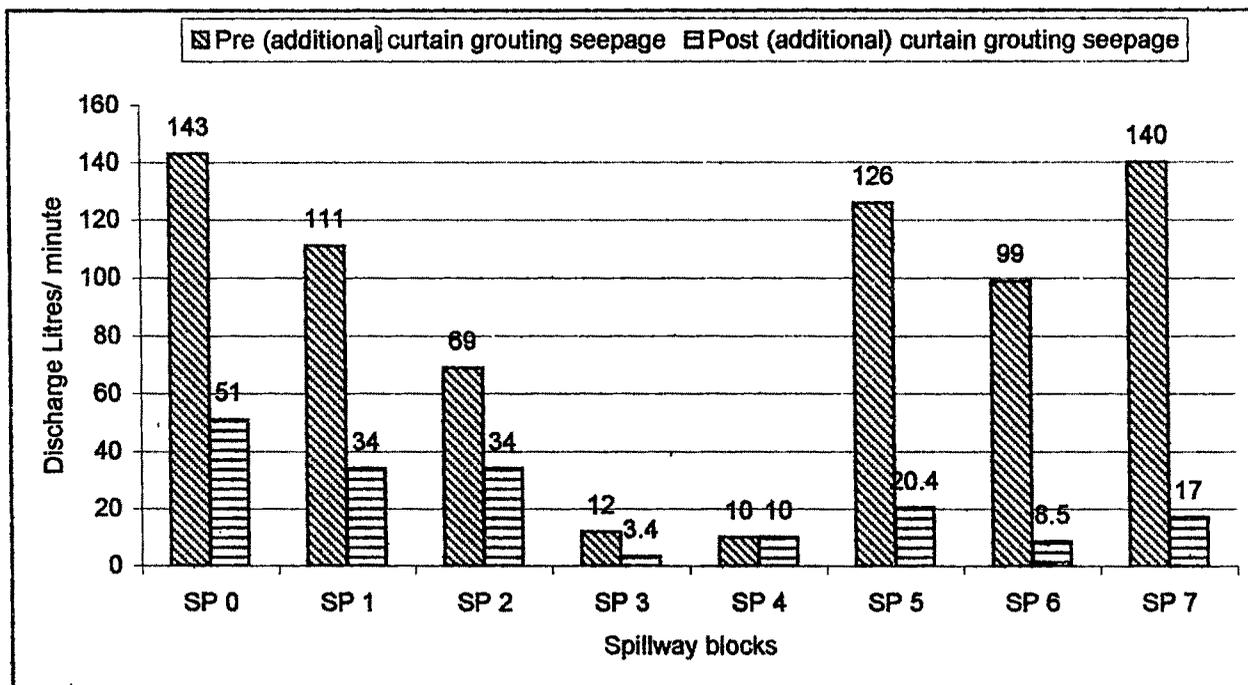
Fig. 27: Post grouting seepage and additional curtain grouting of the foundation of spillway blocks, Karjan dam

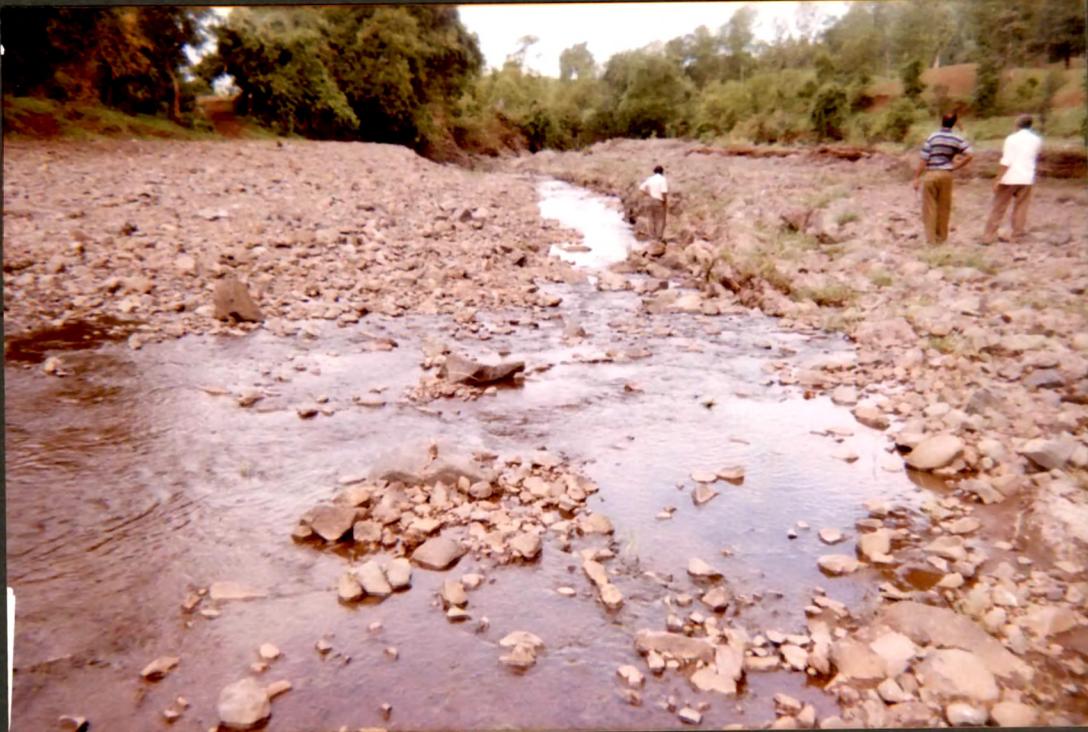
Plate 20: Surface manifestation of the Piplod fault (a & b)

(a) Straight course of Tarav Nala near Piplod

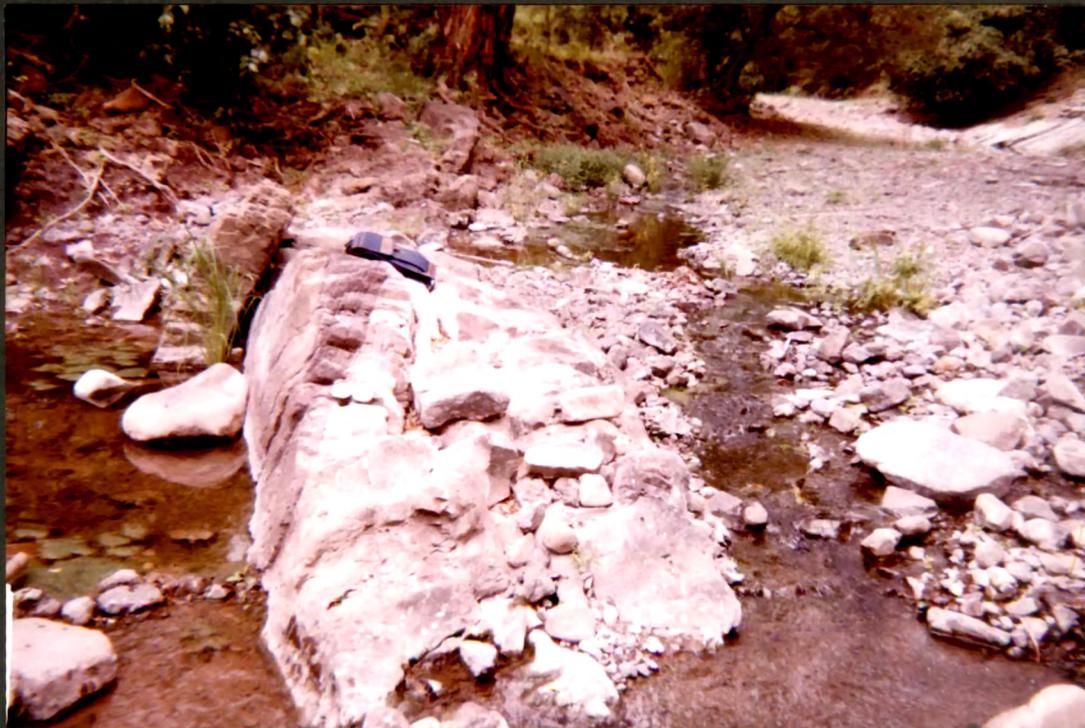
(b) Near vertical disposition of infra-trappean sedimentaries (Bagh beds) adjacent to fault
