BRIEF GEOLOGY OF THE NARMADA DAM SITE

Geotechnical problems and treatment of foundation of major dams on Deccan traps in the Narmada Valley/Gujarat/Western India

ABSTRACT: Foundation conditions of two major concrete gravity dams located across Narmada and Karjan rivers on Deccan traps in the Narmada Valley have been evaluated. Weak foundation media in the Deccan basalt flows are tuff, agglomerate and red bole. Besides, the rocks are dissected by joints, shears and faults. Older sedimentaries have been brought in juxtaposition with the basalt by faults in the vicinity of the Narmada site.

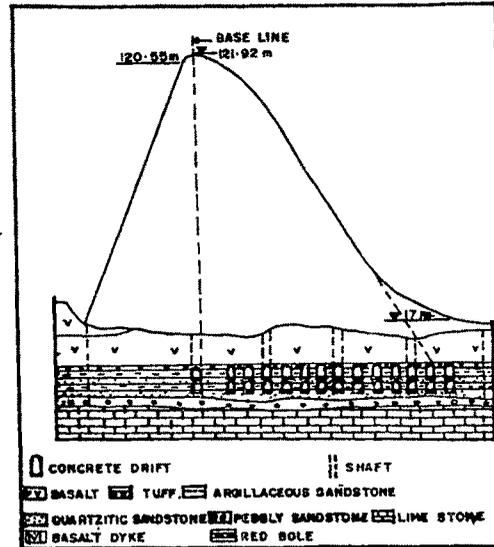
Fig.2 Typical Section of foundation treatment of argillaceous sandstone layers

In view of the low in-situ shear test results obtained at the contacts argillaceous sandstones and quartzitic sandstone, present in the foundations of spillway blocks-44 to 51, treatment for safety against sliding was provided. The treatment envisages removal of the argillaceous sandstone layers and its sheared contacts by excava-

ting 3 m wide and 3.6 - 6 m high drifts in a grid pattern, leaving rock pillars of size 8.5 x 8.5 m in between adjacent drifts and back filling the drifts with concrete/colcrete. The drifts replacing the Lower and Upper argillaceous sandstone are lying directly one over the other separated by upper quartzitic sandstone (Fig.2). For proper

keying; crown of the upper drifts have been excavated in the sound basalt and of lower drifts in the quartzitic sandstone. Tuff layer was removed from the crown of the upper argillaceous sandstone treatment drifts. Some of the lower and upper drifts in block 49 and 50 are combined due to thinning of quartzitic sandstone in between argillaceous sandstone layers. Maximum height of the drifts is 12.50 m.

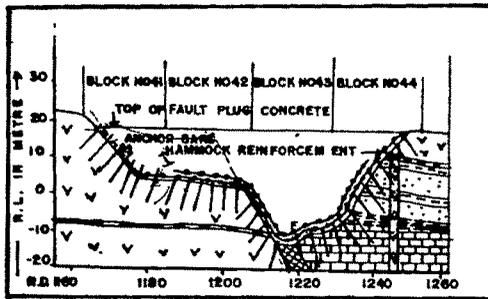
Fig.3 Geological Section across fault zone (for Index see Fig.2)

sed at the dam base cutting across the foundations of five spillway blocks 41 to 44. It is aligned in $N80^{\circ}E - 580^{\circ}W$ direction dipping 60° towards $N10^{\circ}W$. The sedimentaries on the right bank have been brought near the surface in juxtaposition with the basalt by this fault. The length of the fault is about 1.6 km and width at the dam base is 12 m. The basalt on the footwall side is highly sheared and fractured.

About 15 cm thick clay gouge is confined to the hanging wall. In view of this fault, foundation of blocks 41 to 44 are having different lithological units of varying physico-engineering properties on both sides of the fault.

The normal foundation level of the dam blocks adjacent to river channel fault is about EL (+) 18 m. As a part of the treatment, fault zone material was removed by excavating a trench in the foundation of river bed blocks down to 34 m depth (EL (-) 16 m) in the upstream and 26 m depth (EL (-) 8.0 m) in the down stream of the dam. Thus the actual depth of the fault zone treatment was about 2.15 to 2.83 times the width of the fault zone.

parallel to dam axis in one direction and parallel to strike in other direction was provided in the fault plug to uniformly distribute the load and to safeguard against any local weak pockets, and to prevent differential settlement within the plug (Fig.3). For mobilising greater shear resistance high yield strength deformed anchor bars 36 mm diameter, 8 m long in a grid of 3x3 m were also provided.

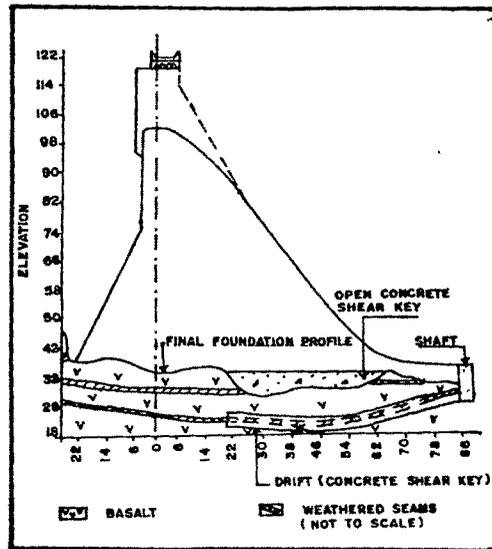
Fig.4 Typical section of foundation treatment of weathered seams

ered seams in the foundations of overflow and non-overflow blocks indicated value of Cohesion 'C' = 0.0 Kg/cm² and the value of angle of internal friction ' ϕ ' = 22° to 26°. In view of the low values of shear parameters and continuity of these seams in the foundation, sliding stability analysis of the spillway blocks and non-overflow block was done. Based on these analysis concrete shear keys were provided in the foundation of spillway blocks against sliding. The shear keys are located at downstream one third foundation area of the blocks where stresses are likely to be maximum under impounding condition (Fig.4).

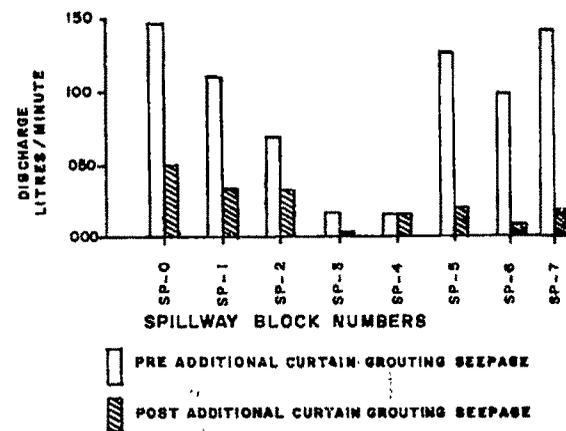
Fig. 5 Pre- and post-additional curtain grouting seepage observed through foundation drainage holes in spillway blocks.

Conspicuous seepage was observed through weathered rock seams during the excavation of shafts and drifts in the foundations of spillway blocks (Mehta and Prakash, 1990). Nearly all the drill holes during pre-construction stage investigations recorded high permeability (upto 75 Lugeons). To reduce the permeability of rock foundation initial curtain grouting was done in four stages with 5, 10, 15 and 20 kg/cm² pressures, gradually increasing with depth when the reservoir level was at minimum. Depth of curtain grouting in spillway section varies from 42 to 60m. It was observed in five spillway blocks that post grouting seepage was more than 100 litres/minute. It clearly indicated ineffectiveness of initial curtain grouting. Therefore, to reduce the seepage additional curtain grouting was done with uniform high pressure of 20 kg/cm², after filling of the reservoir upto El.78m, to seal remaining gaps/permeable windows in the grout curtain. Seepage has reduced in general by about 70 to 90% after providing additional curtain grouting (Fig. 5).

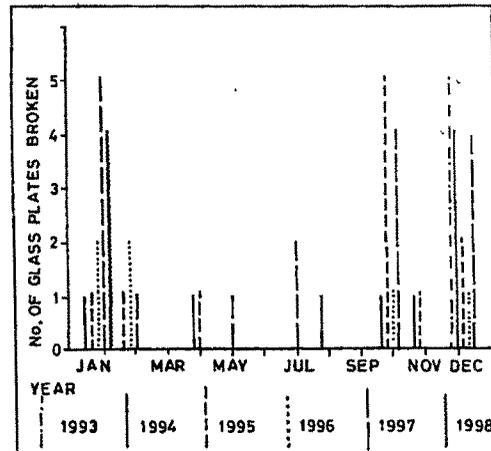
Figure 7. Glass plates breaking data of the downstream wall and bus galleries.

Glass plates have been installed in the downstream wall and bus galleries to monitor the existing cracks. Analysis of the data for the period October, 1993 to February, 1998 show that the activity of glass plate breaking is intermittantly continuing and is of periodic nature. The activity is prominent during the period October - February of each consecutive year (Fig. 7). Reasons for enhancement of the activity can be attributed to either reduction in the strength of the rock mass after saturation or to the development of hydrostatic pressure in the walls or to both.

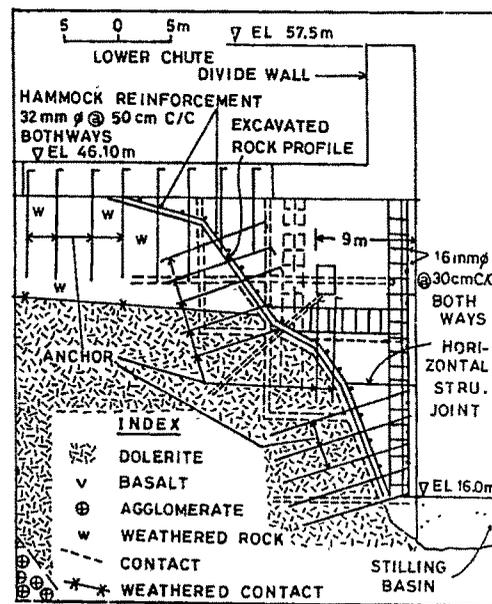
Figure 3. Typical section of left divide wall block-28 showing foundation treatment.

in the weathered rock area during September, 1994 flood when the flood water level (El. 52m) was above the foundation level. Final scoured topography of the foundation is having trapezoidal section with narrow base and broad top. Longer anchors and reinforced columns and beams resting on good rocks have been provided besides additional drainage to stabilise the wall (Fig 3).

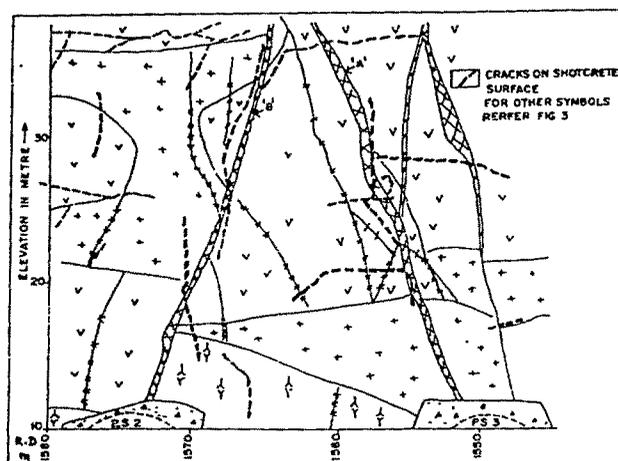
FIG.4 - PART OF UPSTREAM FACE OF THE MACHINE HALL SHOWING DISPOSITION OF CRACKS

The crack started developing in the wall when excavation progressed to El.14 m. The first 18 m high crack at RD 1569 m was noticed in March, 1991. Length of the crack increased from 18 to 22 m in Sept.1991, and new cracks developed during benching operation from El.14 m to (-)2 m till April 1992. Most of the cracks developed between RD 1547 and 1580 m are vertical in nature with maximum opening of the order of 15 mm. A few horizontal cracks have also been noticed. These vertical & horizontal

The probable reasons for the development of cracks can be one or the combination of (a) Differential movement of rocks in the vicinity of shear zones; (b) Adjustment of rock mass between inadequately supported pressure shaft openings; (c) High in-situ
