CHAPTER 6: ANTHROPOGENIC ACTIVITIES: POTENTIAL THREATS TO ECOLOGY OF NARARA REEF

6.3 RESULTS:

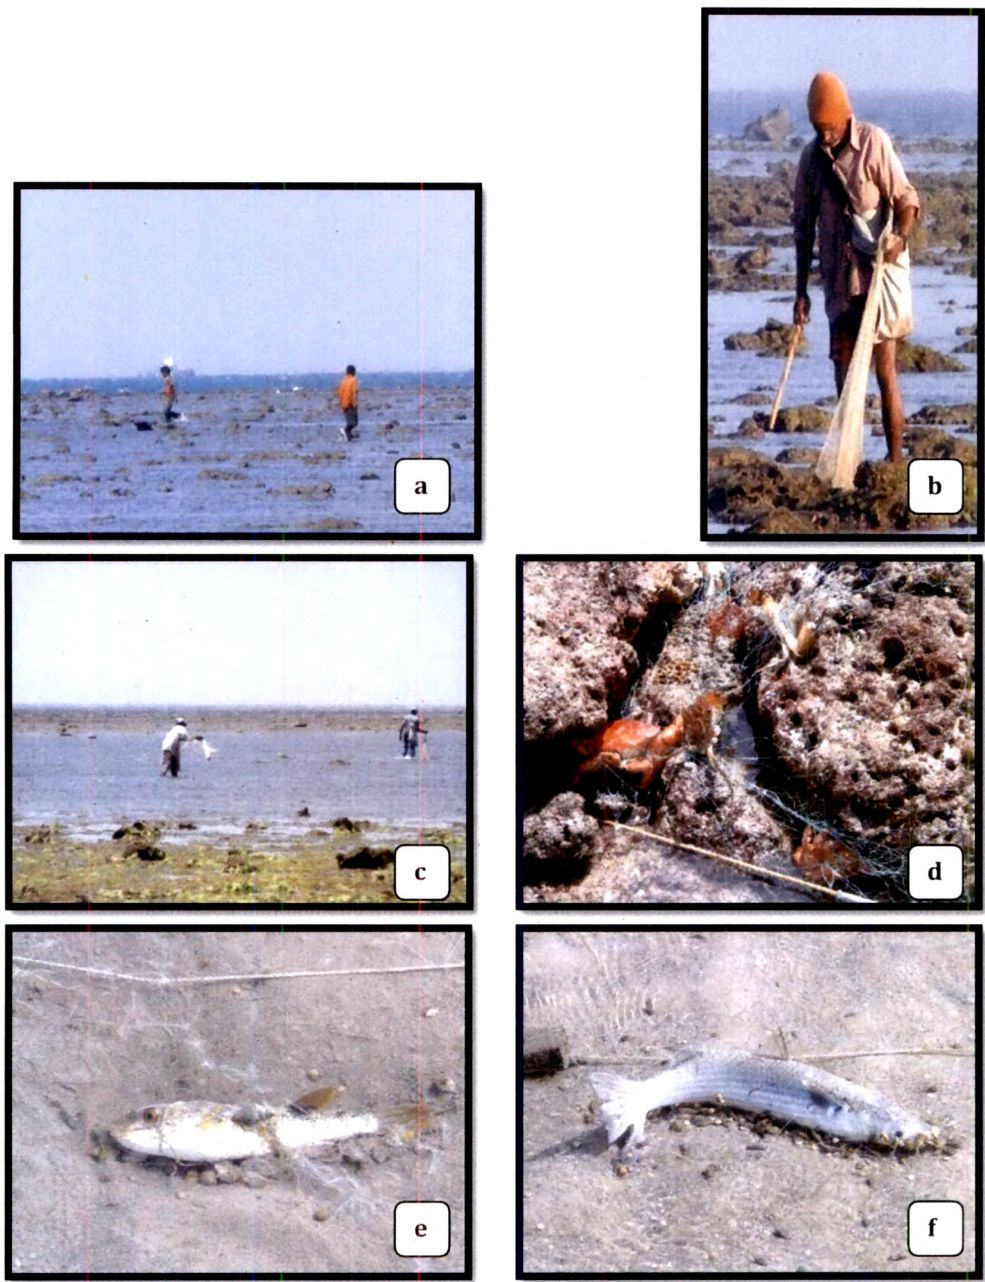
Plate: 6.1

(a, b, c) fishermen searching for crabs and octopuses, (d, e, f) crabs and fishes used as bait.

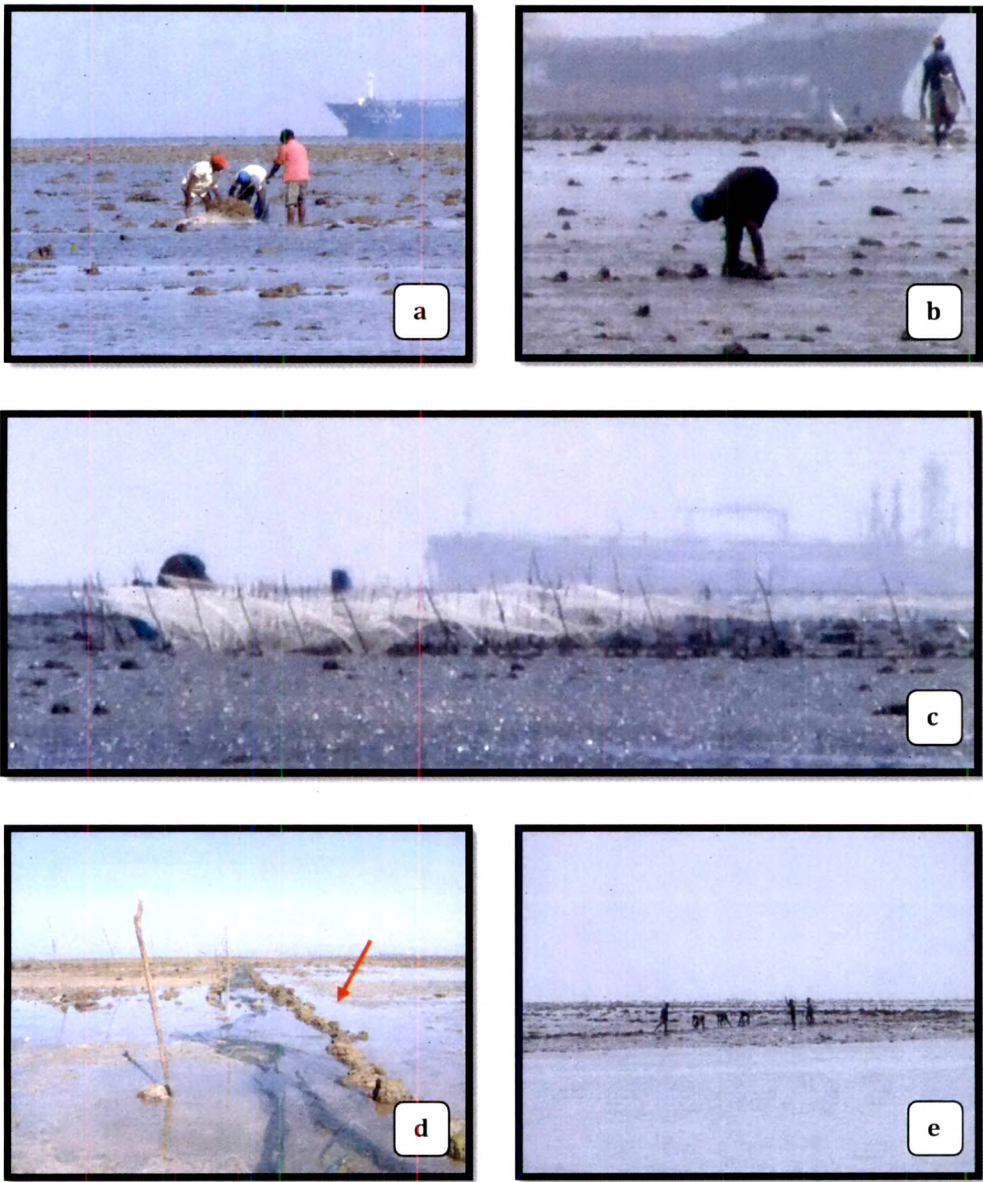
Plate: 6.2

The crabs and octopuses are cryptic in nature and take shelter when threatened. Therefore, fishermen dislodge rocks/dead coral boulders (sometimes live coral colonies are also dislodged) to reveal the hidden fishable organisms. They also deploy fishing nets on the reef flat and reef edge areas of Narara. They move small to moderate sized rocks from one place to another to make rock-lines (arrangement of rocks in a line on the intertidal area to tug the lower end of fishing nets, this is also known as WADA fishery in local). The area near to LTL was preferred by fishermen to erect fishing net with help of metal rod/bamboo involving digging into the coralline areas (Plate: 6.2 a-e).

(a) fishermen uprooting the rocks, (b) fishermen arranging rocks in a line, (c) fishing net erected with wooden sticks, (d) rock-lines (pointer), (e) group of fishermen digging coralline area to setup fishing net.

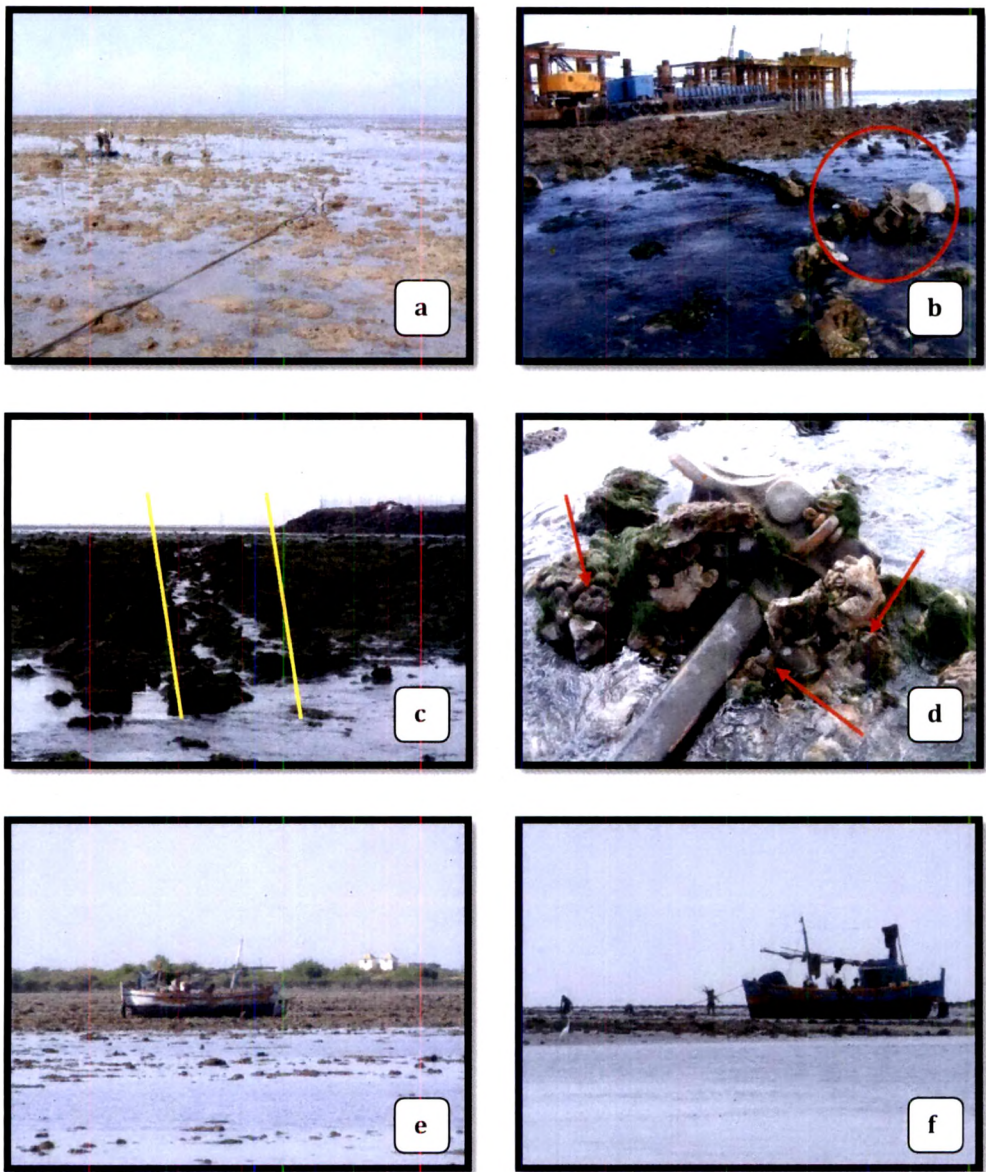
Plate: 6.3

Another kind of anthropogenic activity is related to fishing and port in vicinity. Studies on anchoring on coral reefs suggested significant degradation of coral community structures on reefs affected by anchorage (Dinsdale and Harriott, 2004; Saphier and Hoffmann, 2005). During the study sub-site S1 was found to be affected severely by direct anchoring of barges and other vessels on the reef area (Plate: 6.3 b). Close observations revealed presence of live coral colonies entangled and uprooted in the anchor (Plate: 6.3 d).

(a) anchor of a small fishing boat, (b) a barge anchored on coralline area, sub-site S1, (c) trench made due to anchorage (habitat damage), (d) presence of live corals (pointers), (e, f) landing of fishing boats on reef flat.

Such anchorage by large sized vessels damage the substratum on the large scale (Plate: 6.3 c). However, in other sub-sites also anchoring of smaller fishing boats is done.

Fishermen in groups of 15-20 people were observed to visit Narara reef in boats. Generally they land their mechanized fishing boats on the outer reef flat, reef edge or inner reef flat (Plate: 6.3 e, f). This was found to crush coral colonies present under the landed boat. Three to four boats landed on reef area was a common sight during study period.

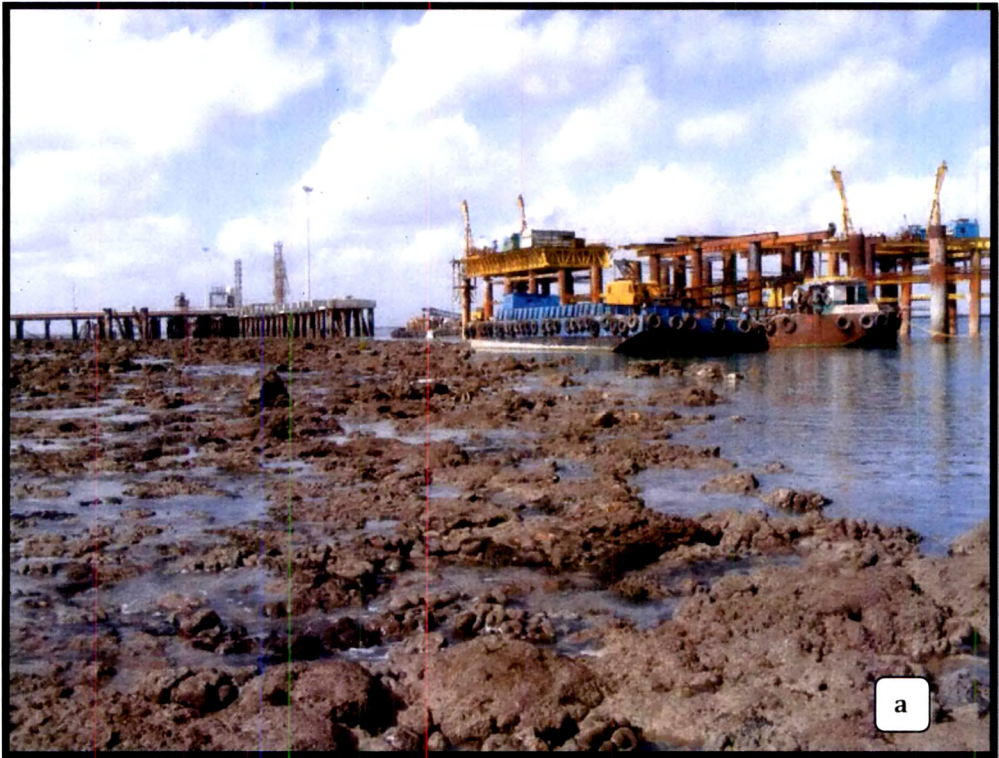
Plate: 6.4

A fully operational port managed by Kandla Port Trust, Vadinar is situated on the western limits of Narara reef near sub-site S1. The casual threat from a port in vicinity to coral reef is increase in sediment load due to heavy traffic of large vessels and periodic dredging. In Narara, the vessels visiting KPT complex berth very near to the healthy coral patches (Plate: 6.4). This poses potential threat of grounding of ships during cyclones and unfavorable weather condition which cause physical damage to the reef ecosystem beyond the recovery.

(a) berthing of vessels near the coral reef area at sub-site S1,

(b) live corals in vicinity to port structure.
