## **5. Geotechnical problems and treatment of underground structures**

Fig. 29: Geological sections of the machine hall, Sardar Sarovar (Narmada) Project

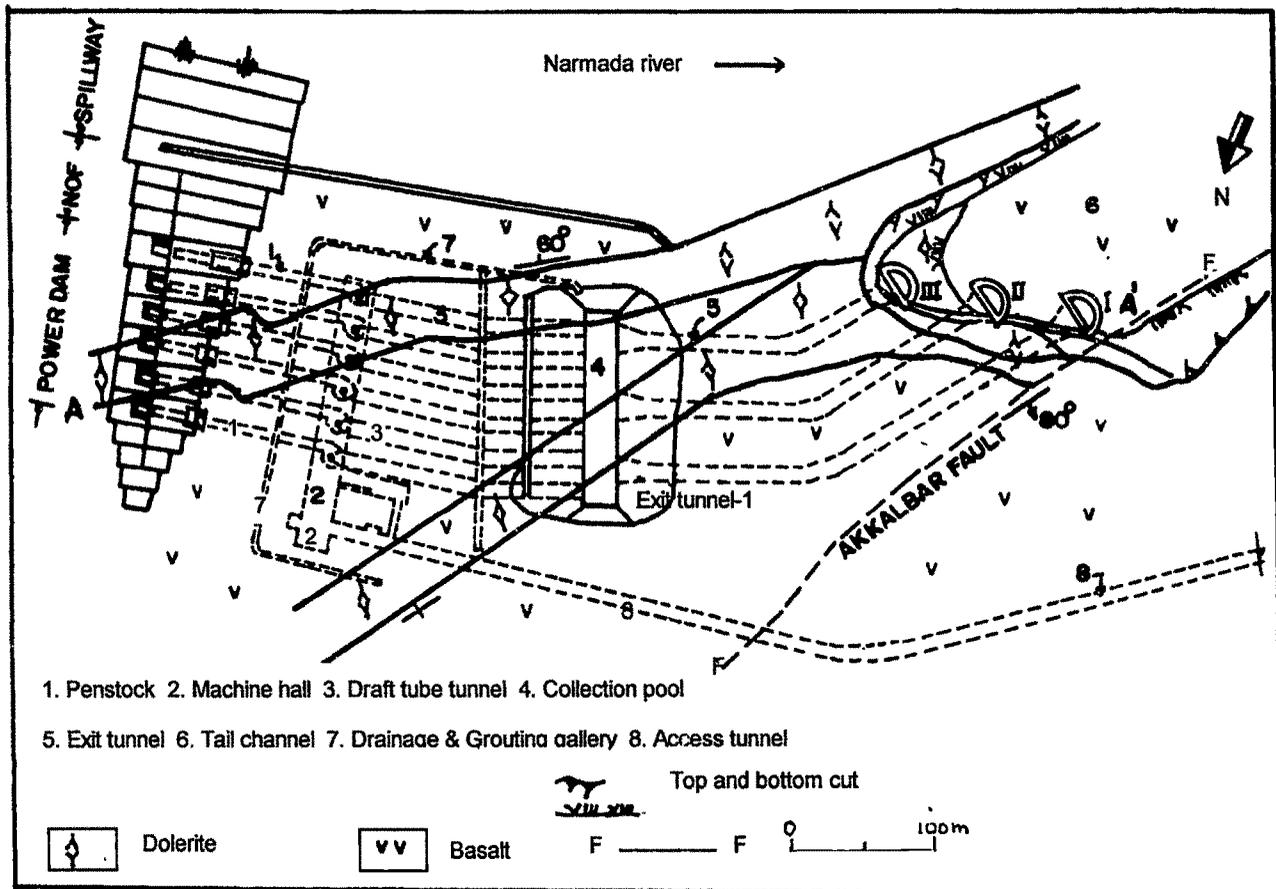
Fig. 28: Geology and layout of underground powerhouse

The Sardar Sarovar underground powerhouse is located at 160m downstream of the dam on the Right Bank in basalt flows intruded by dolerite dykes and sill. The location of powerhouse cavern has been selected in between vertical and inclined dolerite dykes so as they would act as seepage barrier for Rock fill dam-I reservoir water in the north and for Main River water in the south, respectively (Fig. 28 & 29).

The machine hall (cavern) is oriented in  $N10^{\circ}E -S10^{\circ}W$  direction i.e. longer axis of the powerhouse cavern is nearly aligned parallel to the direction of maximum horizontal stress  $\pm N5^{\circ}E$ . Major shear zones are cutting across the longer axis of the cavern. Tunnels (Access tunnel and draft tube tunnels) are aligned across the major discontinuities except exit tunnels, which are aligned, parallel to Akkalbar fault (Fig. 28).

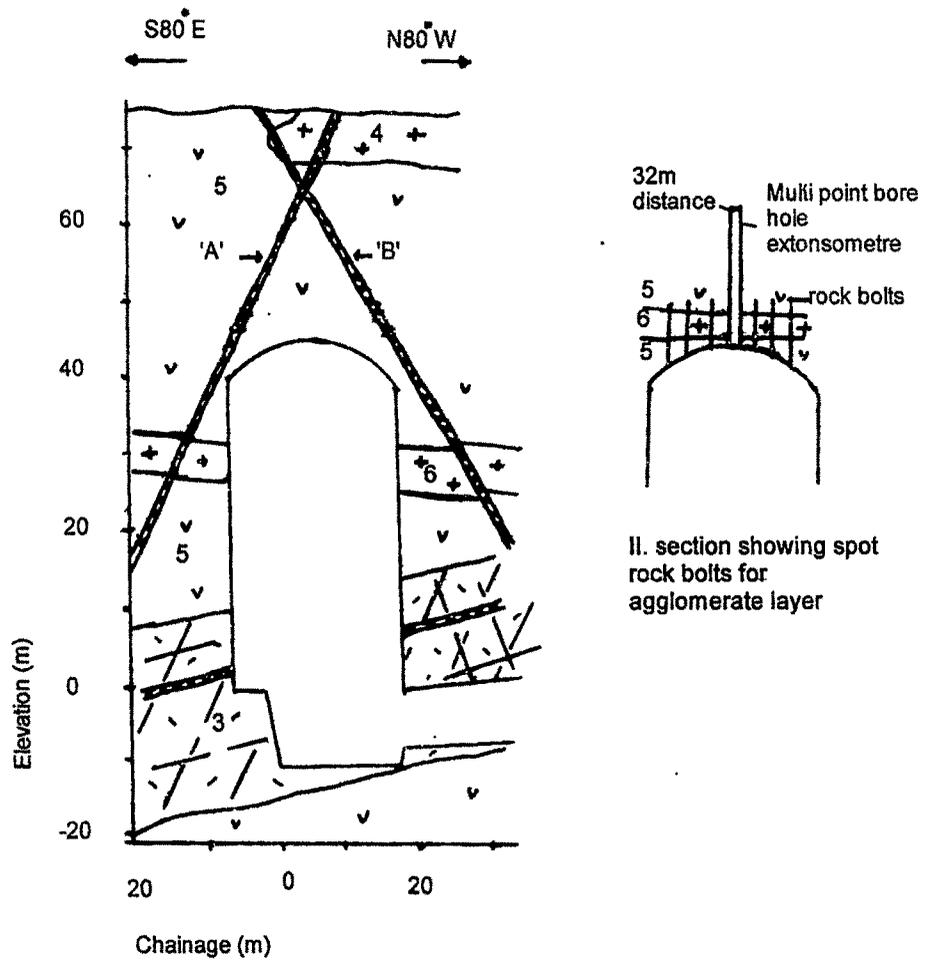
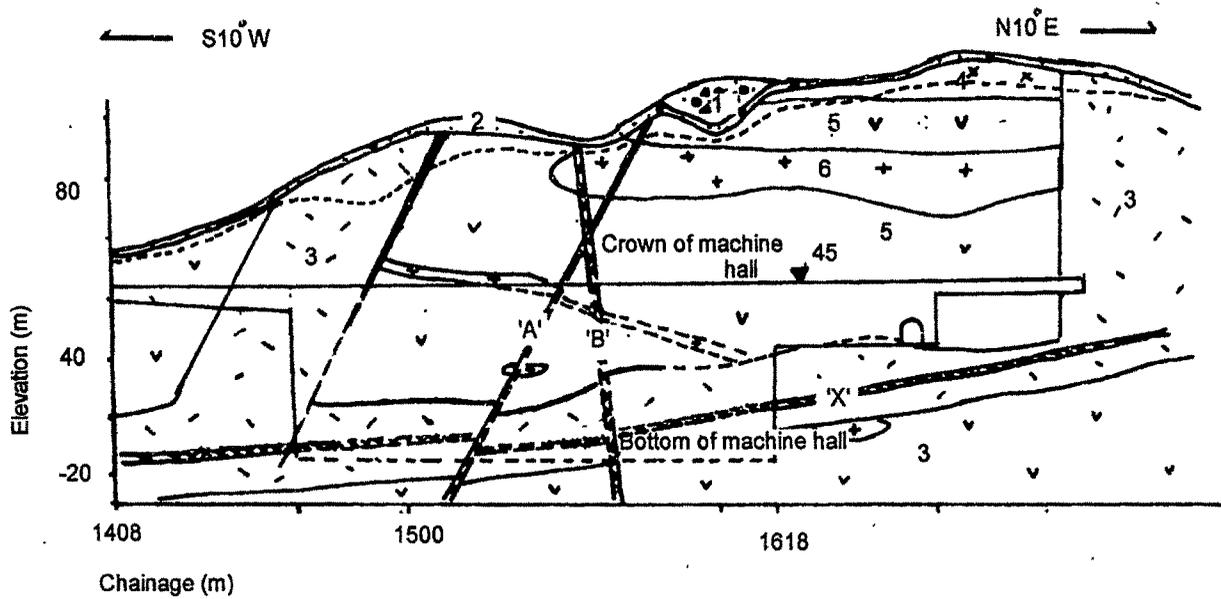
I. Geological cross-section of machine hall

1. Fill material 2. Over-burden 3. Dolerite 4. Amygdaloidal basalt 5. Porphyritic basalt 6. Agglomerate

II. Geological longitudinal section of the machine hall

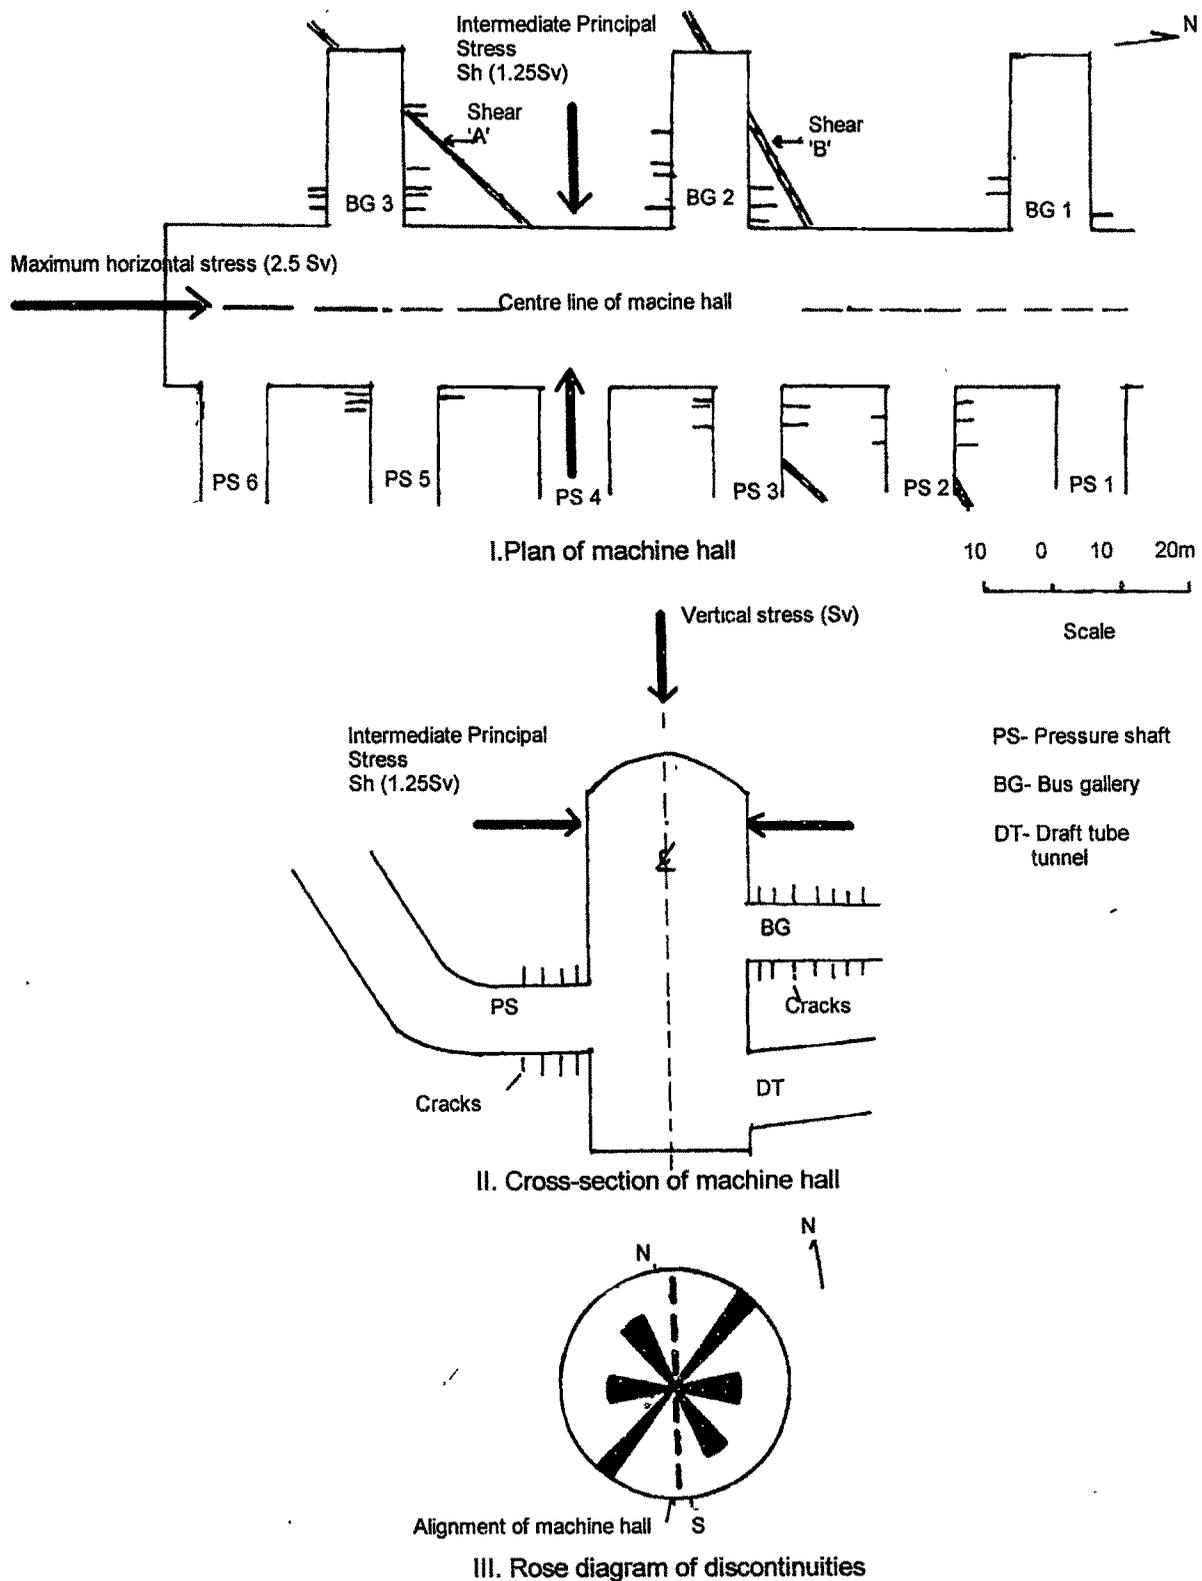
Fig. 30: Plan and section of machine hall of underground powerhouse showing disposition of cracks in the Pressure shafts and Bus galleries

Cracks (fissures) developed in the pressure shafts and bus galleries are aligned parallel to the longer axis of the machine hall (Fig. 30). These cracks are not following geological discontinuities. Sub-horizontal to low dipping cracks developed in the downstream wall in an echelon pattern parallel to the excavated profile of the ramp. A few cracks were also observed near the major shear zones 'A' and 'B'. These cracks were observed extending inside the rock mass by opening windows in the shotcrete.

b. Plane failure analysis: One of the primary condition of the plane failure is that the plane on which sliding is to occur must strike parallel or nearly parallel (within approximately  $\pm 20^\circ$ ) to the slope face (Hoek and Brown 1980). In the machine hall, prominent shear zones and joints are striking at an angle more than  $30^\circ$  to the longer axis of the cavern and thus posing no problem of plane failure (Fig. 30).

Major problem associated with excavation of this powerhouse cavern, in jointed rock mass having shallow rock cover, is that of *stress relief* due to low confining stress. This is analogous to the situation, which arises when excavating very steep slopes in hard but jointed rock masses. The stress relief caused by removal of the 'cut' can induce movement and/or failure in the rock mass. The vertical cavern walls can be thought of as steep rock slopes and unless adequate support would have been provided during excavation, deformation and cracking would occur. Thus in the absence of adequate supports, vertical tension cracks (which are very common in steep rock slopes) can form parallel to the walls. Symmetry of pattern of cracks parallel to the longer axis of the cavern in the pressure shafts and bus galleries also suggest that these cracks are developed due to tensile stresses acting on inadequately supported rock mass (Fig. 30).

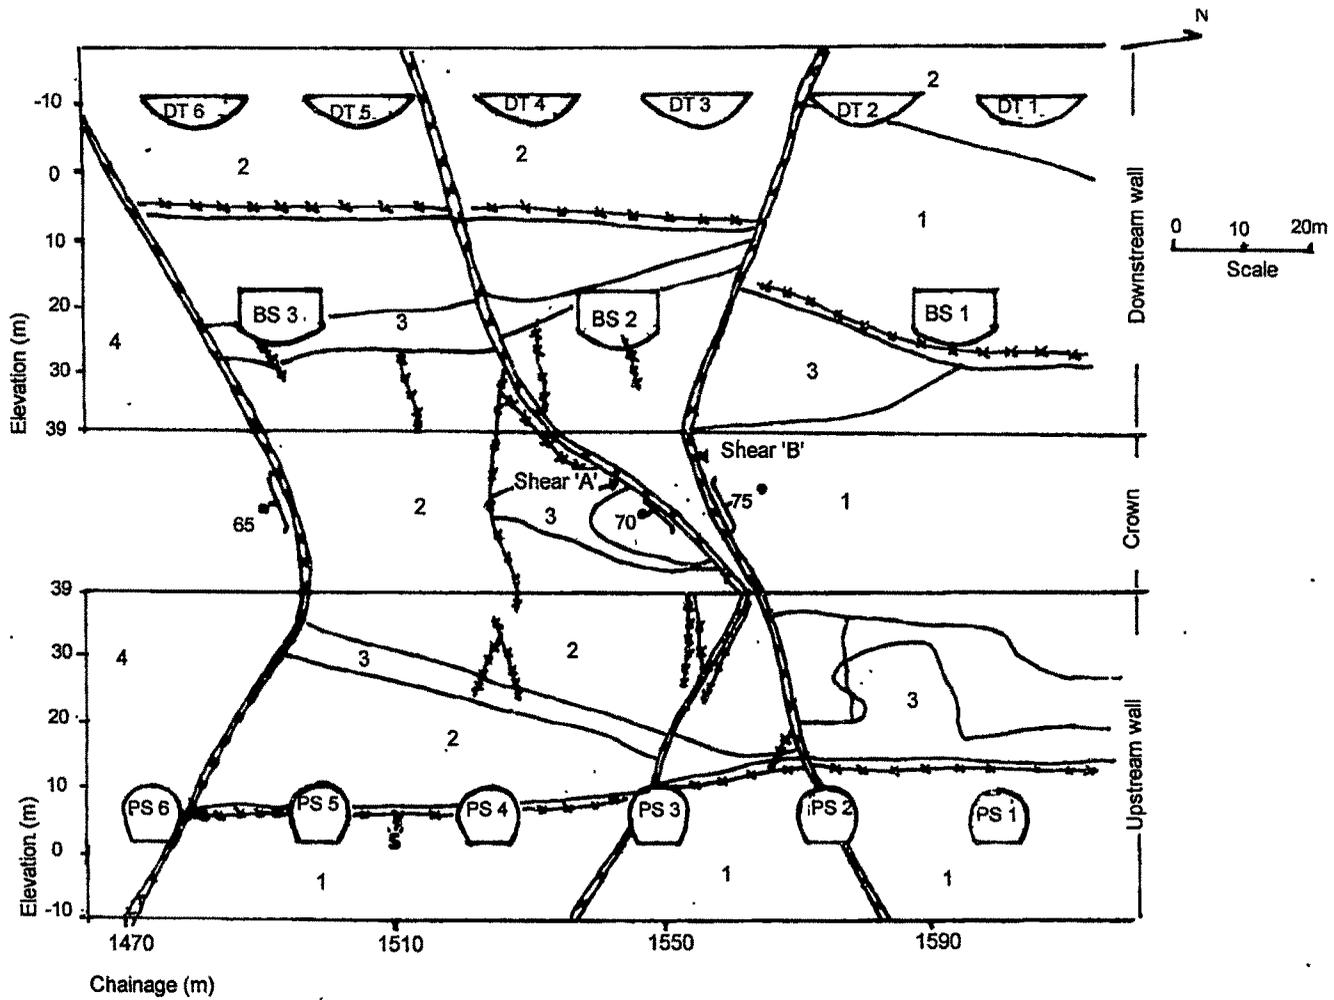
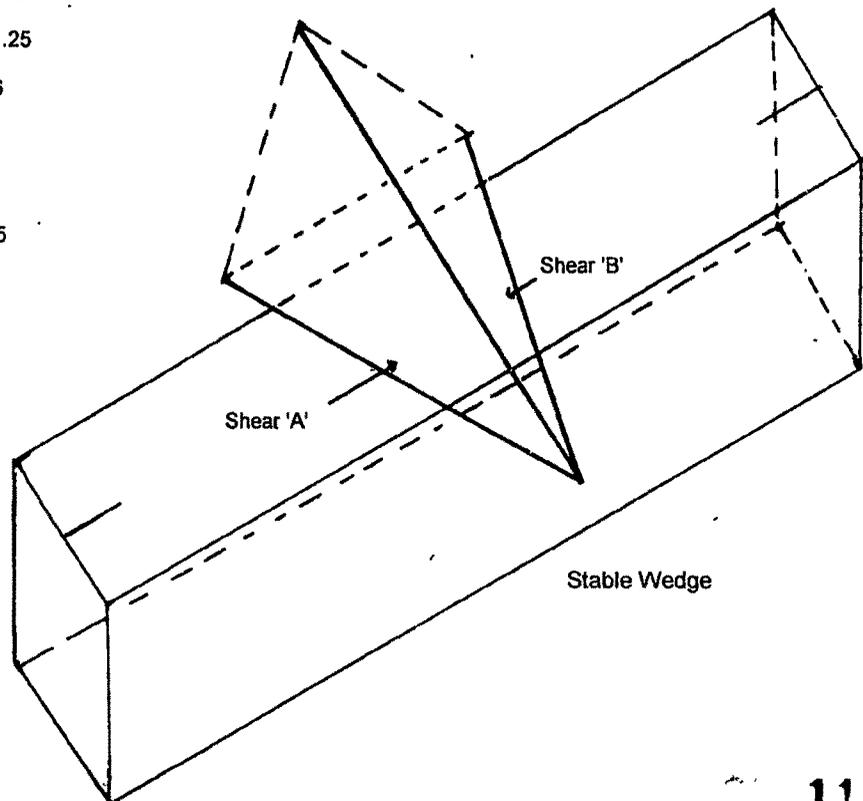
3-D Geological log of the machine hall

Bieniawski's RMR	Barton's Q
1. Jointed/ sheared dolerite sill	30-40	0.6-1.25
2. Jointed basalt	60	9.16
3. Agglomerate	50	-
4. Jointed Inclined dolerite dyke	63	10
5. Shear zone	35	1.25

Fig. 31: Rock mass characteristics and disposition of shear zones in the machine hall

'B' (N70° E-S70° W/ 70° -80° N20° W). Low dipping (20° -25° SE) shears 'X', 'Y' and 'Z' are traversing dolerite sill (Fig. 31 & 32)).

a. Wedge failure analysis: The most common types of failure in jointed rock masses at relatively shallow depth are those involving wedges falling from the roof or sliding out of the side walls of the openings (Stacey and Page 1986). Major shear zones 'A' and 'B' traversing the machine hall are forming stable wedge in the upstream wall as the plunge of the intersection of these shear zones is about  $22^\circ$  towards northeast (i.e. inside upstream wall). Sliding of wedge can only occur along the line of intersection of two planar discontinuities if it "day light" in the open space (i.e. free face). In the downstream wall these shears are diverging by virtue of their orientation and thus they are also not creating any problem of wedging (Fig. 31 and 32).

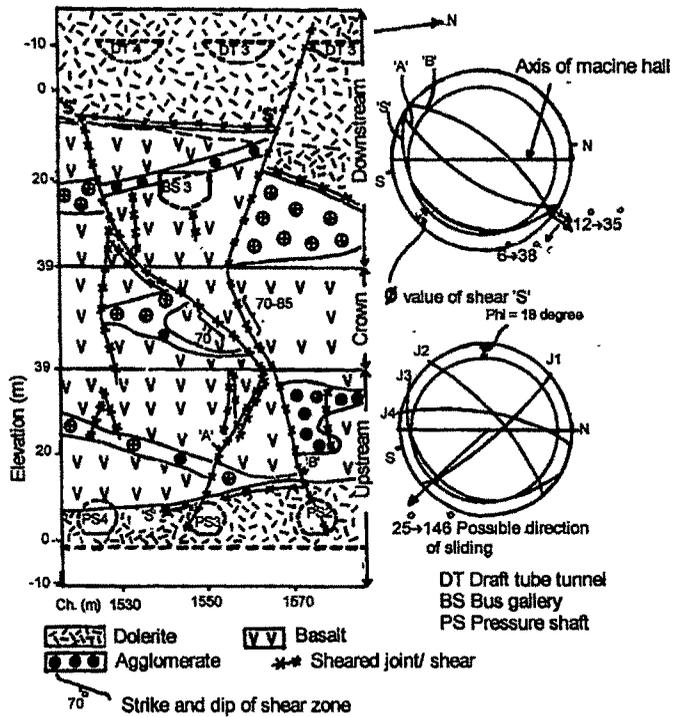
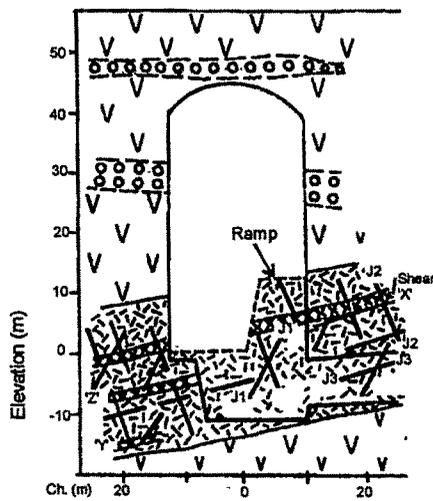
I. 3-D Geological map of part of machine hall

II. Geological cross section of machine hall

Fig. 32: Geological map of part of machine hall showing disposition of major discontinuities

Sliding wedges are formed at the lower part of downstream wall of the machine hall in the dolerite sill with intersection of joints  $J_1$  and  $J_3$ . These wedges are having  $25^\circ$  plunge towards  $S34^\circ E$  (i.e. towards free face) (Fig. 32). Similar minor rock wedges are formed with the intersection of joints  $J_1$  and low dipping shears 'X', 'Y' and 'Z'. These wedges were stitched by 12m long rock bolts during progressive excavation.

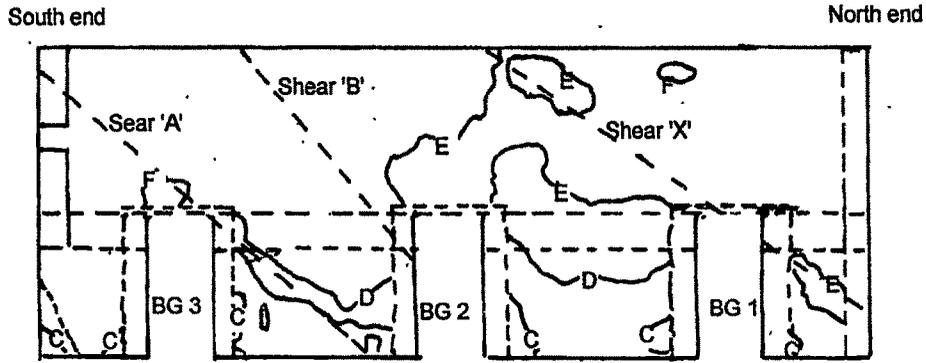
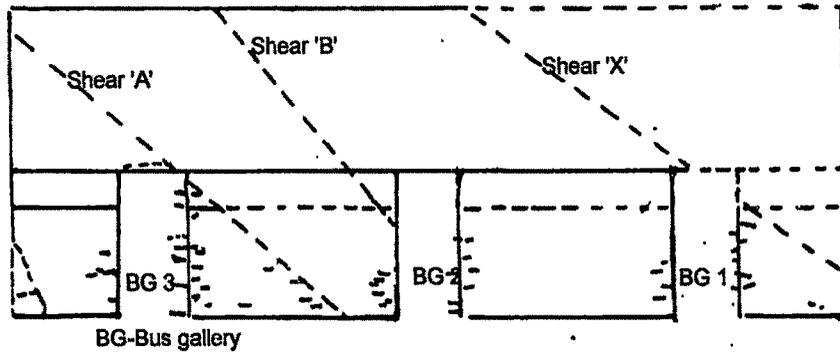
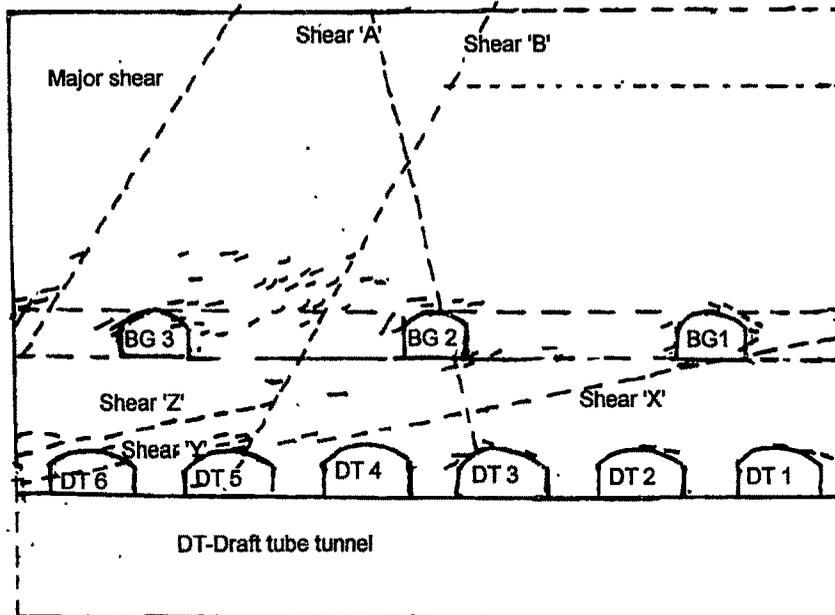
I. Minor Principal Stress Contour (A-F) Plan at El. 20m

II. Plan showing cracks as observed in the model studies at El. 20m

III. Section of the downstream wall showing cracks as observed in the model studies at 5m distance from the outer face of the wall

Fig. 33: Plot of 3-DEC (3-Dimensional Distinct Element Code) Discontinuum analysis model study results of downstream wall of Powerhouse cavern (Machine hall) prior to the excavation of ramp

Three Dimension Finite element (3-D FEM) and Three Dimensional Distinct Element Code (3-DEC) back analysis were conducted after the development of cracks in the walls of the machine hall to know the present and future behaviour of the underground powerhouse cavern (Fig. 33)(Table 30).

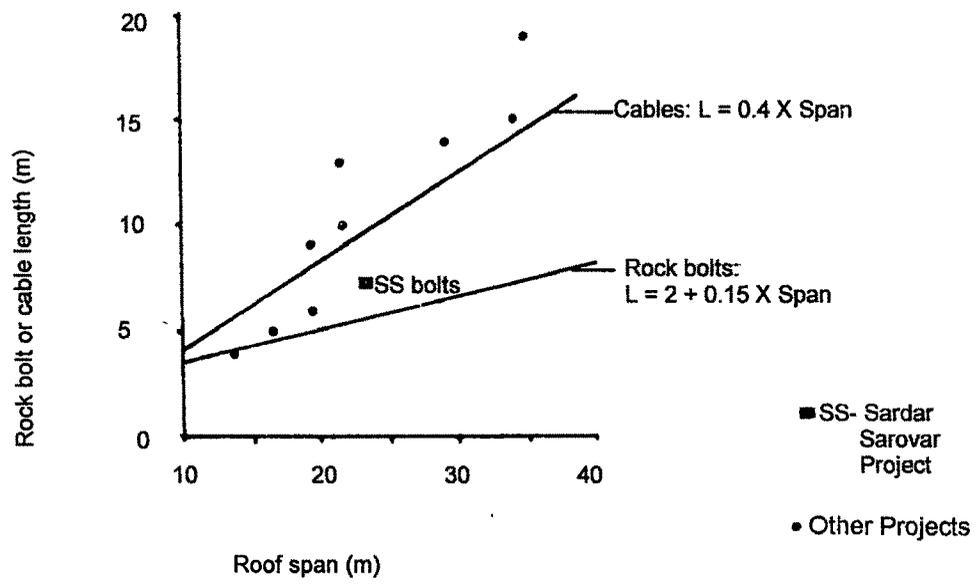
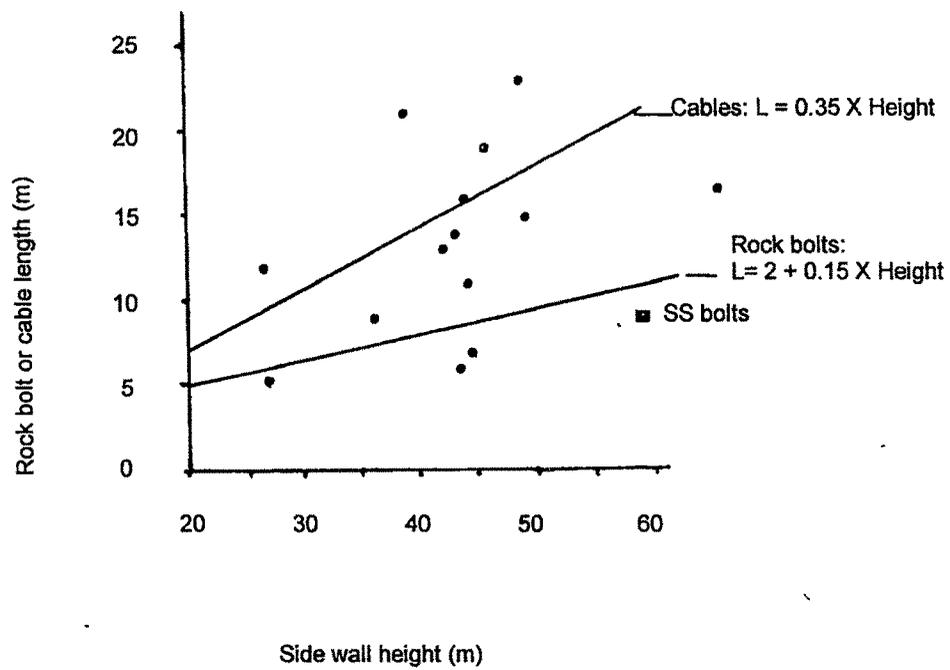
I. Roof Support

II. Wall Support

Fig. 34: Plot of rock bolt and cable lengths for roof (arch) and side wall support of underground powerhouse cavern

Similar approaches and plot for side wall support for a 57-58m high cavern gives the average length for rock bolts and cable 10-11m and 20m, respectively (Fig. 34). It appears that the 6 to 7.5m long rock bolts provided for the side walls of the Sardar Sarovar powerhouse cavern were too short (Goel and Jethwa 1992, Prakash and Srikarni 1998). Thus, they could not provide adequate restraint to prevent development of cracks in both upstream and downstream walls including pressure shafts and bus galleries.

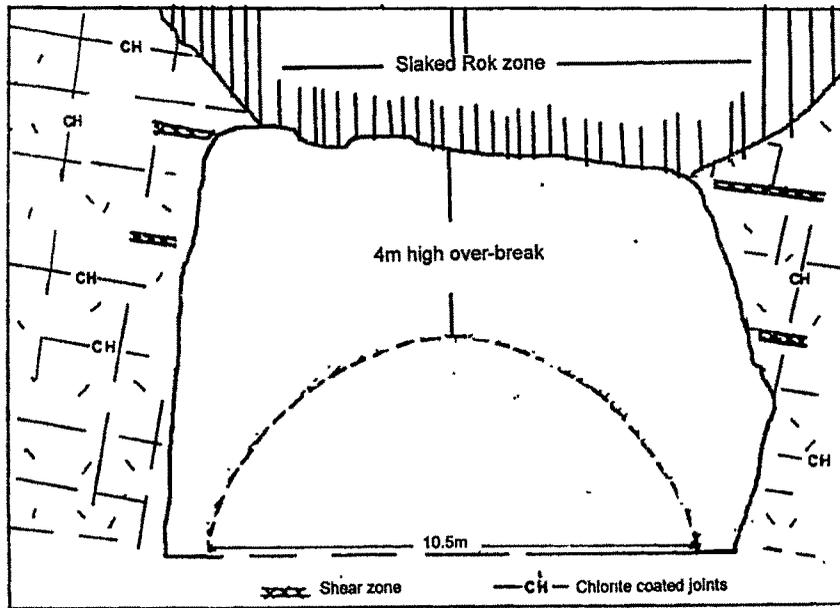
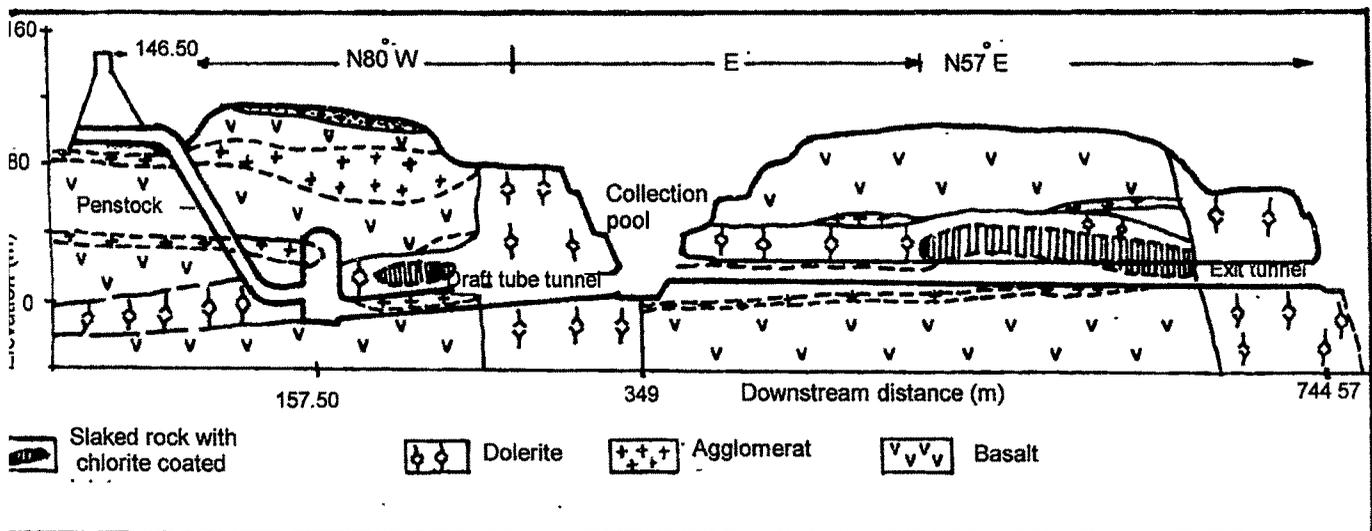
I. Geological cross-section of part of draft tube tunnel-2 showing over-break

II. Geological section along water conductor system

Fig. 35: Geological conditions of water conductor system of underground powerhouse

The tunnel excavation has been done by New Austrian Tunneling Method (NATM) to utilise the rock itself as principal structural material (Subramanian et. al. 1992). Major parts of the draft tube tunnels and exit tunnels and small part of the access tunnel are passing through chloritised and slaked jointed dolerite dyke and sill posing problems of rock falls and roof collapses (Prakash 1994) (Fig. 35).

b. Draft Tube Tunnels: Overbreaks of the order of 4.5m in height occurred in the draft tube tunnel-2 & 3 in the reaches occupied by sub-horizontal shears and slaked rock zones even after the installation of pattern rock bolt supports (Fig. 35). Rib supports were installed in all the tunnels after the roof falls and collapses except in selected reaches (about 80m length in the D.T.1 and 14m length in D.T.2) where chlorite coating along joints was almost negligible.

rock bolts were noticed slipped in these zones during tensioning (Fig. 35). Collapses in part of the tunnel sections traversed by chlorite coated joints and slaked rock zones occurred despite installation of design rock bolt supports. Even change of the excavation pattern by excavating the central 7m wide portion in heading and then excavating the remaining portion after providing shotcrete and longer rock bolts in the central drift could not prevent the rock fall. Therefore, rib supports were introduced in major part of all the exit tunnels (Prakash and Sangneria 1993).

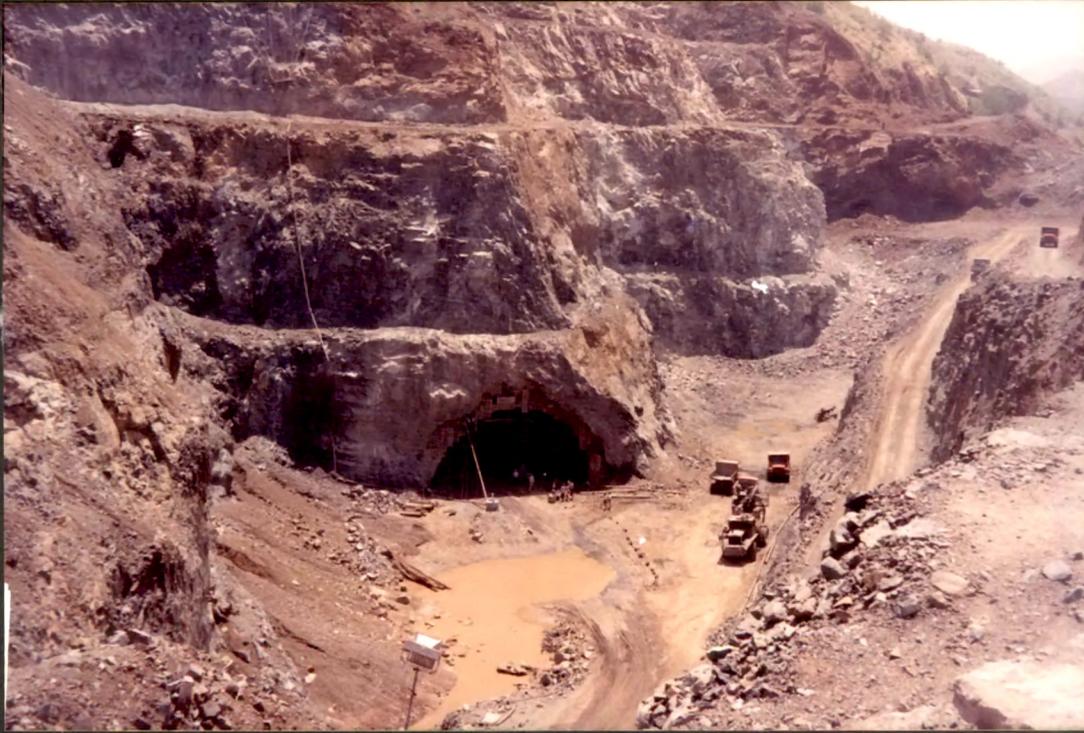
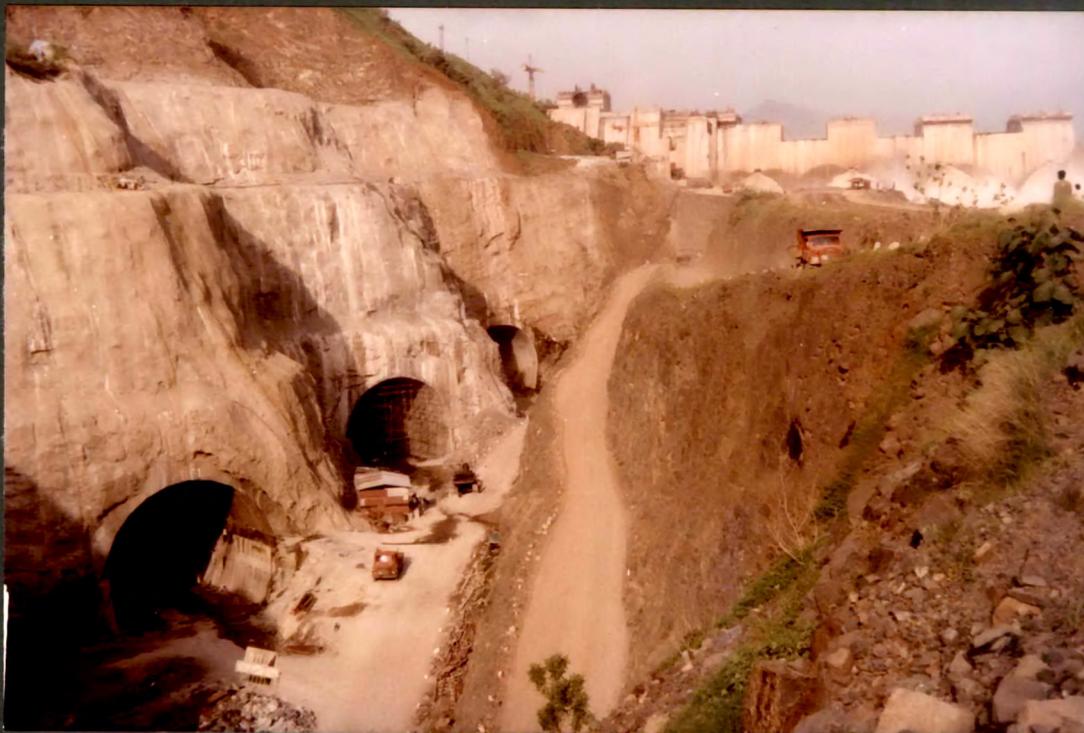
(a) Rock mass condition at the outlet portal face of the tunnels

(b) Shotcreted (with wire mesh) outlet portal face of the tunnels

Plate 21: Outlet portal face of the Exit Tunnels prior and after shotcreting the surface, Sardar Sarovar (Narmada) Project (a & b)

c. Exit tunnels: Adverse effect of the Akkalbar fault was noticed in the exit tunnel-1 where it is running parallel and close to the alignment in about 200m length (Plate 21 & Fig.26). Joints sympathetic to the fault in the E.T.-1 are forming removable/ detachable blocks of size varying from  $1\text{m}^3$  to  $6\text{m}^3$  resulting in major block falls and roof collapses. The rock falls exposed the basic characteristic of crumbling of the rock mass due to chlorite infilled joints and slaking nature of dolerite rock (Plate 22 & 23). About 50% length of the all the exit tunnels is passing through dolerite rock/ dissected by chlorite coated joints and about 50%

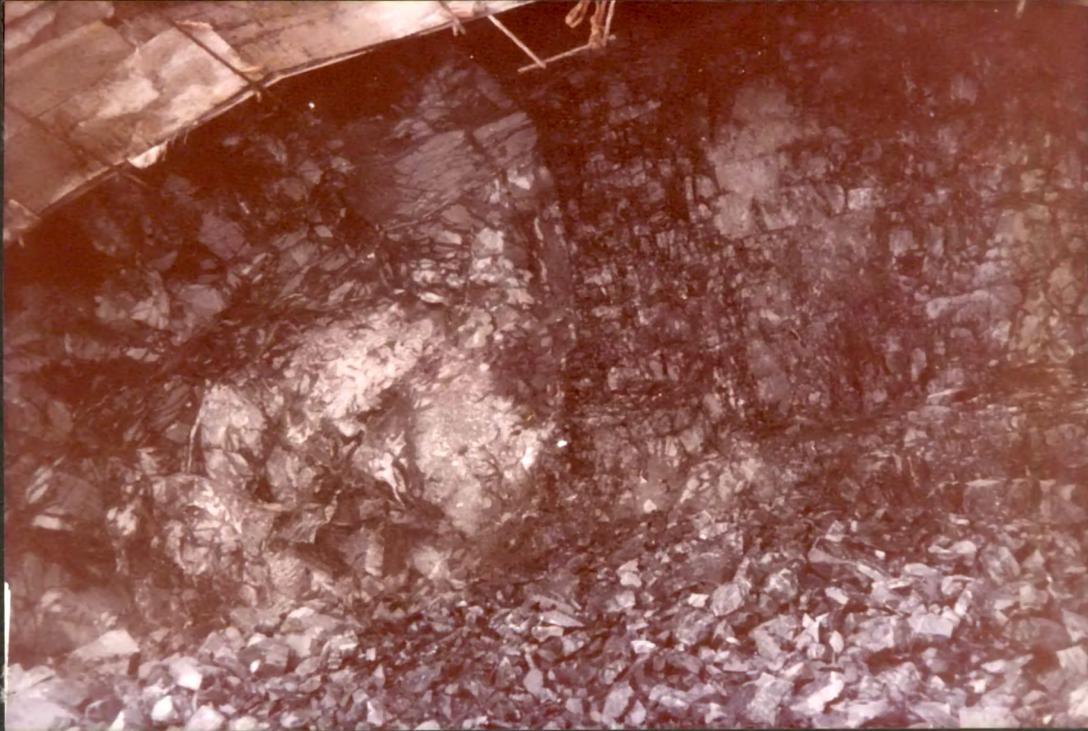
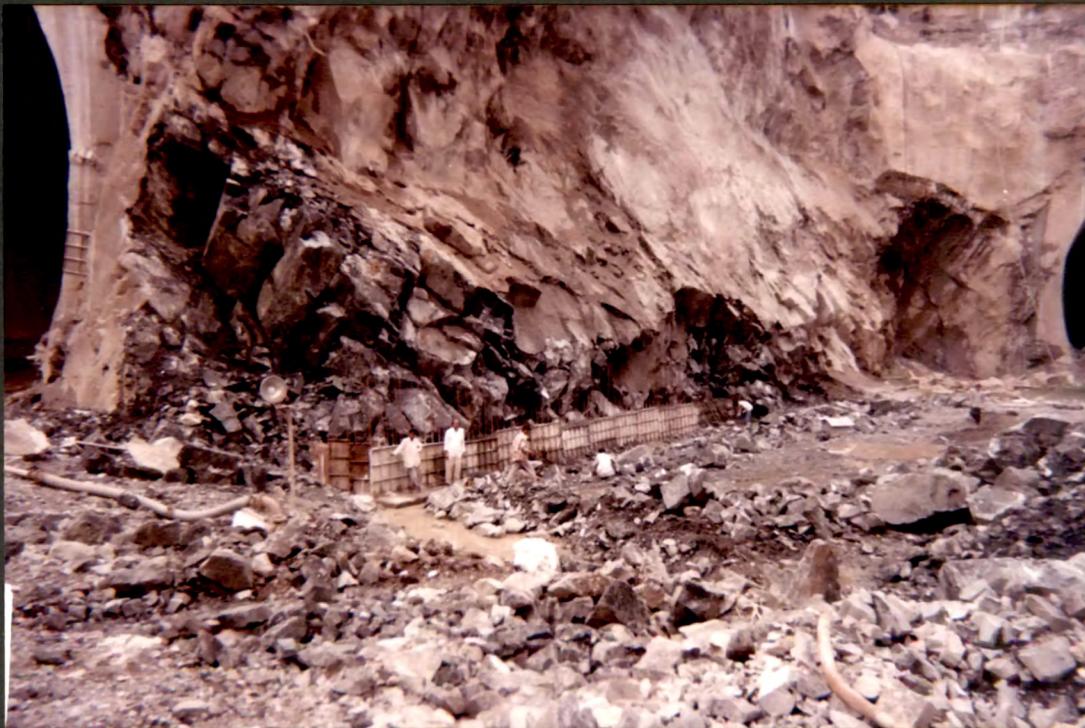
(a) Partly slaked vertical dolerite dyke inside the tunnel

(b) Slaked dolerite sill at the outlet portal site of the tunnel

Plate 22: Slaked nature of vertical dolerite dyke and sill in and around the Exit Tunnel-1, Sardar Sarovar (Narmada) Project (a & b)

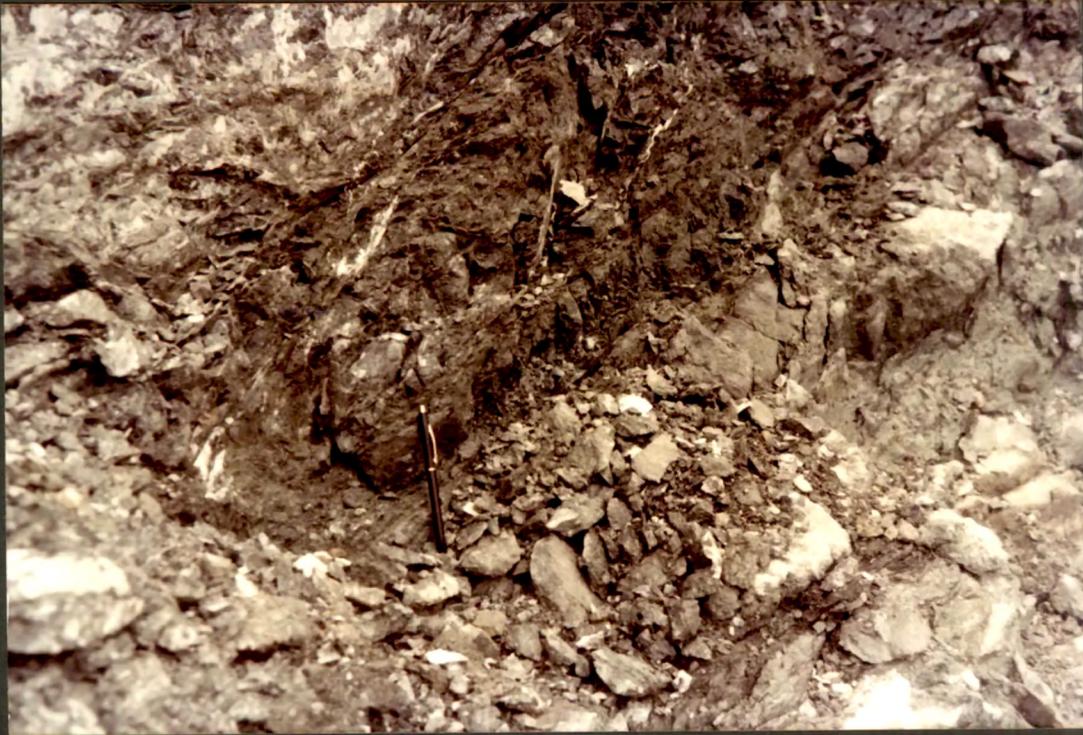
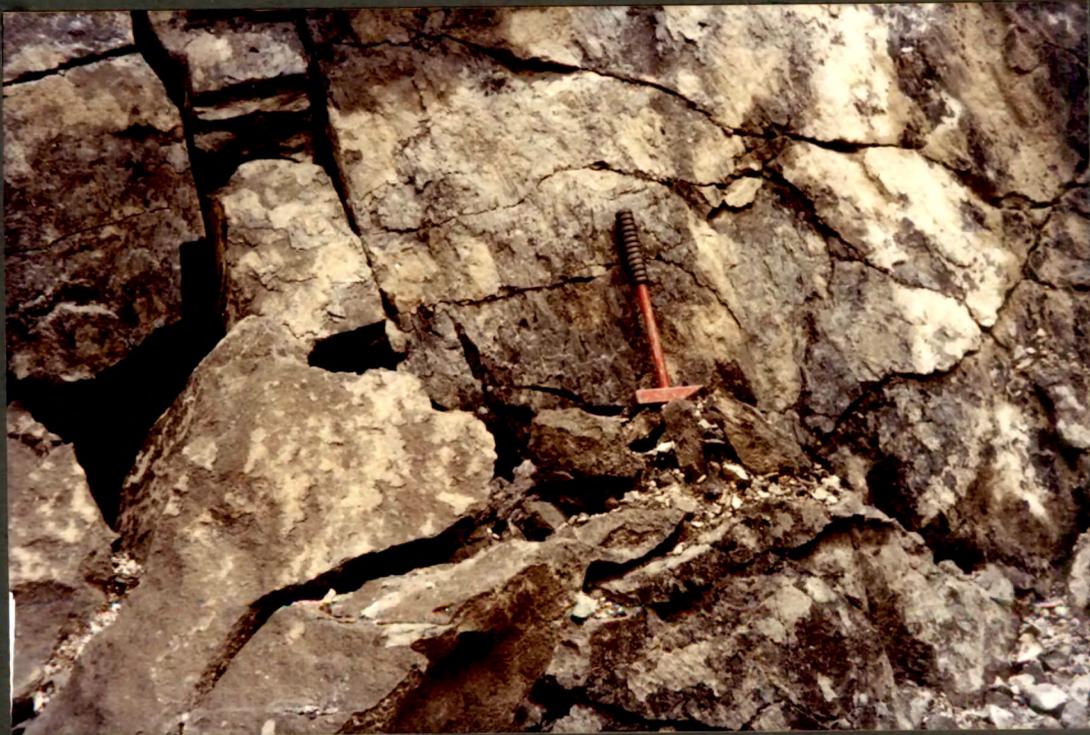
Plate 23: Slaking of dolerite rock at the portal site of Exit Tunnel, Sardar Sarovar (Narmada) Project
