LANDSLIDE INVESTIGATION

ENGINEERING GEOLOGIC MAPPING OF MANGTI LANDSLIDE

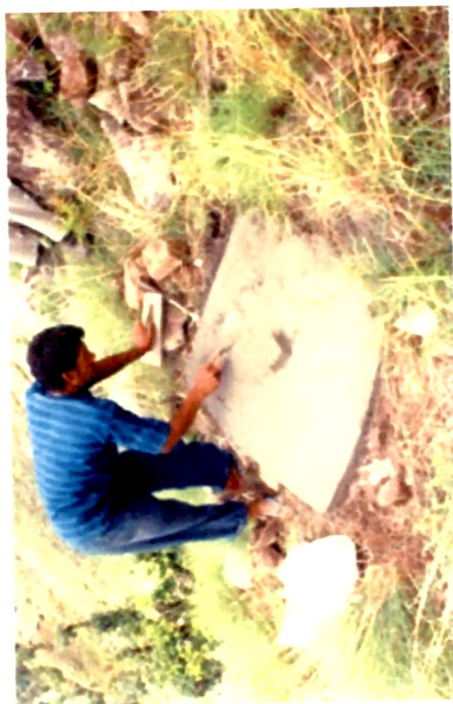
A. Construction of 3'x3' concrete permanent Bench Mark on stable ground

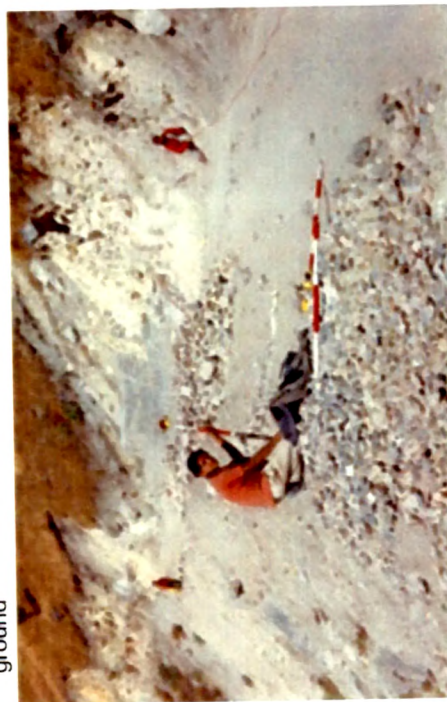
C. Optical Prism being sighted to the Total Station for mapping road and recording other landslide attributes

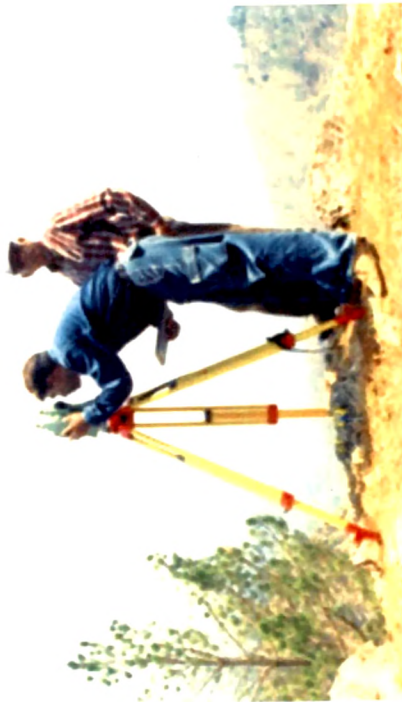
B. Total Station being setup for transferring of levels to the permanent bench marks

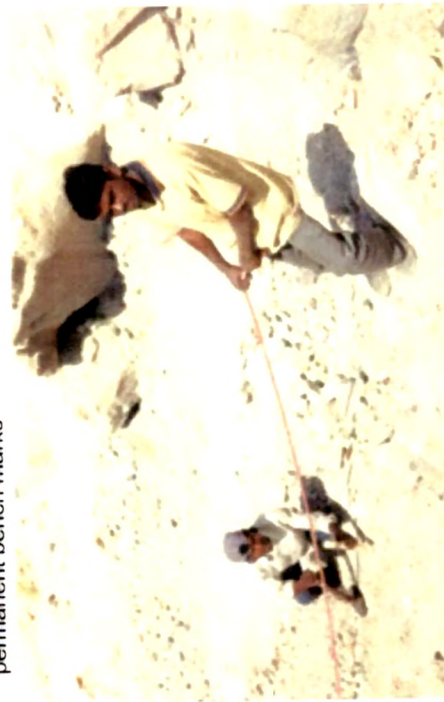
D. Development of 5x5m reference grid of wooden pegs in the active landslide zone

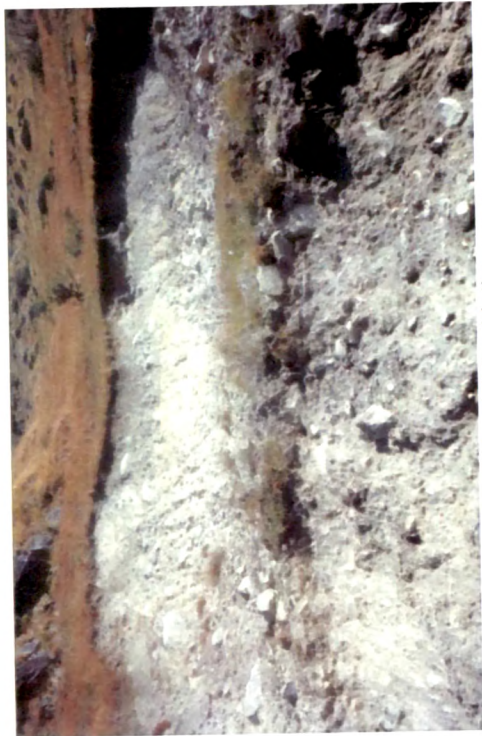
A. View of landslide ablation zone

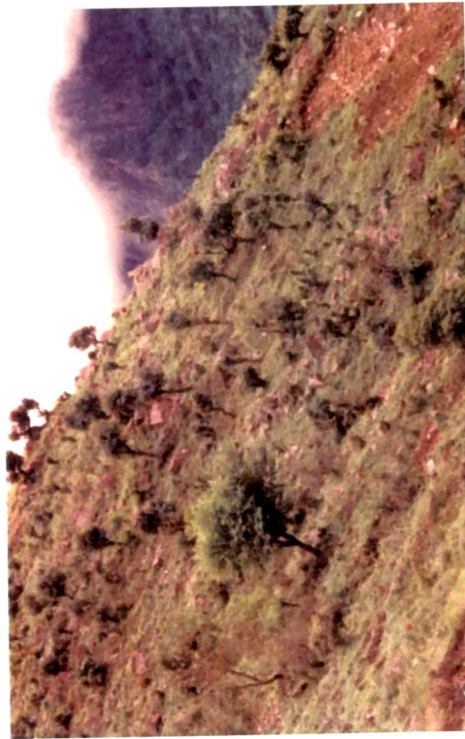
C. Tilting of trees seen on left shoulder of Mangti Landslide indicating slow creep movement

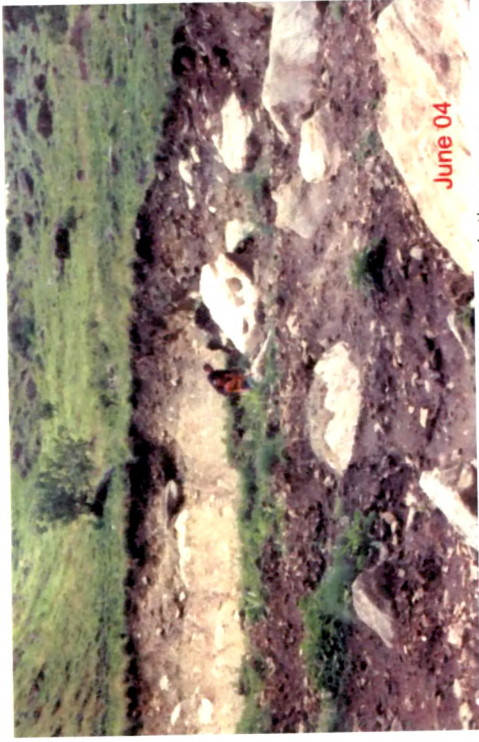
B. View of crown scarp and accumulation zone

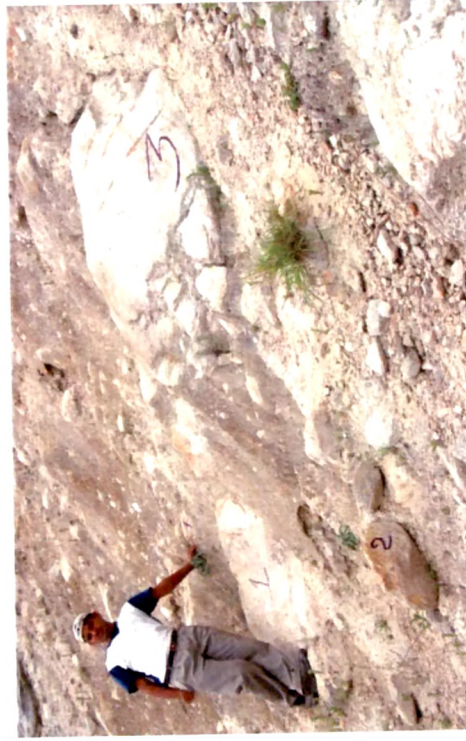
D. Close view of crown scarp sediments showing massive sized boulders embedded with coarse sand matrix
Plate IV.2 – contd....

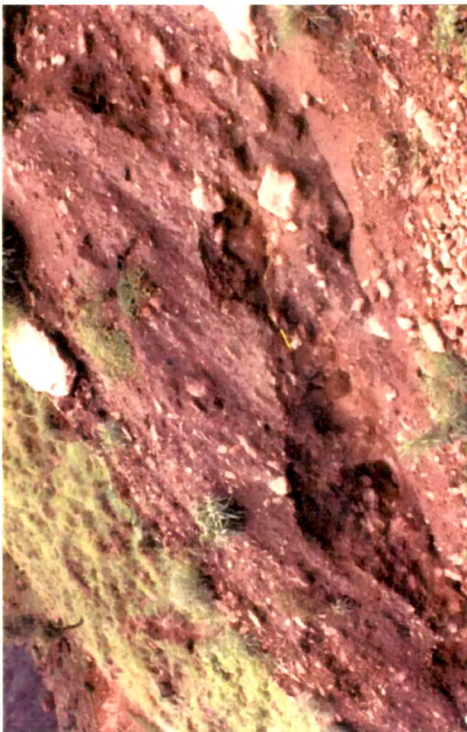
E. Close view of right flank scarp sediments

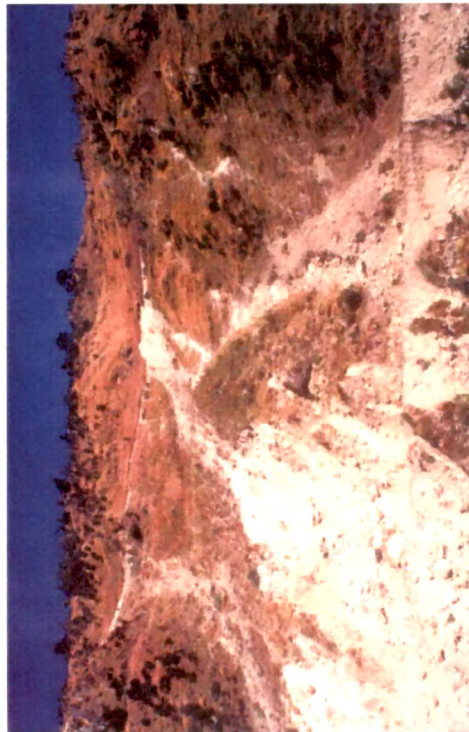
E. View of downside landslide comprising of boulder and gravel size rocks intermixed with coarse sand matrix

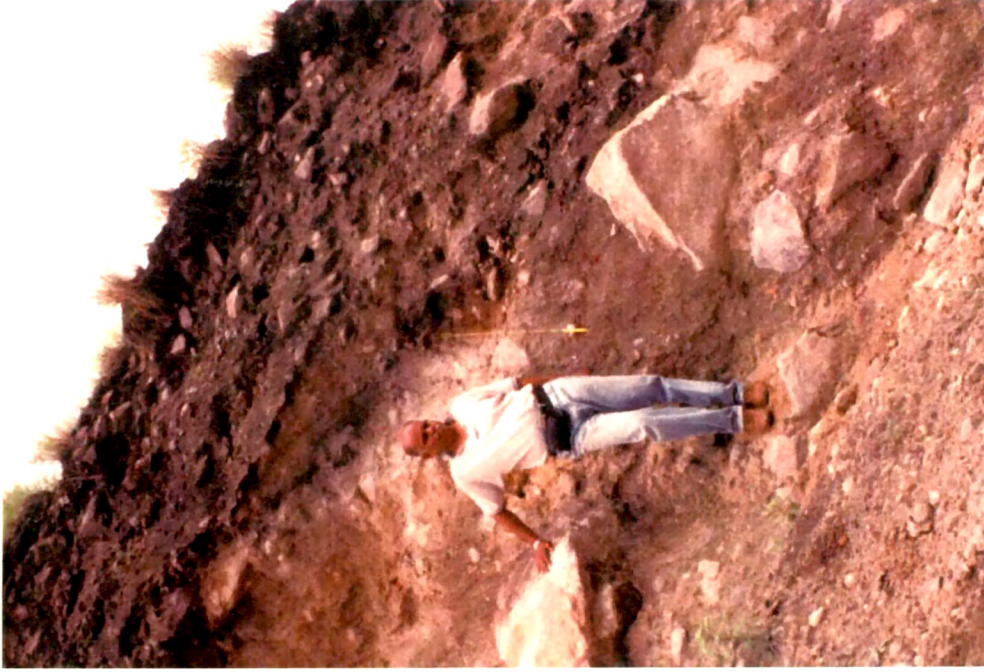
E. View of left side flank scarp showing imbrications in slump mass

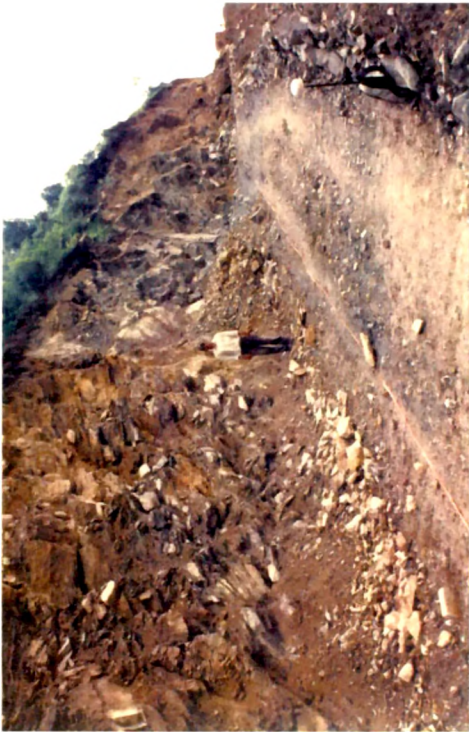
A. Field photograph of Scanline Survey carried out at stretch no. 32 (geo. Lat/lon- 30°01'17.696" N & 80°43'19.093" E)

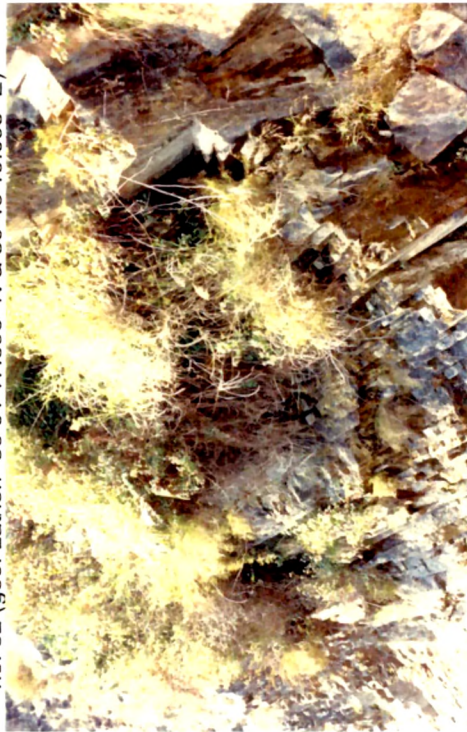
C. Field photograph of Scanline Survey carried out at stretch no. 25 (geo. Lat/lon- 29°59'28.782" N & 80°42'33.681" E)

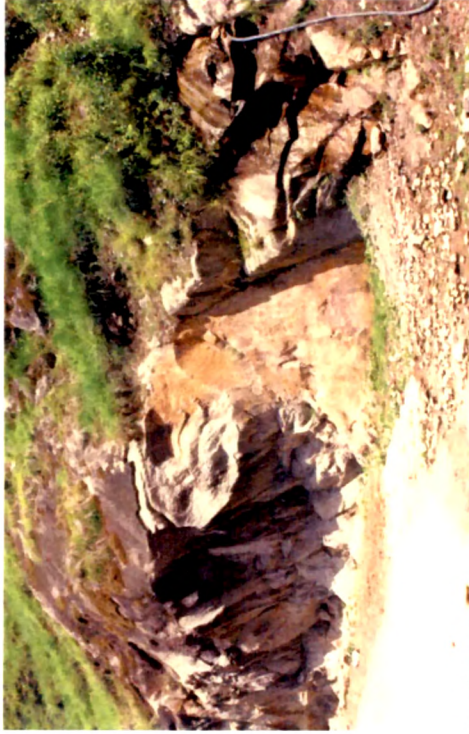
B. Field photograph of Scanline Survey carried out at stretch no. 29 (geo. Lat/lon- 30°00'06.232" N & 80°43'50.984" E)

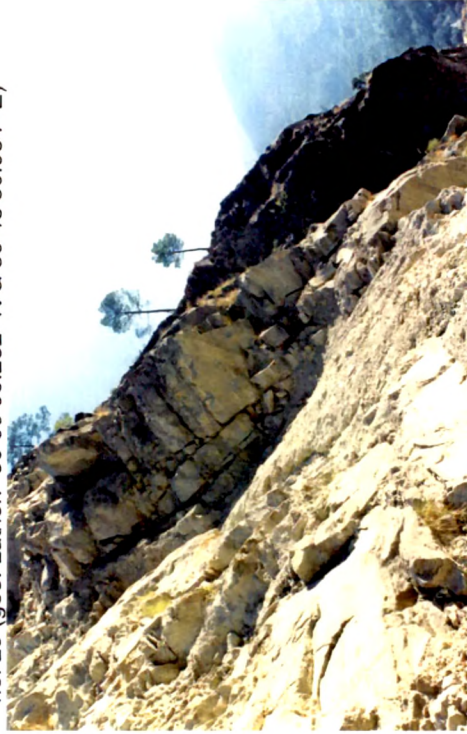
D. Field photograph of Scanline Survey carried out at stretch no. 08 (geo. Lat/lon- 29°57'26.002" N & 80°38'45.878" E)

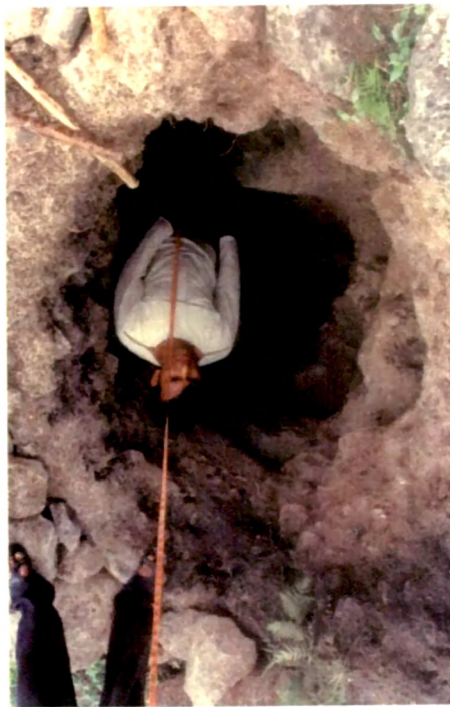
A. Excavation of pit at critical locations in active landslide region

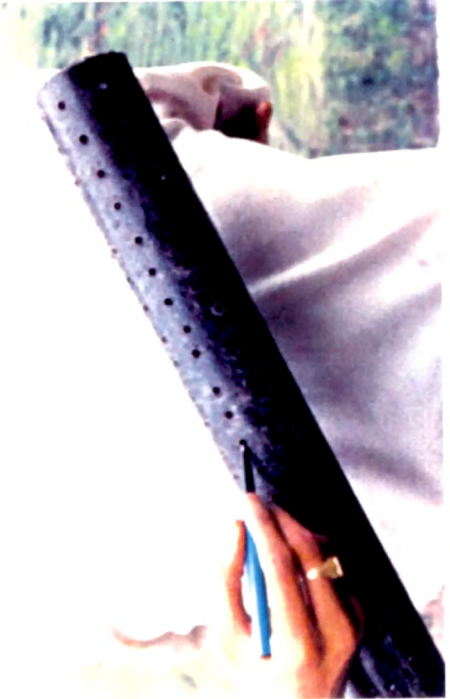
B. Making of 3mm Φ Perforation in PVC Pipe

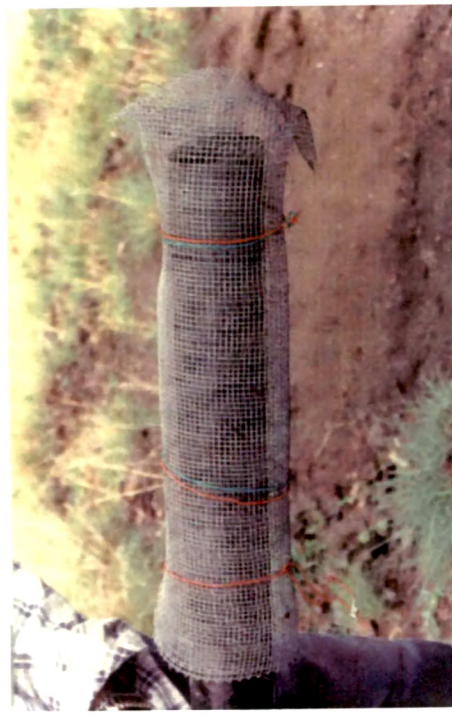
C. Wrapping up the perforated area with wire mesh to avoid entering of sand particles into the Piezometer device.

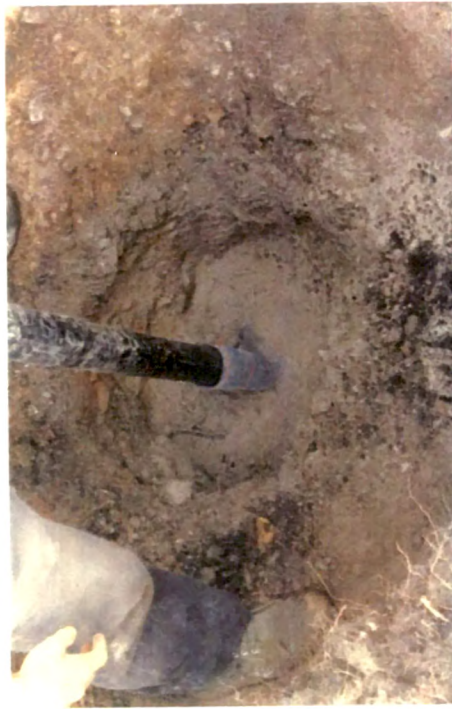
D. Emplacing the perforated pipe wrapped with wire mesh on a base of 30cm sand filter column.

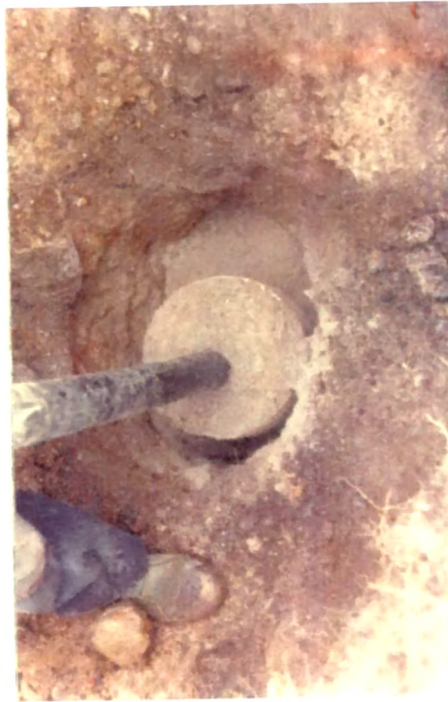
E. Covering with sand from the base of perforation to make a 60cm sand filter column around the perforated pipe section

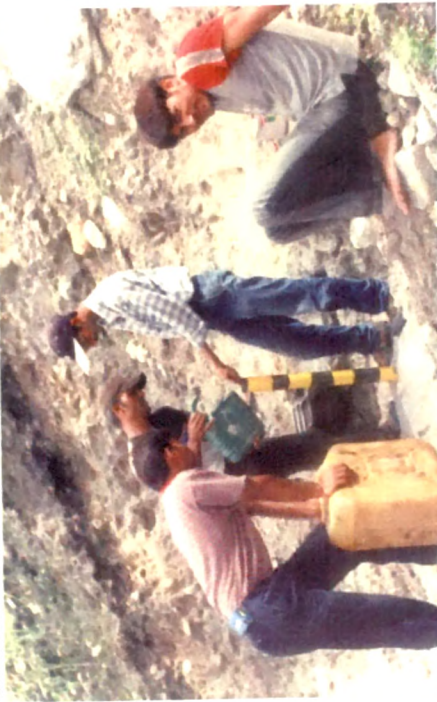
G. Refilling the pit and sealing it with cement then carrying out saturation around the device by filling in water

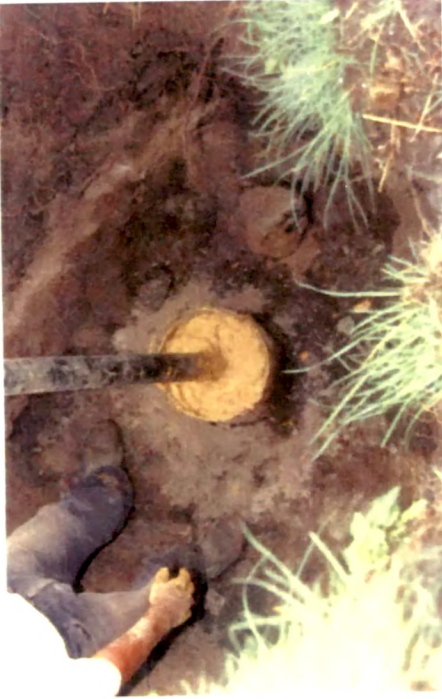
F. Sealing the total 90cm sand filter column with Bentonite Plug to restrict vertical percolation of water into the Piezometer device

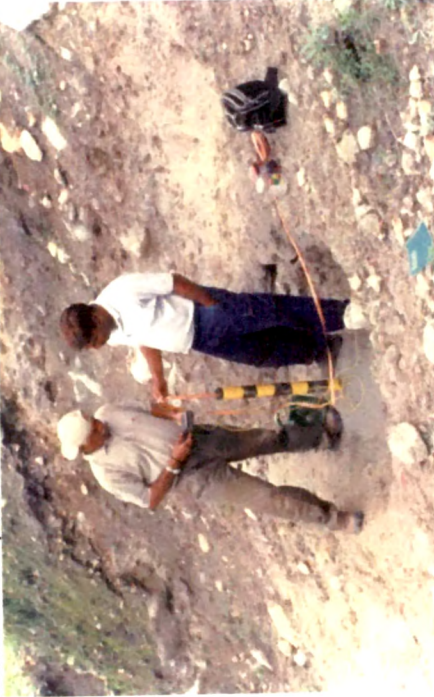
H. Performing Time-Lag observation for evaluation of Piezometer performance and determining the in-situ permeability of the slope mass

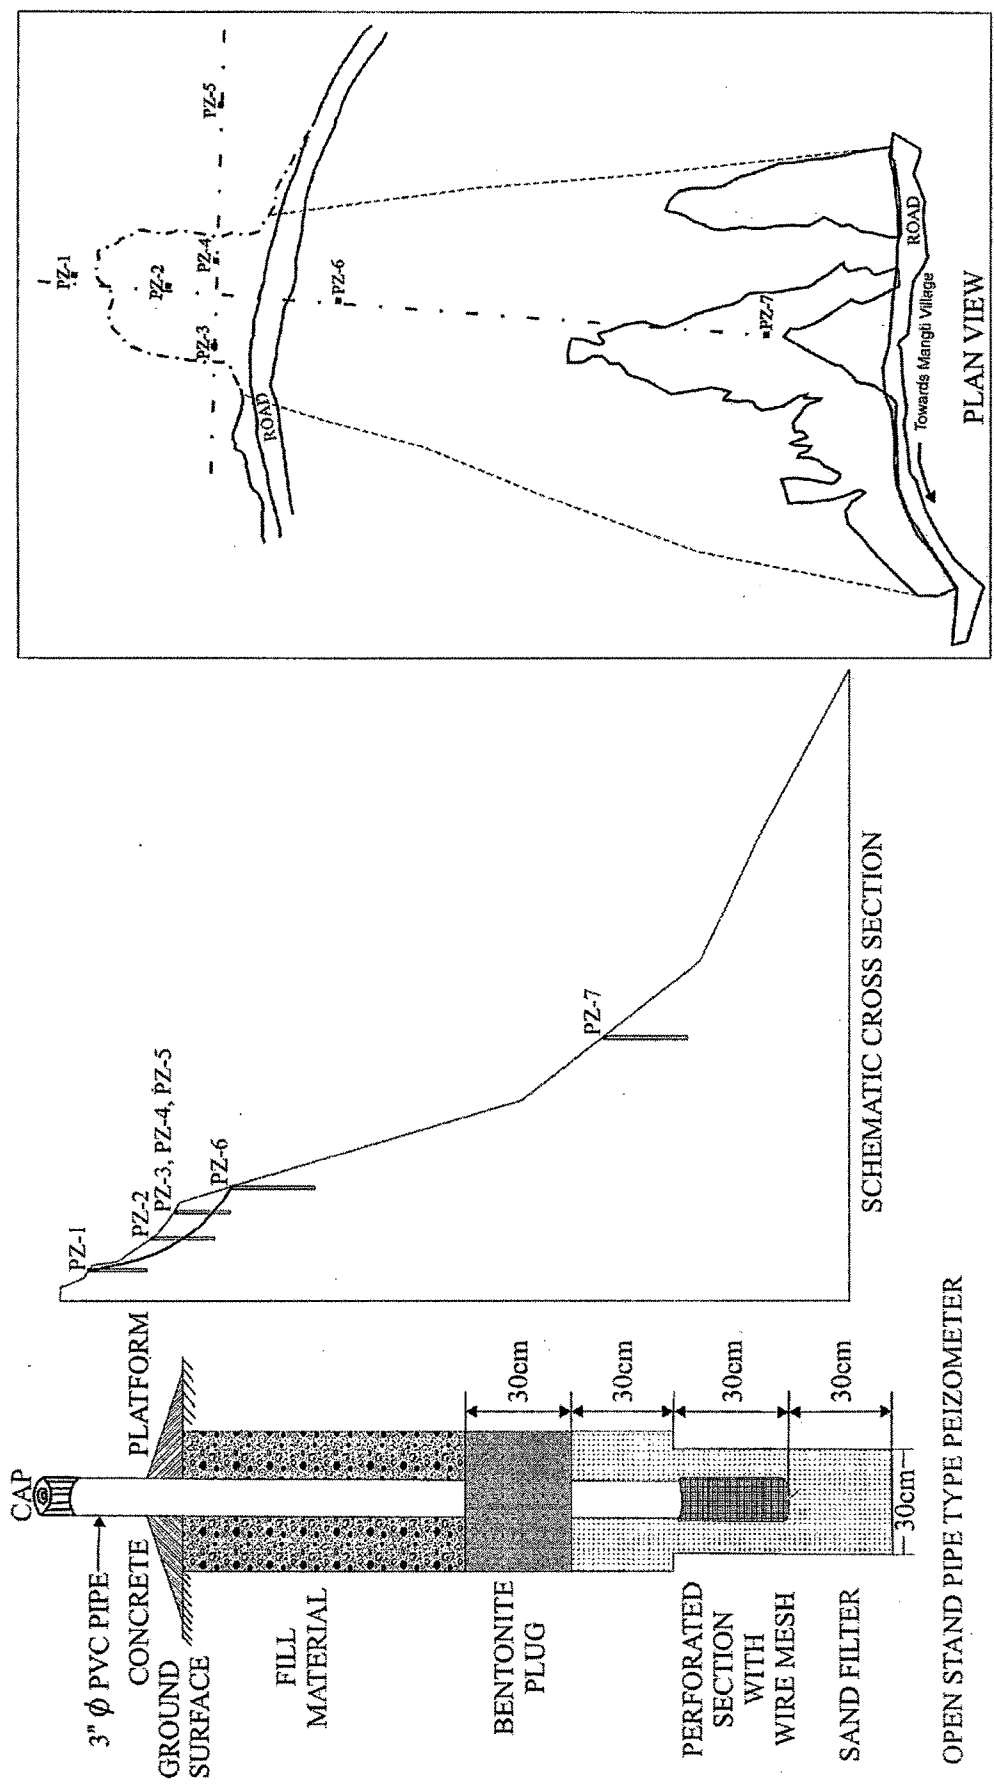
Figure 4.9 - Location Plan of Installed Open Stand Pipe Type Piezometers – Mangti Landslide

The layout plan giving details on Piezometer locations, adopted Piezometers design etc. is furnished in Figure 4.9. The entire activity of Piezometer installation has been carried out with the active support of BRO – GREF staff and by adhering the procedures recommended in Indian Standard Code of Practice [IS: 7356 (Part-I) – 1974].

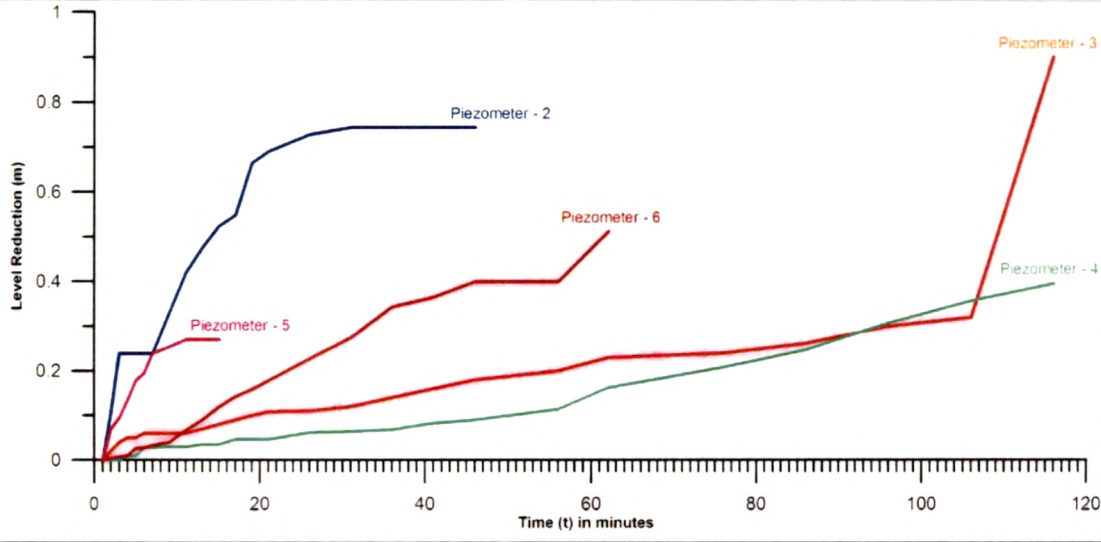
Figure 4.10 - Time-lag Observation Plot of the Piezometers, Mangti Landslide.

The time lag observation results (Figure 4.10) has provided highly satisfactory results showing Piezometers' response within the time range of 25 – 60 minutes for stress adjustment. Based on Hvorslev's (1951) plots, sub-surface in-situ permeability fall in the range of 10^{-2} to 10^{-4} cm/sec. This obtained permeability range is in conformation with the granulometric characteristics of the sediment samples falling in GP – SP – SM groups and indicative of sandy nature (Figure 4.11).

It is probable that the time-lag during normal operating conditions corresponds to an equalization diagram, which for practical purposes may be represented by a straight line through the origin and then running parallel to the X-axis of the diagram obtained in time-lag tests as shown in Figure 4.10.

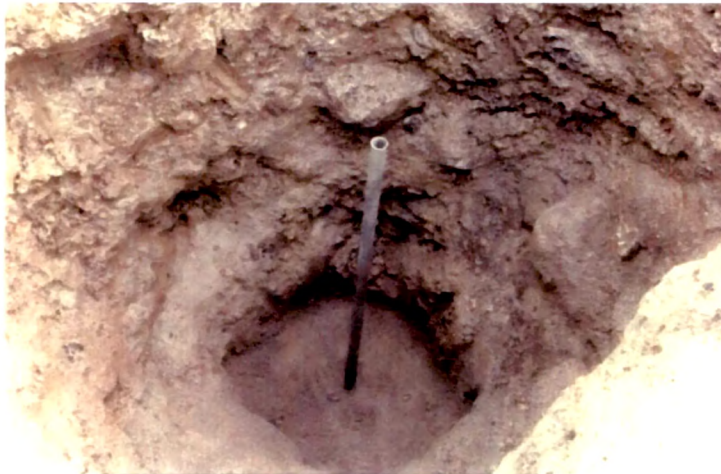
A. Fixing of movement monitoring rod with concrete mix

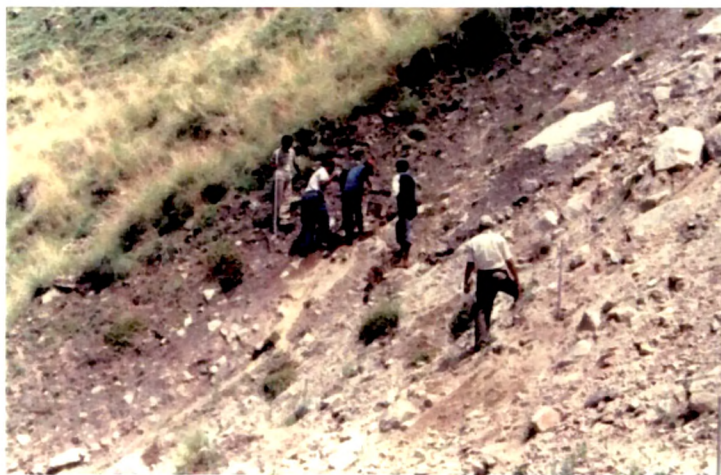
B. View of horizontal row of installed movement monitoring rod in active landslide region

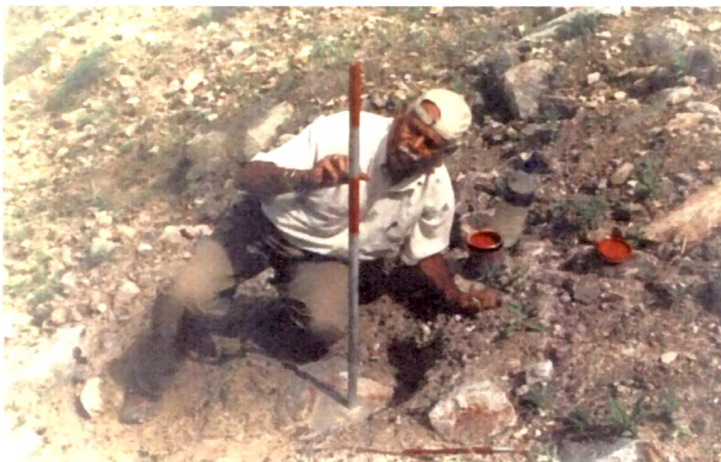
C. View of giving finishing touches to installed movement monitoring rods for distant visibility

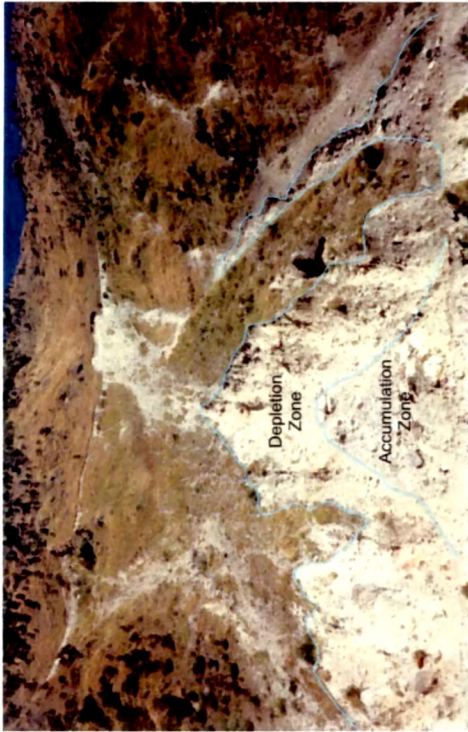
A. Frontal view of lower portion of Mangti landslide (Jan. 2003). Blue line demarcates the boundary of slid mass.

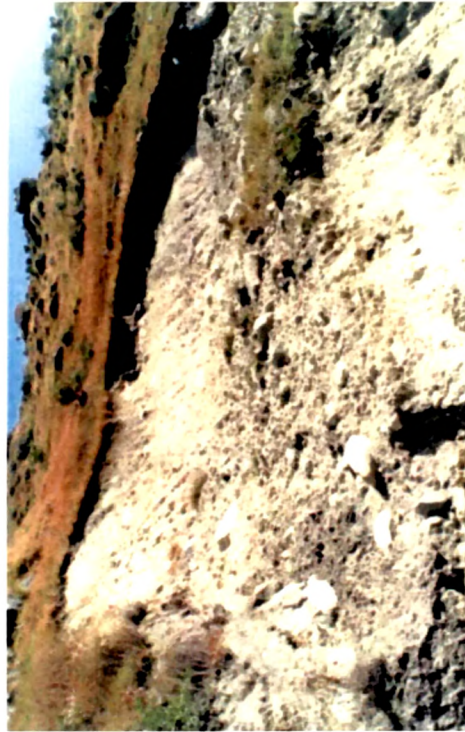
C. View of left side of the crown and left flank on the upper 3rd stage of slope failure in Mangti Landslide (Nov. 2003)

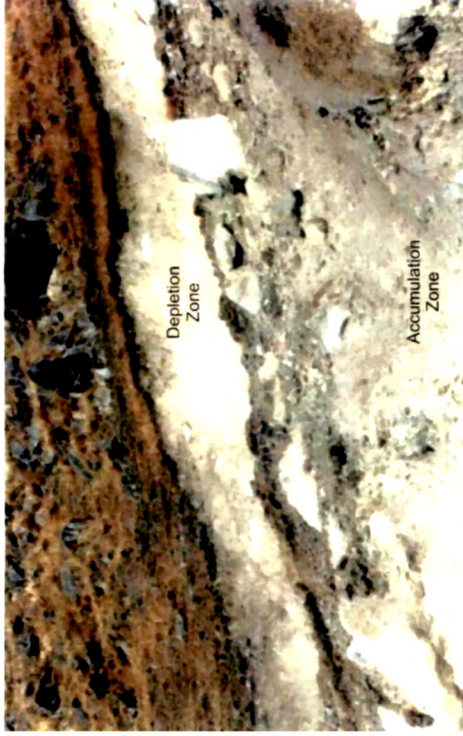
B. View of right side of the crown and right flank on the upper 3rd stage of slope failure in Mangti Landslide (Jan. 2003)

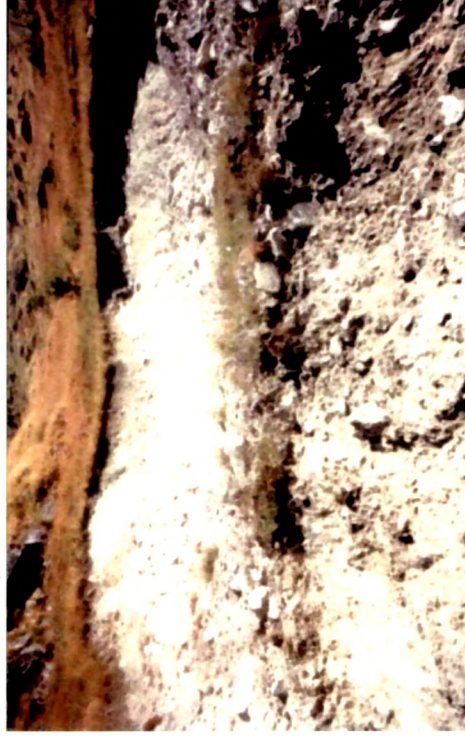
D. View of the crown portion of upper 3rd stage of slope failure in Mangti Landslide (Nov. 2003)

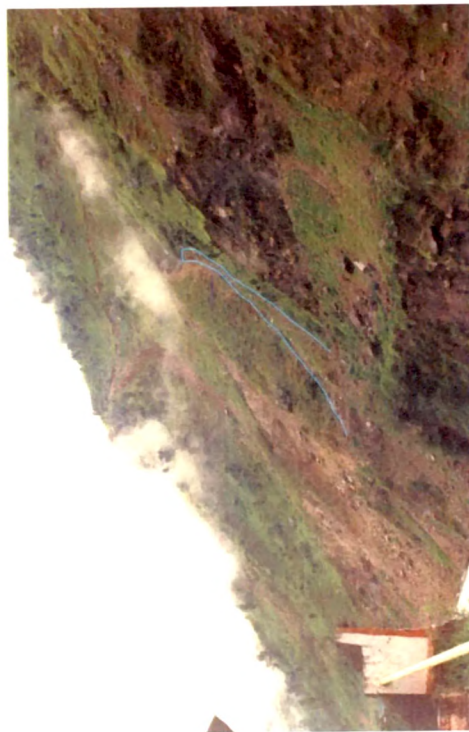
E. Side view of Mangti Landslide from GREF Camp. Blue line shows the periphery of slid mass near the shoulder portion (June 2004)

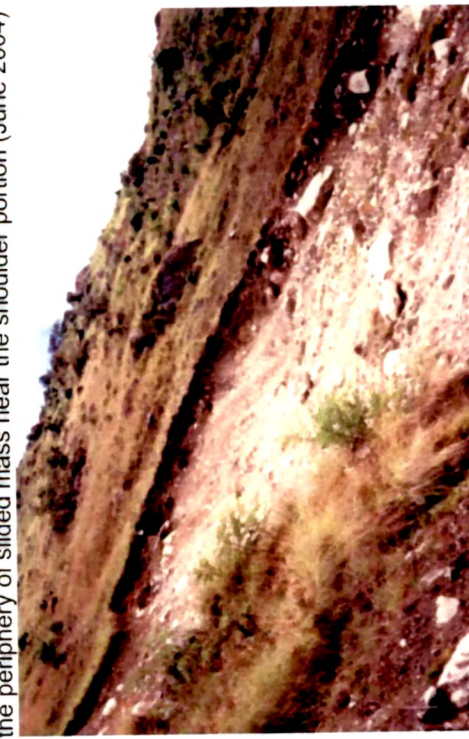
G. View of left side of the crown and left flank on the upper 3rd stage of slope failure in Mangti Landslide (Sep. 2004). Remarkable change in the slope angle of main scarp is observed.

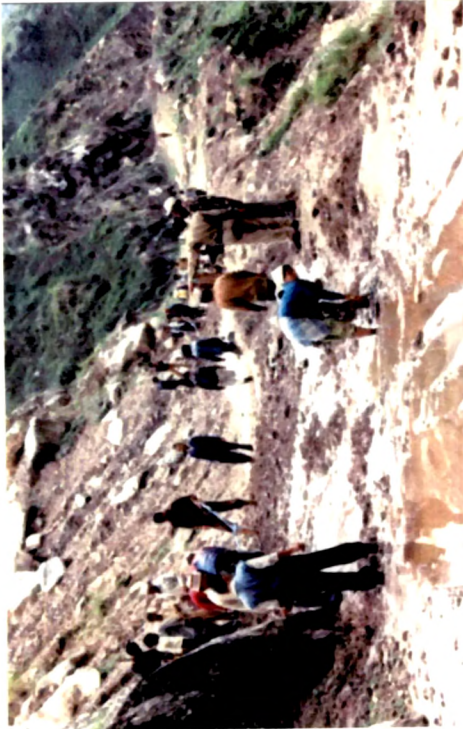
F. View of labourers clearing the slide debris from the road (July 2004)

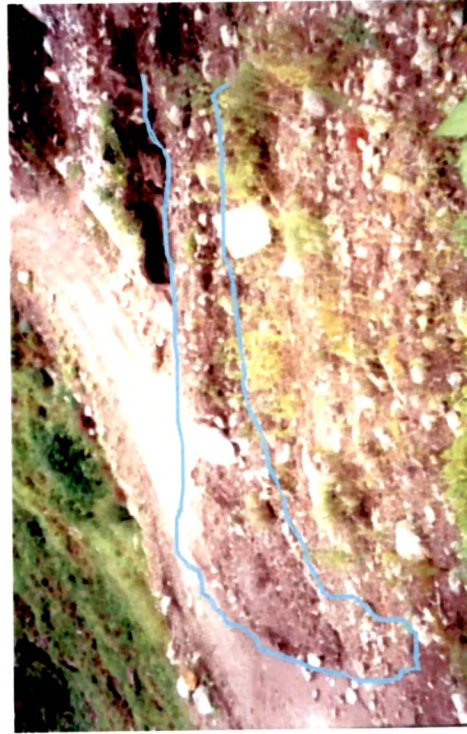
H. View of the Debris flow witnessed in Mangti landslide after complete saturation of the slope mass (Sep. 2004)

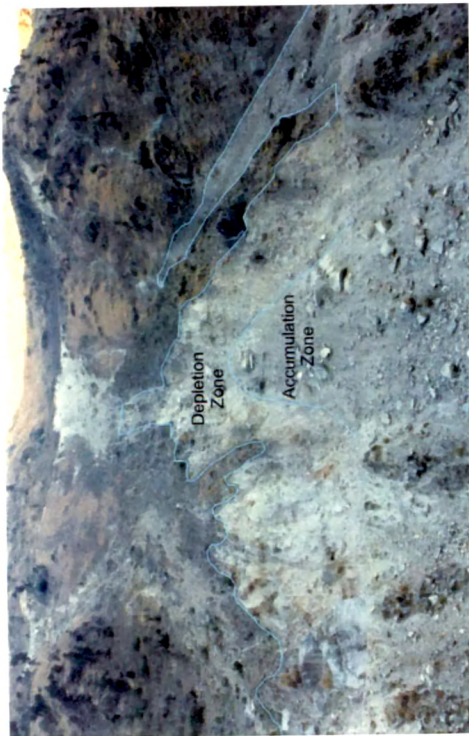
I. Frontal view of lower portion of Mangti landslide (June. 2005). Blue line demarcates the boundary of slid mass.

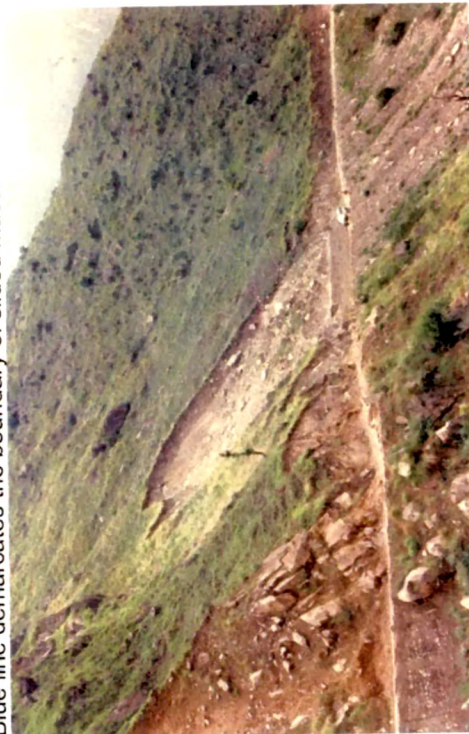
K. Distant view of upper level of Mangti Landslide. Lateral advancement of the slide zone can be observed (June 2005)

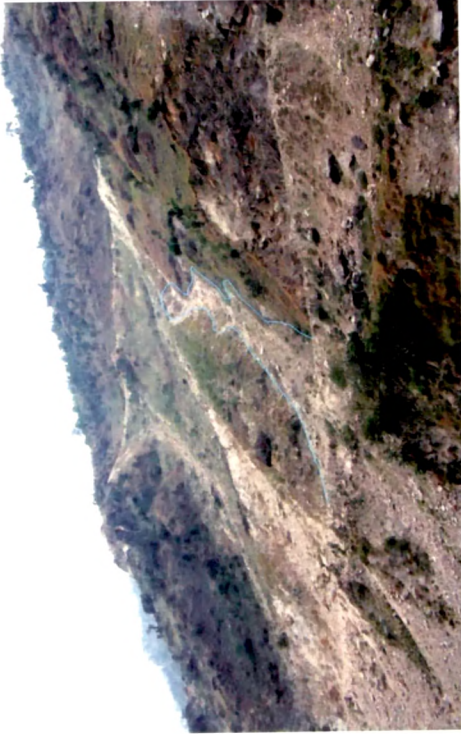
J. Side view of Mangti Landslide from GREF Camp. Blue line shows the periphery of slid mass near the shoulder portion (June 2005)

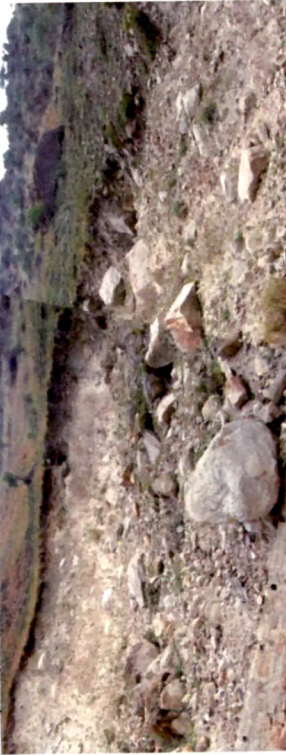
L. Heaving of slope mass in accumulation zone along the left shoulder portion of the upper level of Mangti Landslide is observed (Sep. 2005)
