LANDSLIDE HAZARD ZONATION AND REMEDIATIONS

LANDSLIDE HAZARD ZONATION OF TAWAGHAT – JIPTI ROUTE CORRIDOR

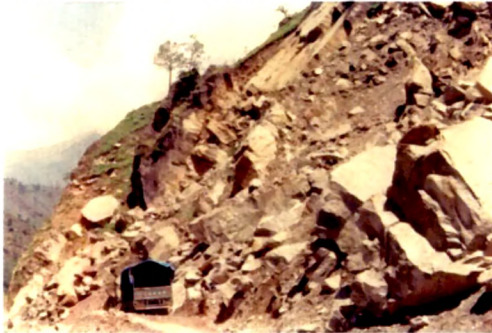
4c. View of the same left flank in June 2004. Surficial material have washed off and huge size rock blocks are seen in critical stage of sliding

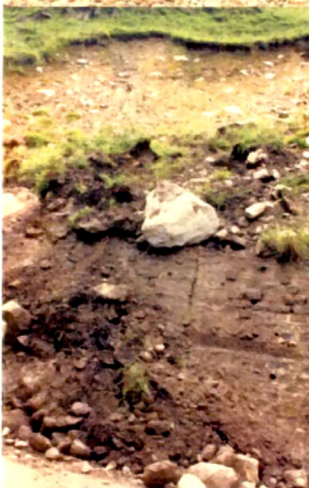
18. View of debris mass at Mangti Landslide flowing down the slope over the retaining wall on saturation -dt-22/7/05

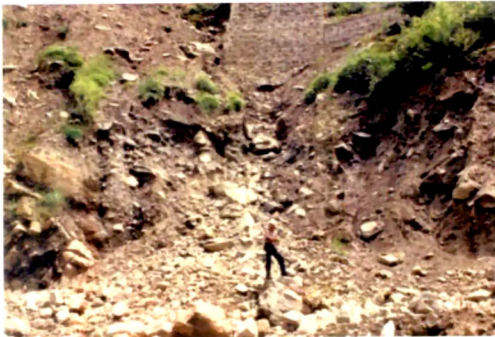
20b. View of toe erosion at the foundation of retaining wall caused by sliding of debris mass

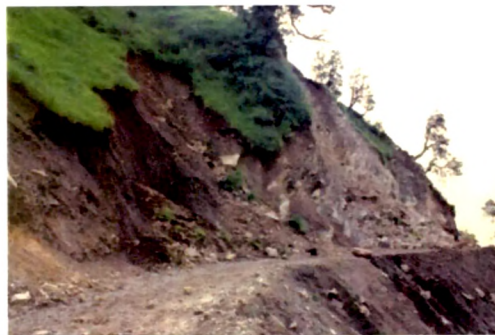
21b. View of laterally expanding shallow soil slips and the expanding wedge slide due to lateral support removal by road construction;dt-18/8/04

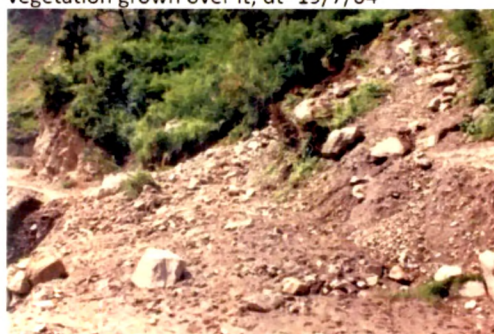
26c. The slope mass is seen to be completely saturated and the soil is flowing down the slope like a viscous fluid. Although the traveling rate is too low, about 5cm/min; dt-29/7/04

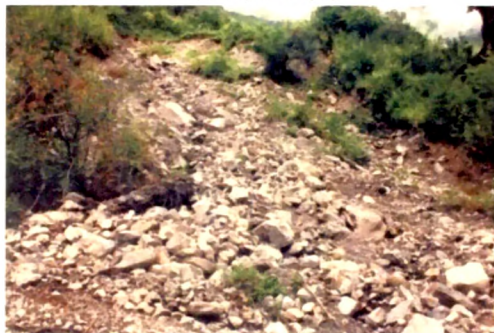
26e. This slide which started as a small shallow slip has now developed into a massive deep seated circular slip debris slide; dt- 16/7/05

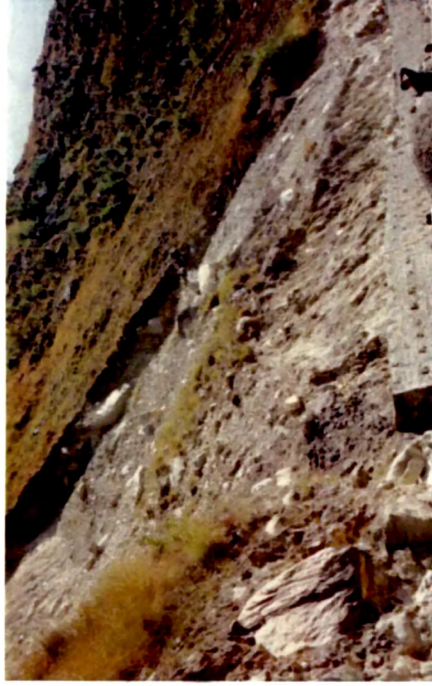
B. View of Under-construction Retaining Wall as Remediation at Upper Level Mangti Landslide

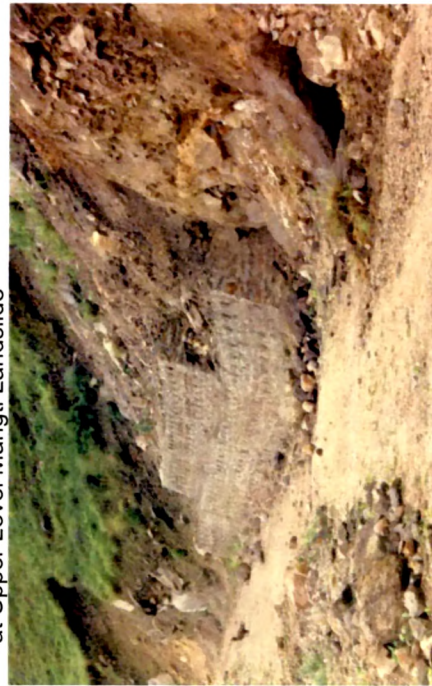
D. View of 4m high constructed Masonry Retaining wall at Upper Level Mangti Landslide

The Mangti Landslide is situated on a presently developing road to Jipti. Its field monitoring has clearly established about its pronounced response to the rainfall threshold value and causing frequent hurdles during onward road construction activities by the BRDO-GREF. The hazards posed by this landslide has necessitated to adopt and implement some measures to prevent its movement particularly its top (3rd Phase) and Toe (1st Phase) parts. Therefore, as an emergency measures construction of masonry retaining wall had been recommended. This recommended construction of retaining wall with in-built provisions of drain holes (Plate VIII.2 A-D) has improved the situation to a great extent. Hence, based on observed effectiveness of masonry retaining wall additional structural retention systems have been recommended based, which are based stability analysis and landslide modelling.
