## **CHAPTER : IX**

### **BARODA'S ROADS**

#### **INTRODUCTION :**

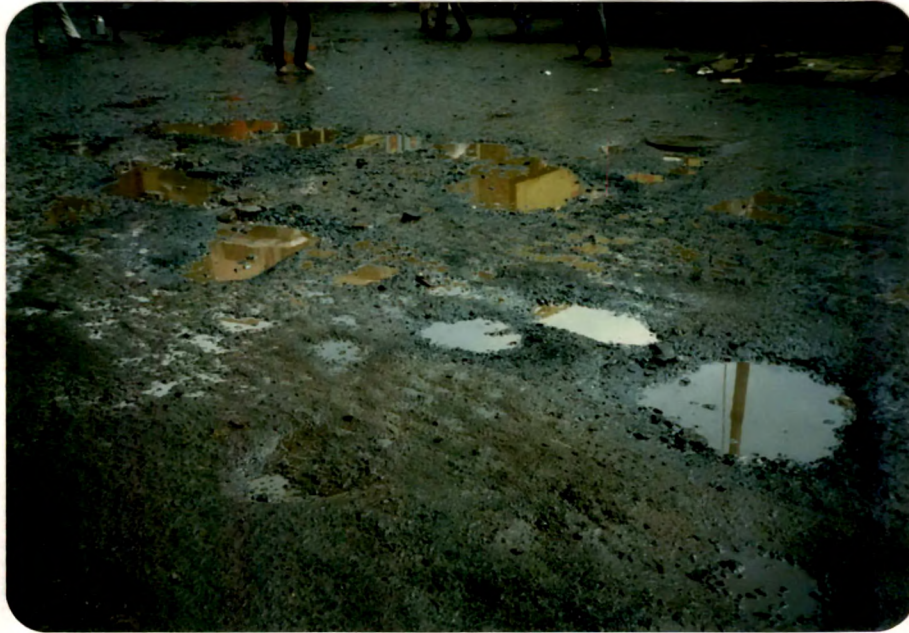
PLATE 30 :

POT-HOLES DEVELOPED ON TAR ROADS DURING THE  
MONSOON.
