Chapter 7

Classification of fault by Sweep Frequency Response Analysis

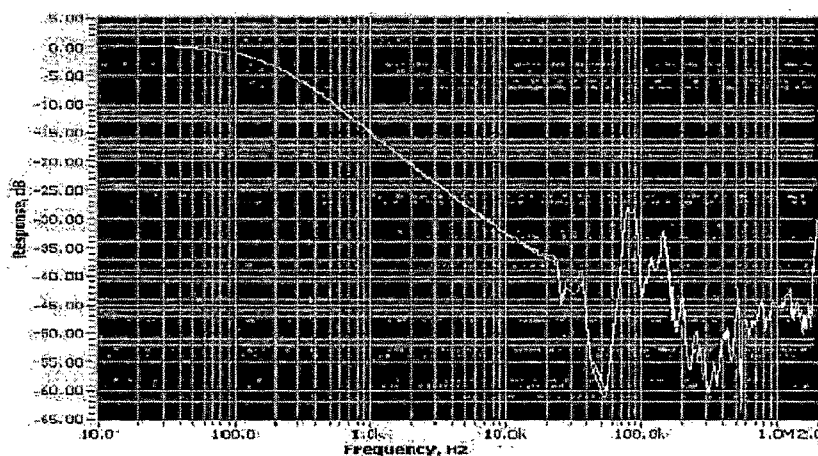
Figure 7.4: Short circuit plot for core fault (3-phase)

After detail investigation, it was found that connecting point of Core ground for earth connection was loose and visible from outside of the Tank. Transformer was commissioned

after making the earth point intact by repair and transformer is saved from unnecessary overheating of the core due to high eddy current circulation after energizing, if this problem was not rectified.

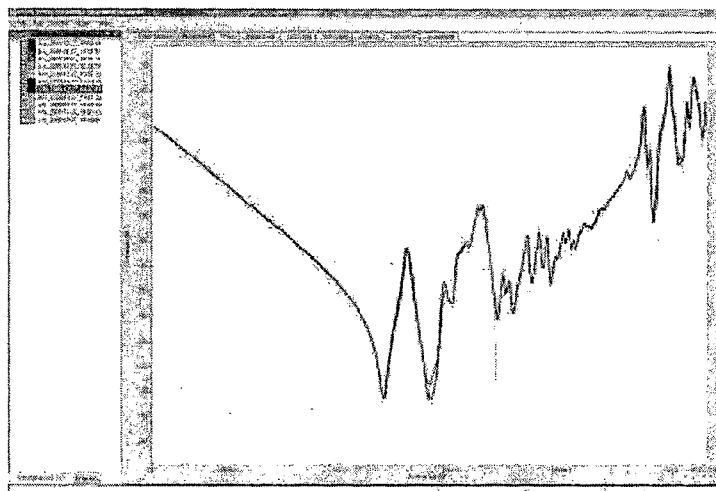
Figure 7.7: Short circuit plot for HV winding (3-phase)

The SFRA test data (After installation at site) of new 100 MVA Auto Transformer, 220/132 kV is shown in Figure 7.5, Figure 7.6 and Figure 7.7. There was no base SFRA data available from factory test hence three phase comparison is performed in this case. It is evident that low frequency response of outer phases was not normal in frequency range of 10 Hz. to 1 kHz for open circuit SFRA plot shown in Figure 7.5 and Figure 7.6.

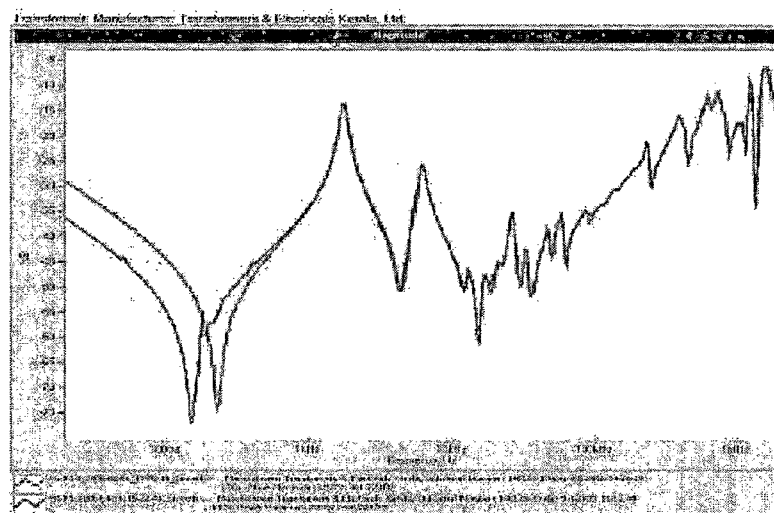
Figure 7.24: Open circuit SFRA plot of H1-X1 winding at Tap positions 1 for ICT 1 (Brown color) and ICT 2 (Blue color)

1. For winding H1-X1-Tap1 (Figure 7.24), H3-X3-Tap1 (Figure 7.26), H1-X1-Tap 17 (Figure 7.27), H2-X2-Tap 17 (Figure 7.28), H3-X3-Tap 17 (Figure 7.29), both the per phase sister unit plots are identical, which indicates that there is no significant winding movement in these parts of the transformer.

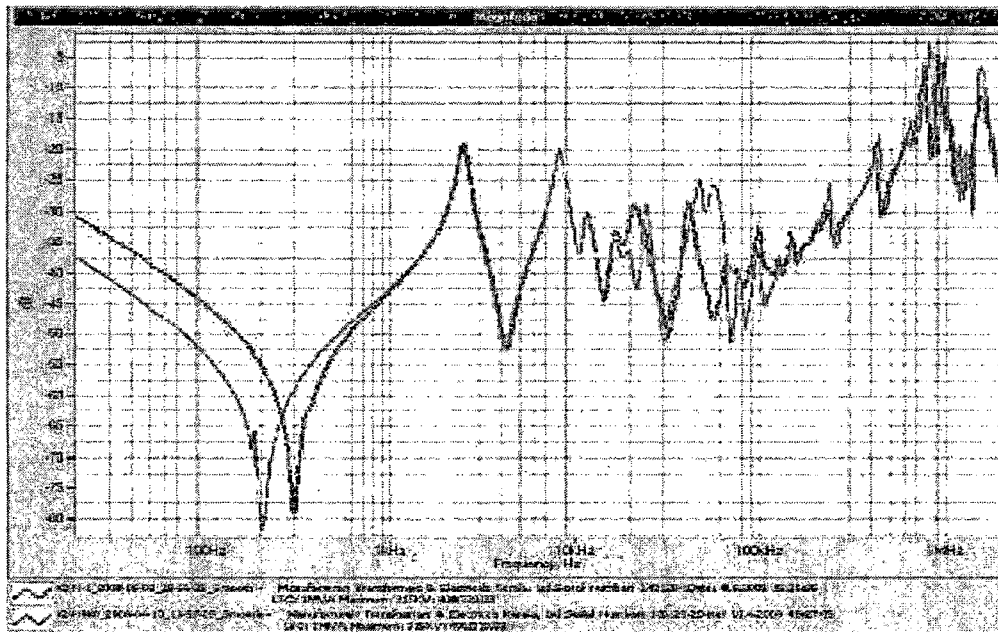
Figure 7.31: Open circuit SFRA plot of X2-N winding at Tap positions 1 for ICT 1 (Brown color) and ICT 2 (Blue color)

3. *Y-Phase deviation is not present in the H2-X2-Tap 17 (Figure 7.28), so it is clear that major deformation is in Y-Phase Tapping winding.*
4. For winding X2-N-Tap1 (Figure 7.31), X3-N-Tap1 (Figure 7.32), X1-N-Tap 17 (Figure 7.33), X2-N-Tap 17 (Figure 7.34), the sister unit plots are not identical

and showing major shift and anti-resonance in the response in the frequency region 20 kHz to 200 kHz, which indicates that there is significant winding movement in all phases of LV winding of the transformer.

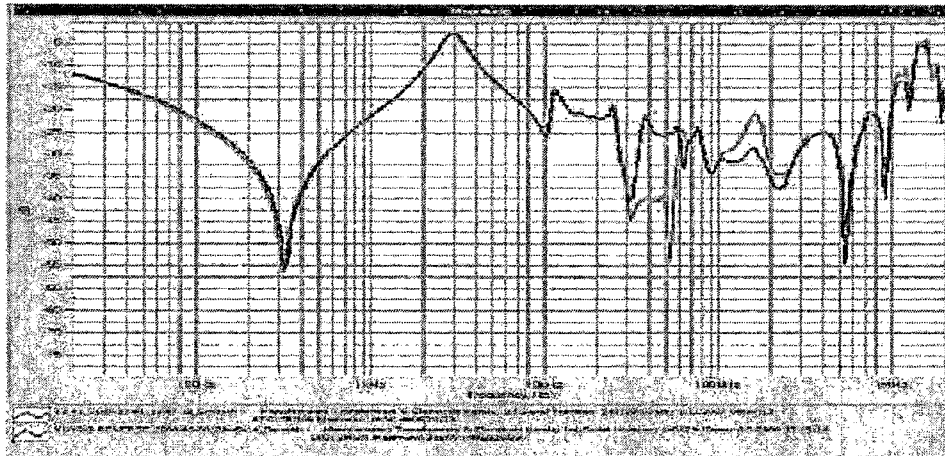
Figure 7.42: Open circuit SFRA plot of Y1-Y2 winding at Tap positions 9B for ICT 1 Before fault (Brown color) and After fault (Blue color)

3. For winding Y1-Y2-Tap 9b (Figure 7.42), Y2-Y3-Tap 9b (Figure 7.43), Y1-Y3-Tap 9b (Figure 7.44), the plots are not identical and showing major shift and anti-resonance in the response in the frequency region 20 kHz. to 200 kHz., which indicates that there is significant winding movement in all phases of Tertiary winding of the transformer.

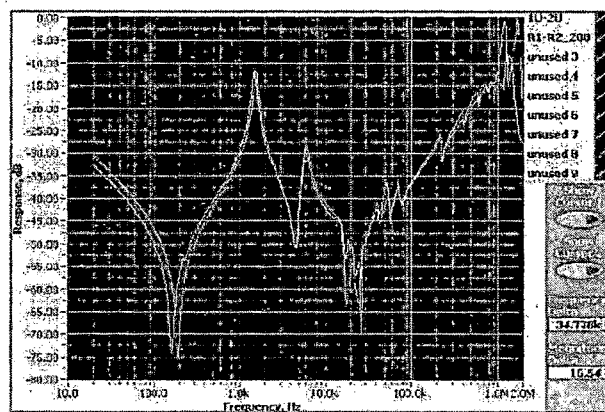
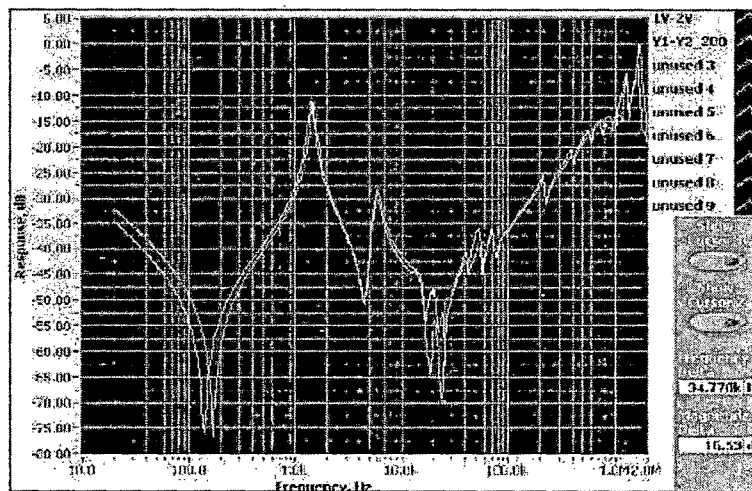
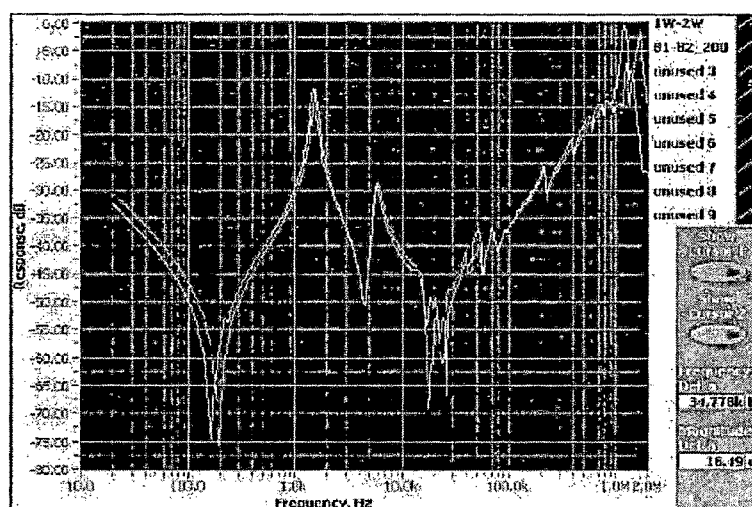
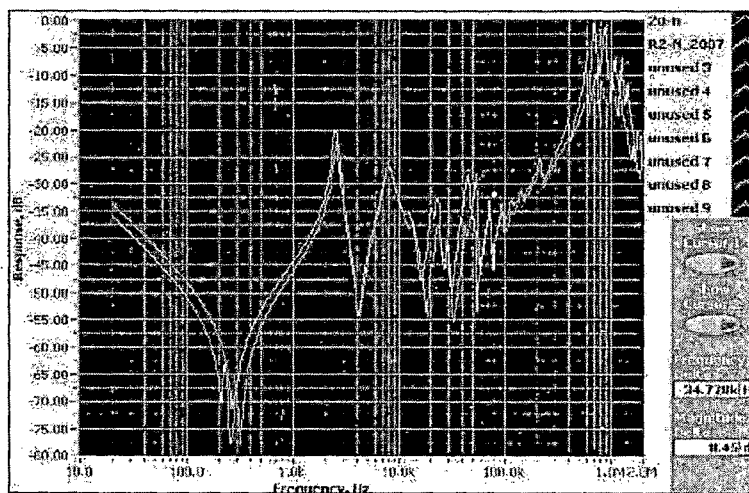
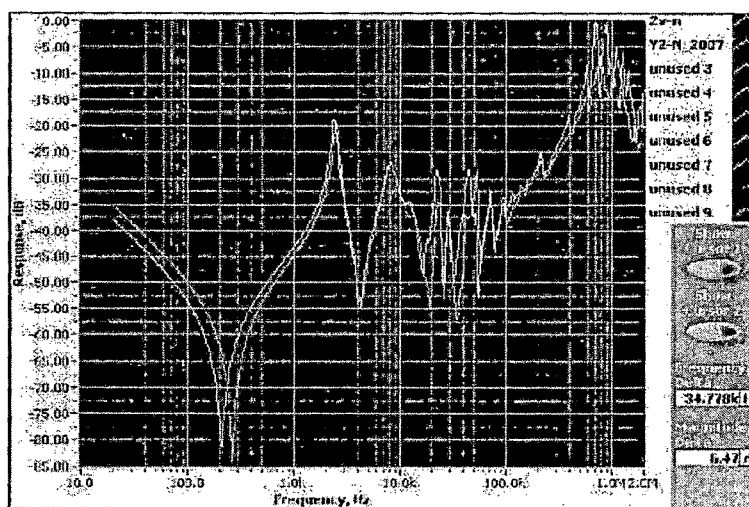
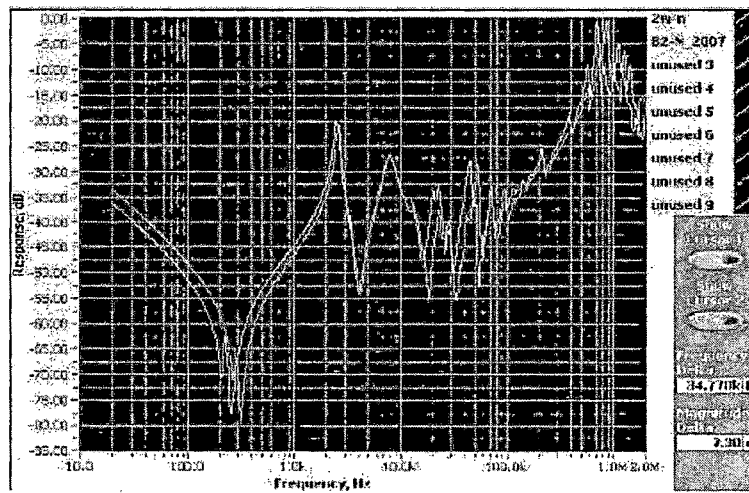
indicated in Figure 7.58 to 7.63. The shift in the resonance is due to the change in the capacitance between the core and tank due to the core earth fault.

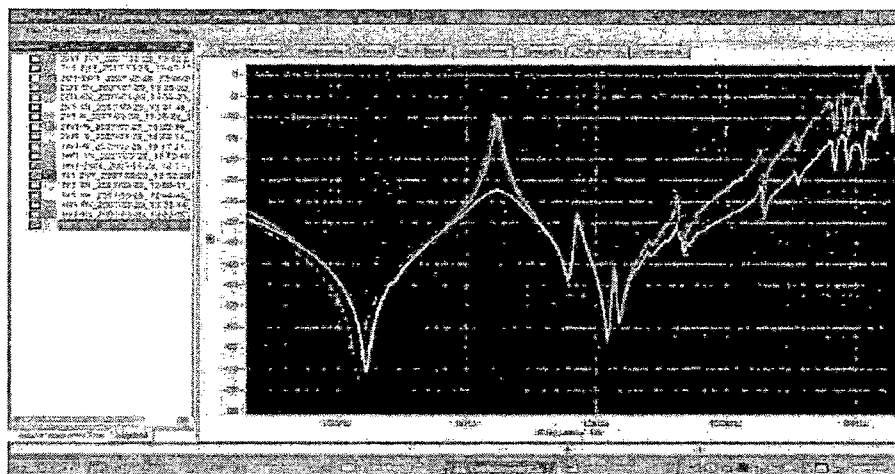
Figure 7.64: Comparison of three phase open circuit plot of common winding (U phase-white color)

After a system fault, SFRA plot of three phase Auto Transformer with Tertiary winding of rating 315 MVA and rated voltage of 400/220/33 KV was analyzed as mentioned below. It was an overall deformation of U-phase common winding (1U-2U) of auto transformer which was evident from the SFRA plot shown in Figure 7.64. Also the same pattern of deviation is observed in SFRA short circuit plot indicating an high impedance fault with overall deformation of U-phase as mentioned in Figure 7.65 and 7.66.
