4. Engineering geological study of dam sites, Identification of Geotechnical problems and treatment

4.1 Engineering geological investigations at Narmada dam site

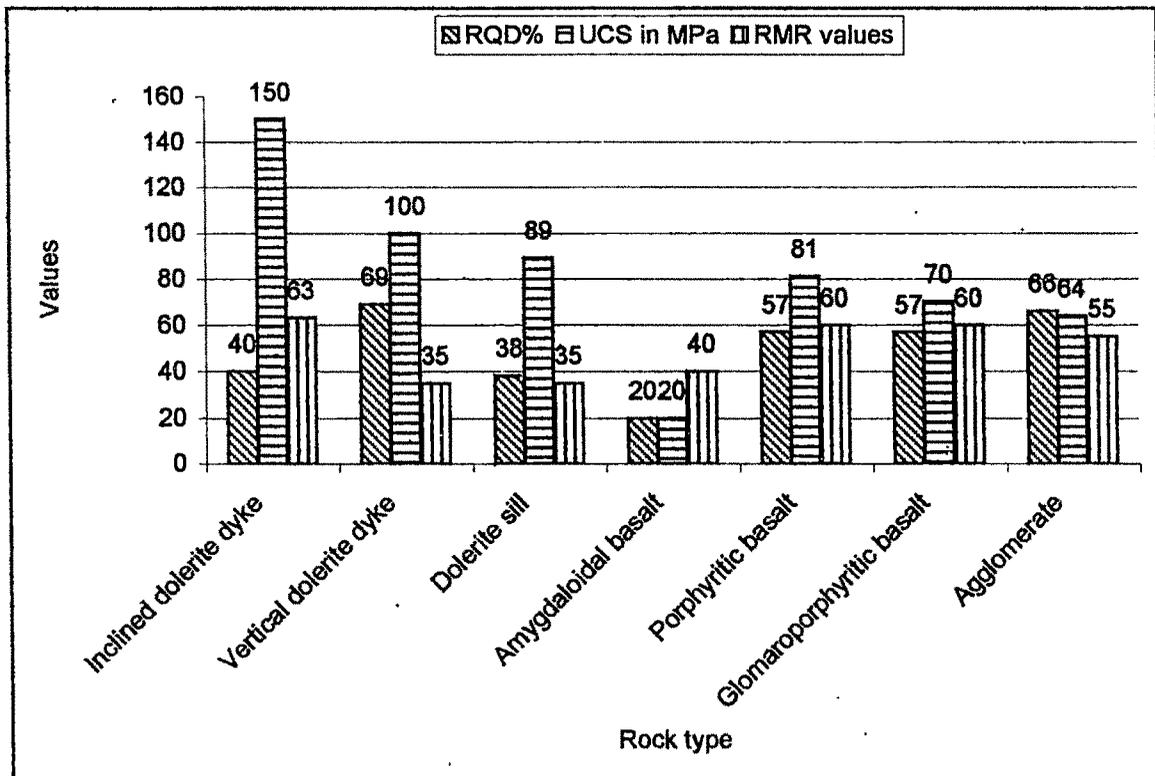
Fig. 16: Rock Quality Designation (RQD), Unconfined Compressive Strength and Rock Mass Rating of underground powerhouse, Sardar Sarovar (Narmada) Project

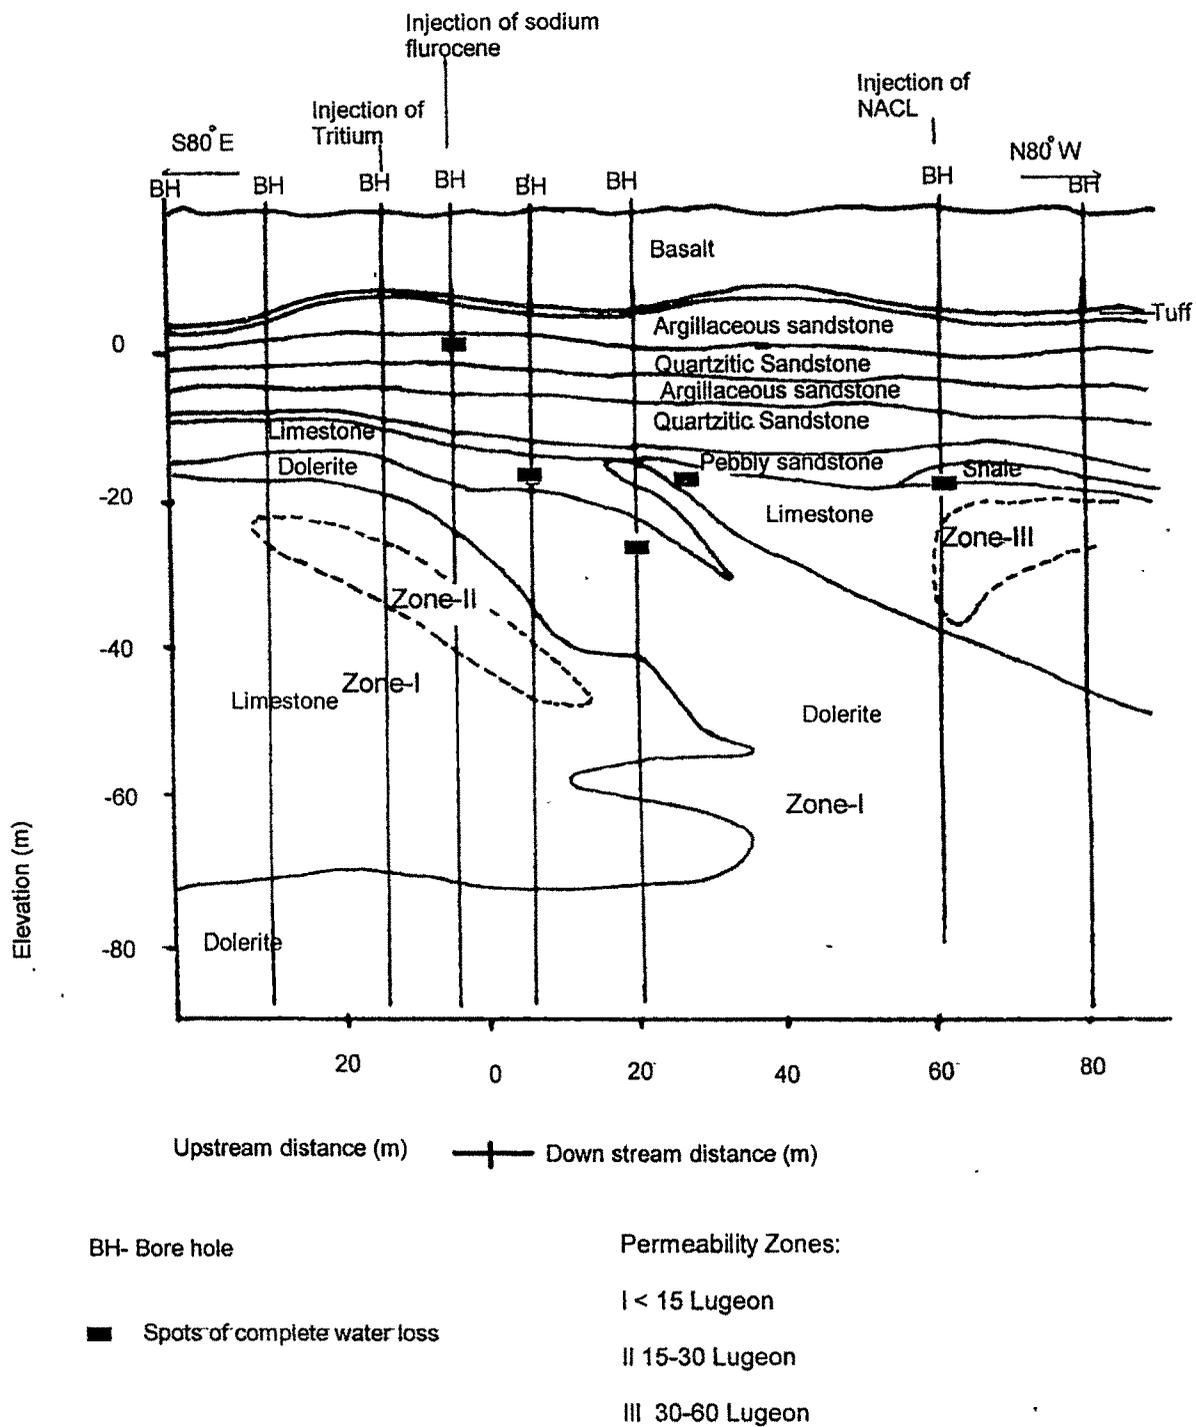
In general appreciable seepage was not observed in the foundation through basalt flows except at few locations where flow contacts were sheared and weathered (Plate 19). Seepage was observed through the contacts of infratrappean sedimentary rocks during the excavation of treatment shafts and drifts. These rocks are present in the foundation of Right Bank blocks at shallow depth. The limestone (30 to 60m thick) occurs in the foundation of spillway blocks 44 to 59 at about 40m depth (Fig. 26).

- (i) Sodium Fluorescein and Tritium were injected in the drill holes located in the upstream of Mokhadi fault. Even after 15 days tracers were not observed in the boreholes located in the downstream of the fault.
- (ii) Sodium Fluorescein was injected in the hole located 5m upstream of the dam axis (Fig. 26). Average velocity of 20 to 30m per day was observed on the basis

Fig. 26: Geological section (at Chainage 1275m) of Narmada dam foundation showing tracer study holes and permeability results of limestone rock

of observation in two bore holes located at 20m and 80m downstream, respectively. In another hole at 30m upstream of dam axis sodium chloride was used. No tracer was noticed even after 5 days in the observation holes located 5 and 60m away. Similarly, Tritanium was used in other holes but no tracer of Tritanium could be traced even after 8 days.
