BRIEF GEOLOGY OF THE NARMADA DAM SITE

Geotechnical problems and treatment of foundation of major dams on Deccan traps in the Narmada Valley/Gujarat/Western India

ABSTRACT: Foundation conditions of two major concrete gravity dams located across Narmada and Karjan rivers on Deccan traps in the Narmada Valley have been evaluated. Weak foundation media in the Deccan basalt flows are tuff, agglomerate and red bole. Besides, the rocks are dissected by joints, shears and faults. Older sedimentaries have been brought in juxtaposition with the basalt by faults in the vicinity of the Narmada site.

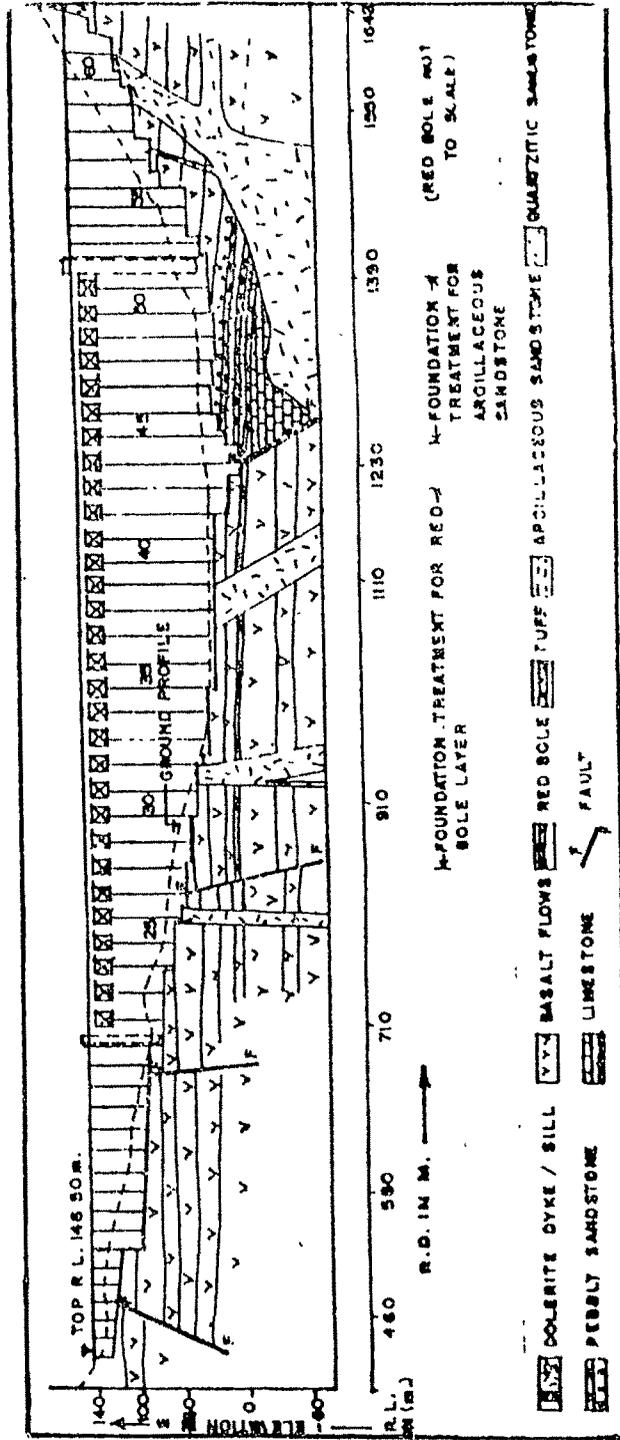
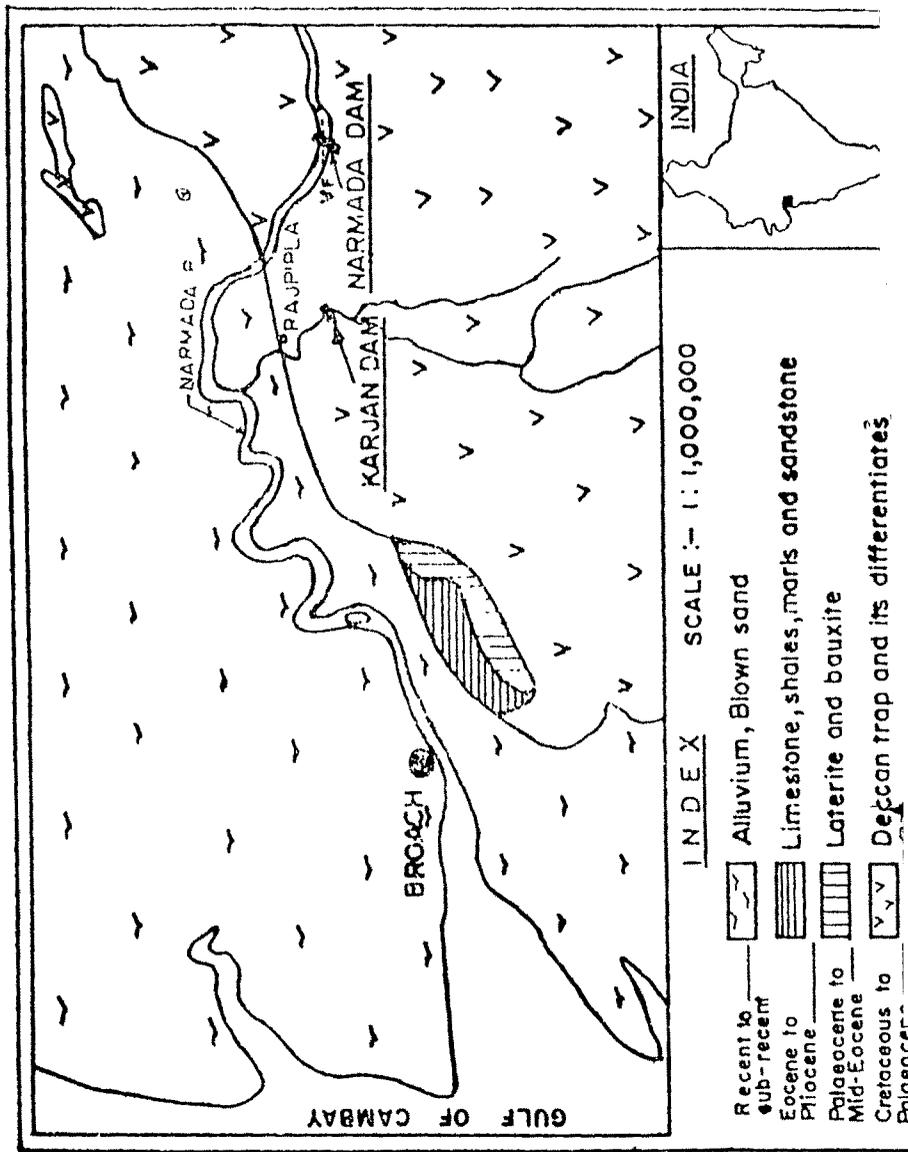
FIG. 2: GEOLOGICAL SECTION OF NARMADA DAM

Sedimentaries have been brought in juxtaposition with the basalt at the base of the dam by a river bed fault aligned in N 80°E-S 80°W direction, cutting across the foundations of five spillway blocks. The fault zone is about 12 m wide. The basalt on the footwall side of the fault is highly sheared and fractured. About 15 cm thick clay gauge is confined to the hanging wall. Sedimentaries adjacent to the fault zone on the right bank are also fractured.

sed at the dam base cutting across the foundations of five spillway blocks 41 to 44. It is aligned in $N80^{\circ}E - 580^{\circ}W$ direction dipping 60° towards $N10^{\circ}W$. The sedimentaries on the right bank have been brought near the surface in juxtaposition with the basalt by this fault. The length of the fault is about 1.6 km and width at the dam base is 12 m. The basalt on the footwall side is highly sheared and fractured.

About 15 cm thick clay gouge is confined to the hanging wall. In view of this fault, foundation of blocks 41 to 44 are having different lithological units of varying physico-engineering properties on both sides of the fault.

Deep reinforced concrete plug has been provided in the river bed fault at Narmada dam site in view of the low modulus of deformation value of the fault zone material and high modulus ratio of the adjoining rocks. Concrete shear keys have been provided in the foundation of Narmada and Karjan spillway blocks in order to prevent them against sliding along sub-horizontal weak layers having low values of shear strength.

The normal foundation level of the dam blocks adjacent to river channel fault is about EL (+) 18 m. As a part of the treatment, fault zone material was removed by excavating a trench in the foundation of river bed blocks down to 34 m depth (EL (-) 16 m) in the upstream and 26 m depth (EL (-) 8.0 m) in the down stream of the dam. Thus the actual depth of the fault zone treatment was about 2.15 to 2.83 times the width of the fault zone.

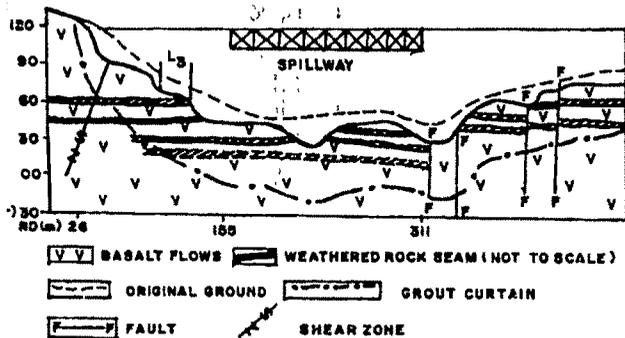
Fig. 2 Longitudinal geological section of part of the dam showing disposition of weathered rock seams.

characteristic feature in this area is the presence of weathered rock seams at 4 to 10m intervals, developed along interfaces of flows and sub-horizontal joints (Fig. 2).

Weathered rock seams occurring in the foundations of dam blocks have low shear parameters (" C " = 0, " ϕ " = 22° to 26°). These seams were considered as potential planes for sliding (Prakash, 1990). Based on the stability analyses concrete shear keys were provided in the foundation of all spillway blocks and in the foundations of right non-overflow blocks R1-A, R1-B and R2 besides other following remedial measures considered/provided to achieve required shear friction factor :

Treatment to shallow seams overlain by 3 to 5m good basalt rock cover was provided by excavating trenches and back filling them with concrete. For the deeper seams and where the blocks were already partly constructed, drifts were excavated from the approaches through shafts located in the apron area and back filled with concrete without affecting normal concreting work (Fig. 4).

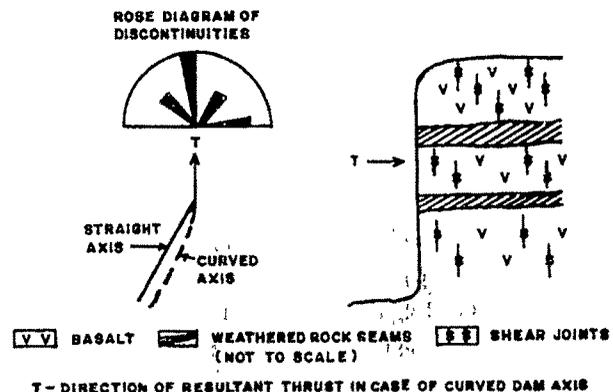
Fig. 3 Critical geological abutment conditions.

Curvature in the alignment of the dam. A mild upstream curvature in the alignment of the dam was initially considered for mobilising greater resistance against sliding. On the basis of geological analyses abutment rocks were not found suitable for arch action as they are dissected by steeply dipping shears, joints and faults aligned almost parallel to the probable direction of thrust in case of curved axis. These abutment rocks are also traversed by sub-horizontal weathered rock seams (Fig. 3).

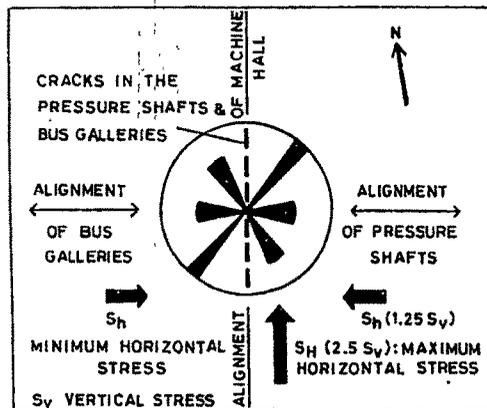
Figure 8. Rose diagram of discontinuities.

Cracks developed in the pressure shafts and bus galleries are aligned parallel to the longer axis of the machine hall. These cracks are not following geological discontinuities (Fig.8). Sub-horizontal to low dipping cracks developed in the downstream wall in an echelon pattern and sub-horizontal cracks in the upstream wall are parallel to the excavated profile of the existing ramp. A few cracks observed near the major shear zones 'A' and 'B' are due to modification of stresses around these weak features as also observed in the 3-D Finite Element Analysis (FEM) carried out by National Institute of Rock Mechanics. Symmetry of pattern of cracks parallel to the longer axis of the cavern in the pressure shafts and bus galleries suggest that these cracks are developed due to tensile stresses acting on inadequately supported rock mass.

Additional supports have been installed in the machine hall in the area affected by cracks. The remedial support in the upstream wall consisted of 10.5 to 32m long 80 tonnes capacity cables, tensioned to 50 tonnes and then fully grouted. In addition 12m long, 32mm dia, rock bolts, tensioned to 20 tonnes, were installed at various locations. In the downstream wall, a large number of 12m long 32mm dia, rock bolts, tensioned to 20 tonnes before grouting, were installed in addition, a number of 25m long 50 tonne capacity cables were also installed. These cables were tensioned to 5-tonnes before grouting.

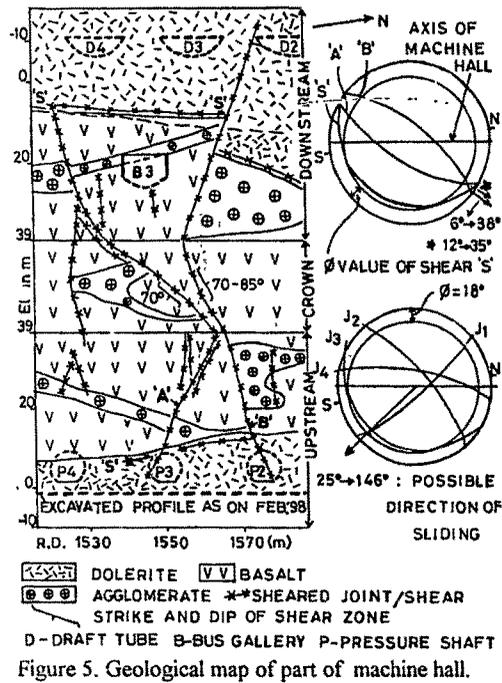
Horse shoe shaped exit tunnels (E.T.) of 12.5m dia, are passing through basalt, agglomerate, dolerite dyke and sill. The Akkalbar fault runs parallel and close to the alignment of the E.T.-1 for about 222m length. Joints sympathetic to the fault are observed in this tunnel. Intersection of three sets of chlorite coated joints in dolerite rock, form removable/detachable blocks of size varying from 1m³ to 6m³ resulting in block falls at places. Collapses in part of the tunnel sections traversed by chlorite coated joints and slaked rock zones have occurred despite installation of design rock bolt supports (Fig.9). Therefore, rib supports have been installed in all the tunnels at critical locations (Prakash & Sangneria 1993)

of their orientation and thus they are not creating any problem of wedging (Fig. 5).

Major part of the remaining excavation in the downstream is required to be carried out in the dolerite sill dissected by chlorite coated joints. Sliding wedge is formed with the intersection of joints J_1 and J_2 having 25° plunge towards $S34^\circ E$ (i.e towards free face). Similar minor rock wedges are formed with the intersection of joints J_1 and low dipping shears 'X', 'Y' and 'Z' (Fig.6). Therefore, it has been suggested to adequately stitch these rock wedges during progressive excavation.

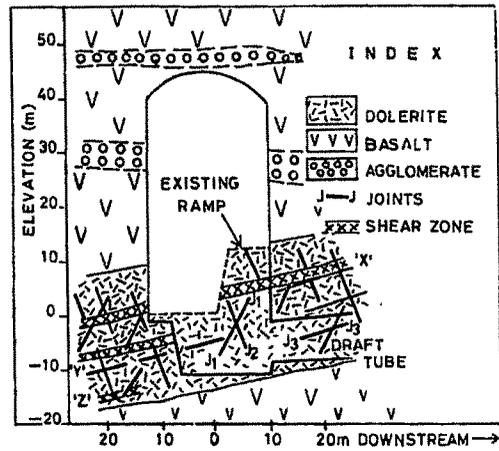
Figure 6. Geological cross section of machine hall.

Glass plates have been installed in the downstream wall and bus galleries to monitor the existing cracks. Analysis of the data for the period October, 1993 to February, 1998 show that the activity of glass plate breaking is intermittantly continuing and is of periodic nature. The activity is prominent during the period October - February of each consecutive year (Fig. 7). Reasons for enhancement of the activity can be attributed to either reduction in the strength of the rock mass after saturation or to the development of hydrostatic pressure in the walls or to both.

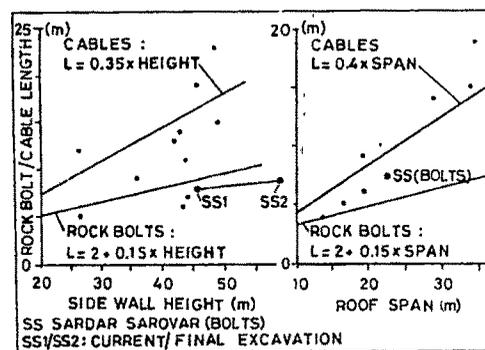
Figure 4 Plots of rock bolt and cable lengths for side wall and arch (roof) supports in various underground hydroelectric projects (Hoek 1995)

The excavation has been done by NATM to utilise the rock itself as principal structural material. Analysis of the design supports show that length of the rock bolt designed for roof is adequate while that for the walls is inadequate. The wall rock bolt length from the various empirical approaches has been estimated to be at least 10m against 6 to 7m long rock bolts installed in the machine hall (Goel & Jethwa 1992). For 58m high cavern 11m long rock bolts or 20m long cables are required (Fig. 4).

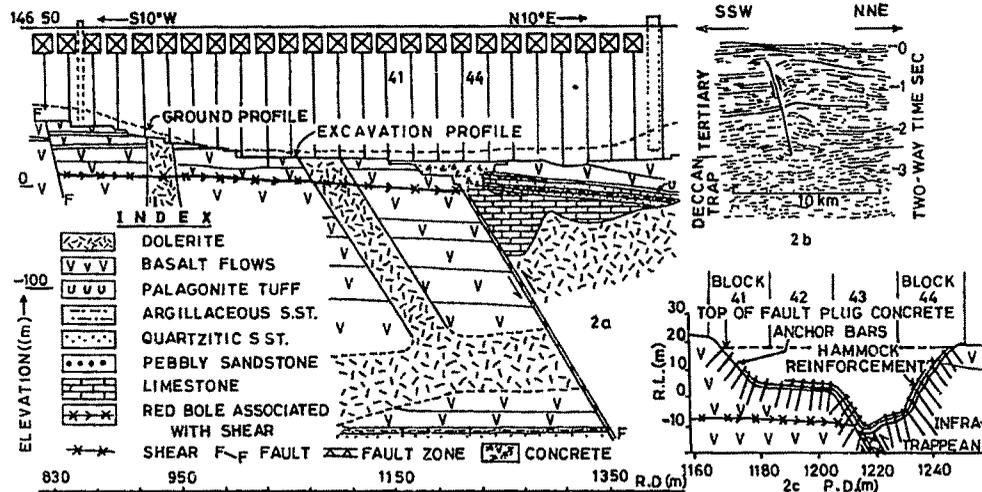
Figure 2(a) Longitudinal section of spillway blocks, 2(b) Seismic section across north Tapti anticline in onland Tertiary sequence in western part of 'SONATA' zone (RaviShanker 1993) and 2(c). Section depicting fault zone treatment.

Sympathetic to main fault, seven minor faults are obliquely traversing the foundation of dam blocks 4-5, 21-24, 25-27, 30-34, 45-47, 45-48, 48-55. These local

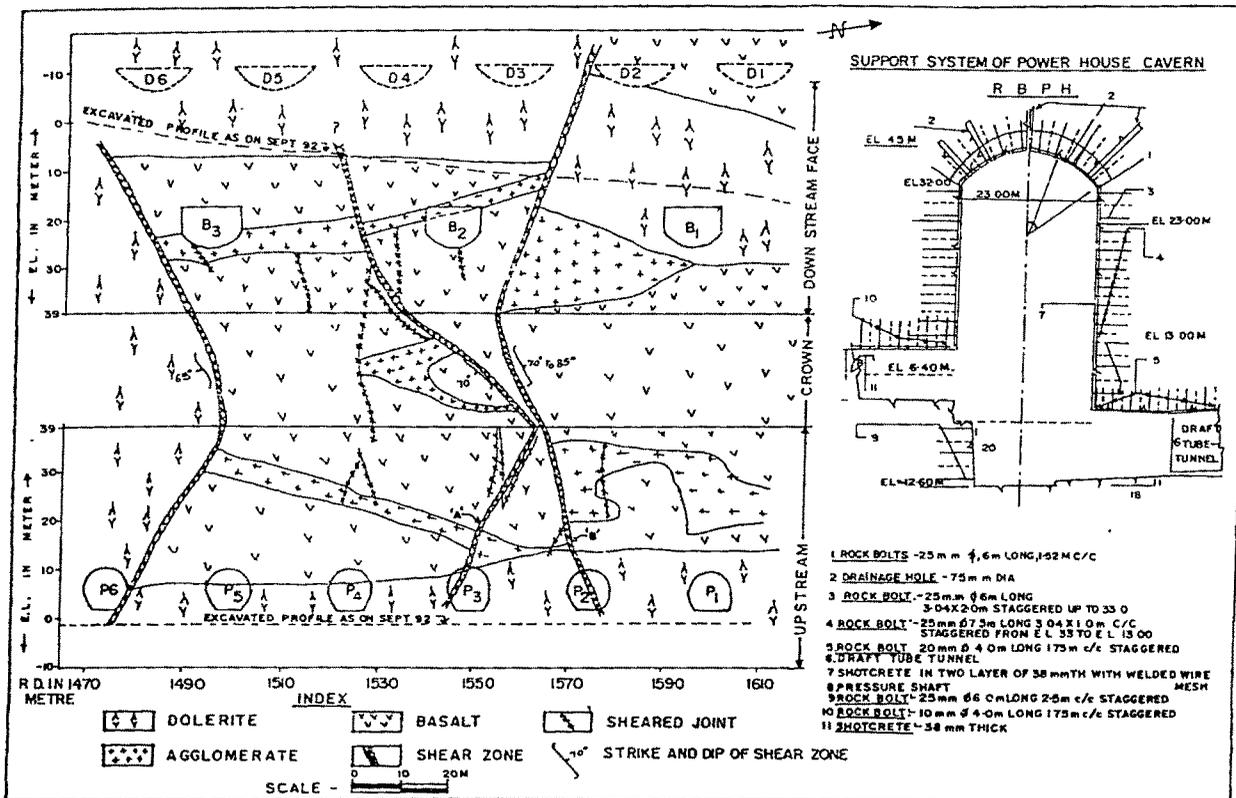
FIG. 3. 3-D GEOLOGICAL LOG OF MACHINE HALL

The crack started developing in the wall when excavation progressed to El.14 m. The first 18 m high crack at RD 1569 m was noticed in March, 1991. Length of the crack increased from 18 to 22 m in Sept.1991, and new cracks developed during benching operation from El.14 m to (-)2 m till April 1992. Most of the cracks developed between RD 1547 and 1580 m are vertical in nature with maximum opening of the order of 15 mm. A few horizontal cracks have also been noticed. These vertical & horizontal

cracks are developed along and adjacent to shear zones 'A' and 'B' above pressure shafts - 2 & 3 between E1.11 and 37 m. Extension of the cracks inside the rock mass has been observed by opening windows in the shotcrete. Snapping of the wiremesh has also been noticed. Detachment of the shotcrete has been observed just below the spring line of the machine hall in about 30 m length. Maximum dislocation of the shotcrete from rock face of the order of 200 mm has been noticed between E1.36.5 and 37.5 m, that is just below the spring line E1.39 m (Fig.4).

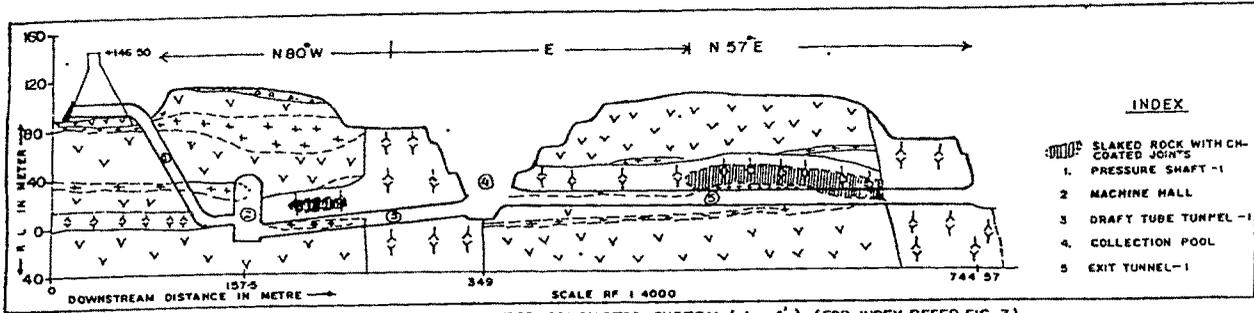
FIG.5 GEOLOGICAL SECTION ALONG WATER CONDUCTOR SYSTEM (A - A') (FOR INDEX REFER FIG-3)

Horse shoe shaped exit tunnels (E.T) of 12.5 m diameter are passing through basalt, agglomerate, dolerite dyke and sill. The Akkalbar fault runs parallel and close to the alignment of E.T-1 from the outlet portal (RD 0 m) to kink point (RD 222 m). Joints sympathetic to the fault are traversing all the three tunnels, but they are more prominent in the E.T-1. A low dipping shear zone dipping 30° towards south (outlet end) is crossing the alignment of E.T-1 at RD 100 m, E.T-2 at RD 62 m and E.T-3 at RD 50 m. Minor water seepage has been noticed along this shear (Prakash & Chidambranathan, 1991). About 50% of the tunnel length is passing through slacked dolerite/chlorite coated joints (Fig.5). The physico-engineering properties of the dolerite are given in the table-3.

Laboratory shear tests of the chlorite coated joints have given the value of C as zero and $\phi = 18^\circ$. Low value of the shear parameters of the chlorite coated joints are indicative of poor shear strength of rock mass.

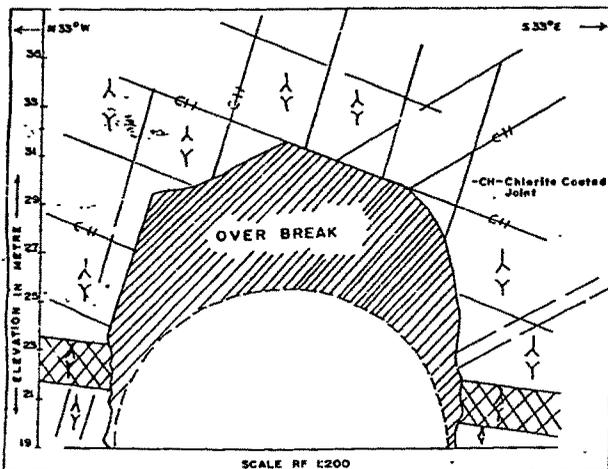
FIG.6 GEOLOGICAL CROSS SECTION OF EXIT TUNNEL- I. RD.79 m. (FOR INDEX REFER FIG 3)

Major roof falls/block falls occurred in the exit tunnel-1 between RD 0 and 113 m after the installation of the rock bolts (Fig.6). About 50% rock bolts have been reported to be slipped in the slacked/chloritized zone during tensioning. Second layer of the shotcrete with wiremesh was not provided in the month of May 1990 and subsequently resulted in the roof falls in the month of Sept.1990 after the entry of flood water. Intersection of three sets of chlorite coated joints are forming removable/detachable blocks of size varying from 0.5 x 1 x 2 m to 1 x 2 x 3m resulting in block falls in the exit tunnels at places. Pattern rock bolts could not prevent the collapses in the slacked rock zones. Design support system based on rock mass classification included pattern tensioned grouted rock bolts and shotcreted with intervening wiremesh. Goodman & Hatzor (1990) opined that in highly discontinuous rock formations general rock classification is questionable. After the collapses support system was reviewed and steel rib supports were introduced in all the tunnels at critical locations.

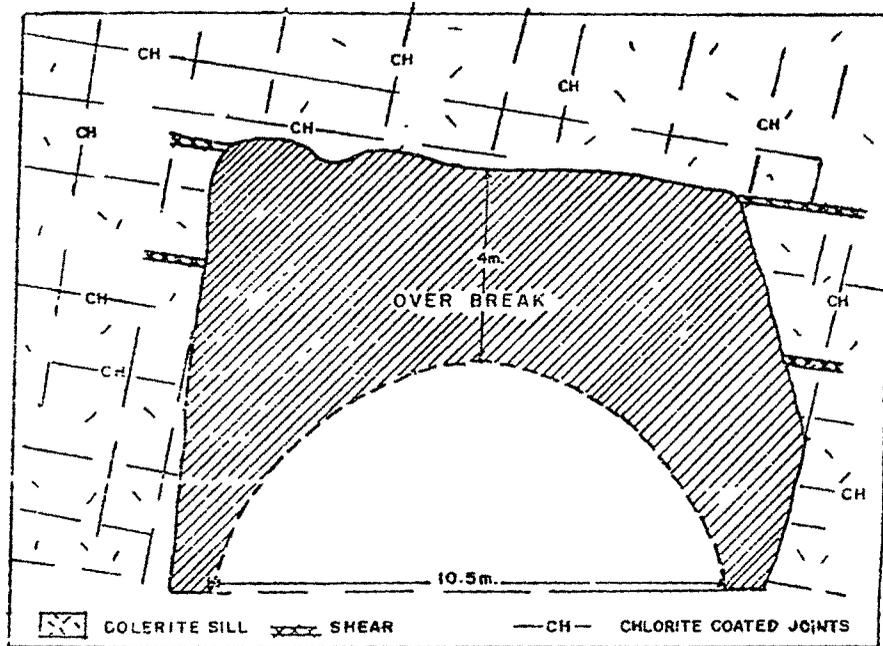
Fig.4 - GEOLOGICAL CROSS SECTION OF PART OF THE DRAFT TUBE TUNNEL-2
SHOWING OVER BREAKS ALONG SUB - HORIZONTAL SHEARS

is dissected by chlorite coated joints and shears. Major rockfall occurred in the D.T-2 on 6.11.90 between R.D. 74 and 86m along the sub-horizontal shears involving overbreaks of the order of 4.5m in height even after the installation of rock bolt supports. Overbreaks in flat roof have been noticed in all the tunnels passing through dolerite sill (fig. 4). Rib supports have been installed in all the tunnels after the collapses except in about 80m length of the D. T-1 and 14m length of D. T-2 where chlorite coating along joints was almost negligible. Reinforced lining has been done in the reaches supported by rock bolt.
